Hilti CFS-CID Firestop Cast-In Device

FIRE RESISTANCE TEST IN ACCORDANCE WITH BS 476: PART 20: 1987

On 6 nos. of PVC Pipes and Conduits (Specimens '20', '22', '23', '24', '25' and '26')

Test Report No.: R16L28-1C

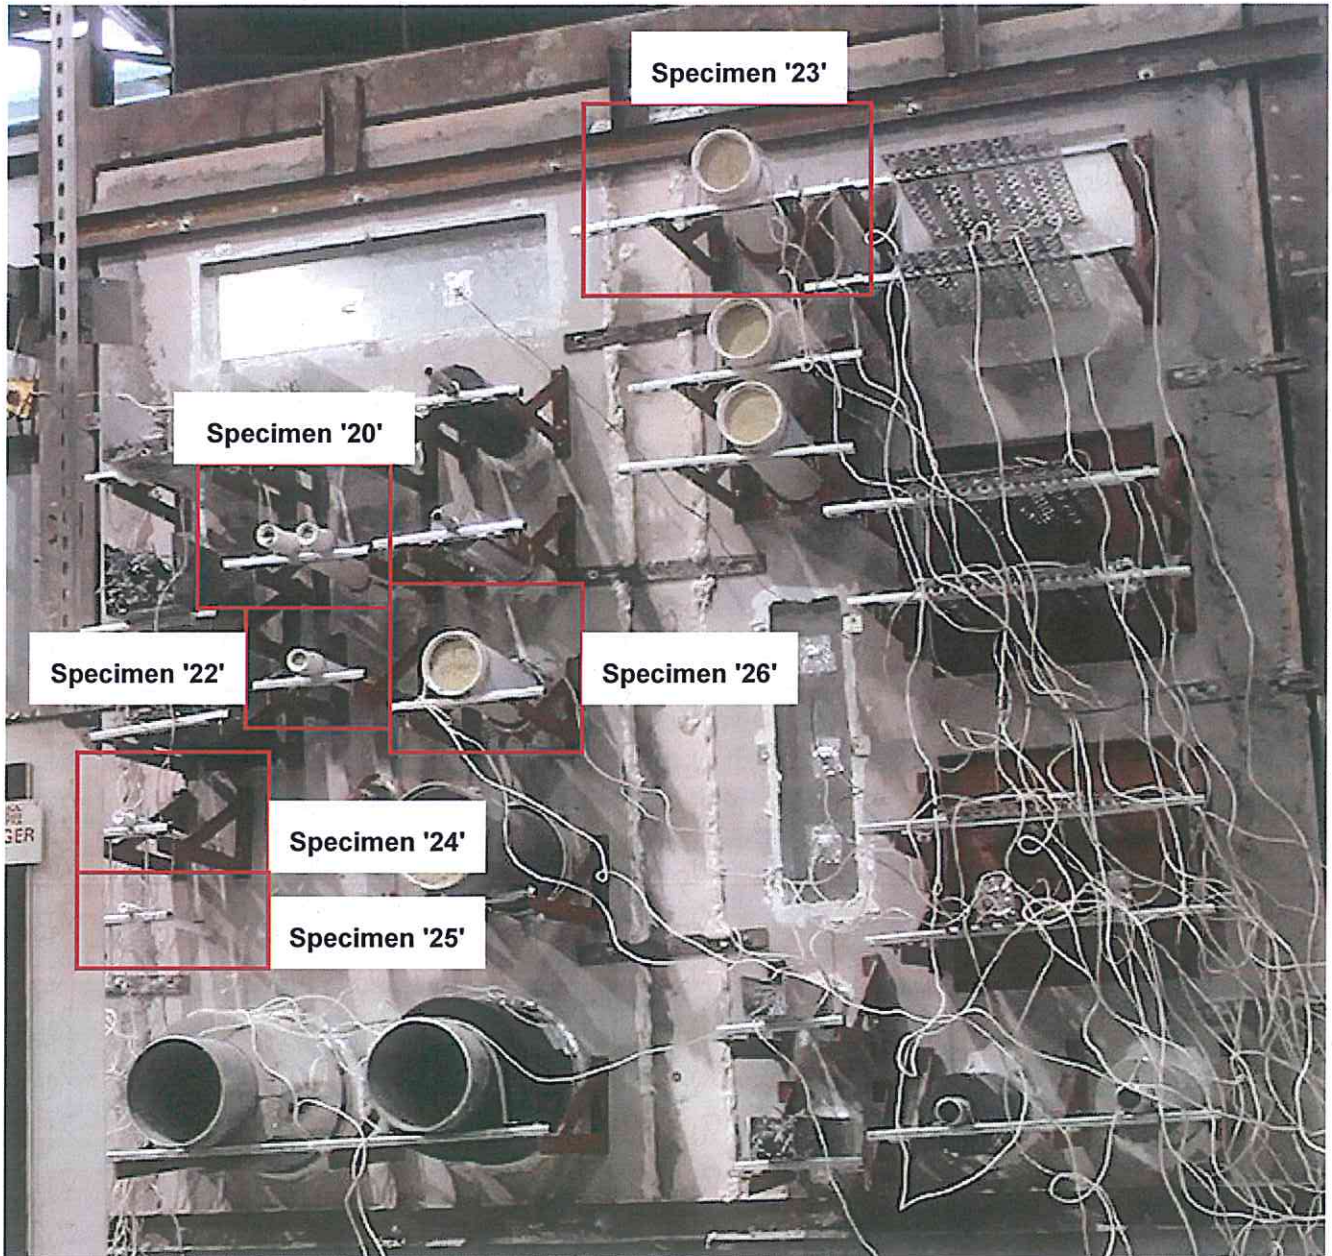
Photo 1: The unexposed face of the specimens before the test.

Note: In this test report, only specimens '20', '22', '23', '24', '25' and '26' were considered.

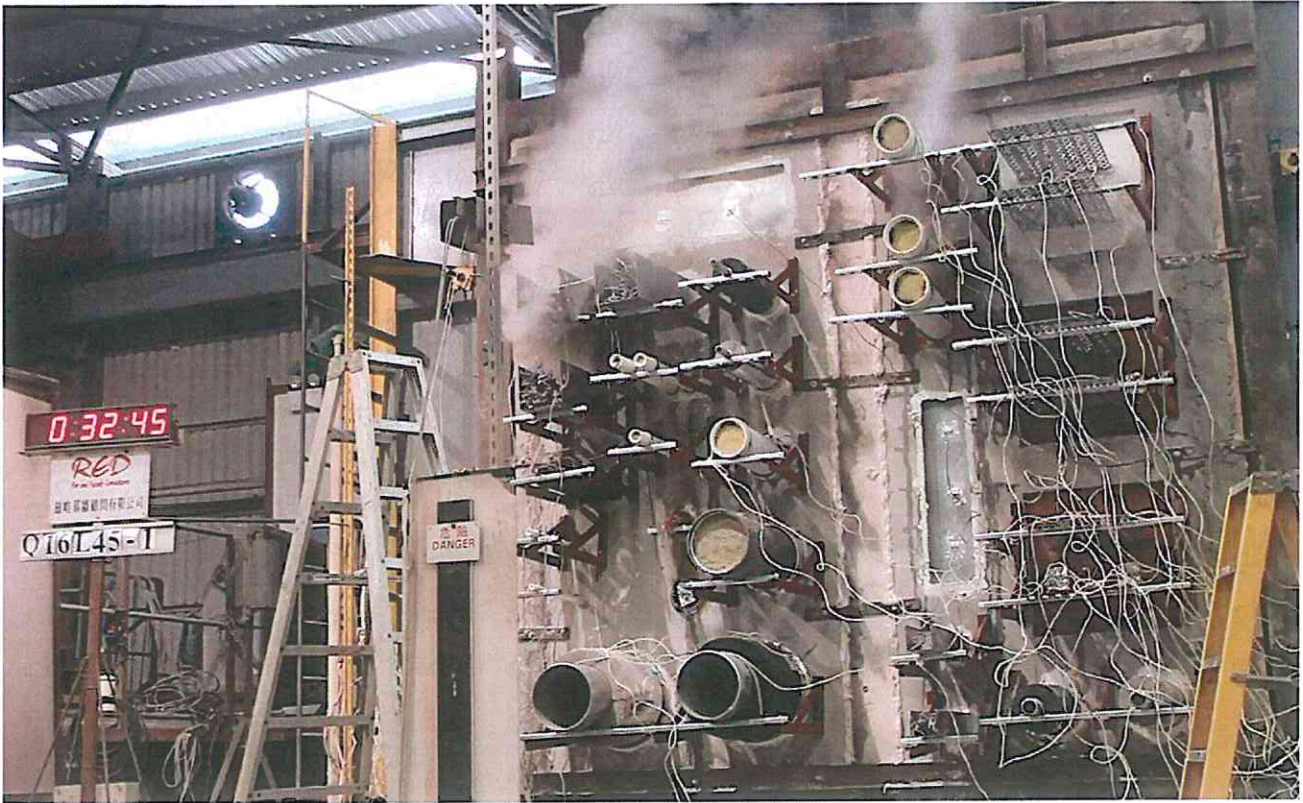
Photo 2: The unexposed face of the specimens after a heating period of 32 minutes.

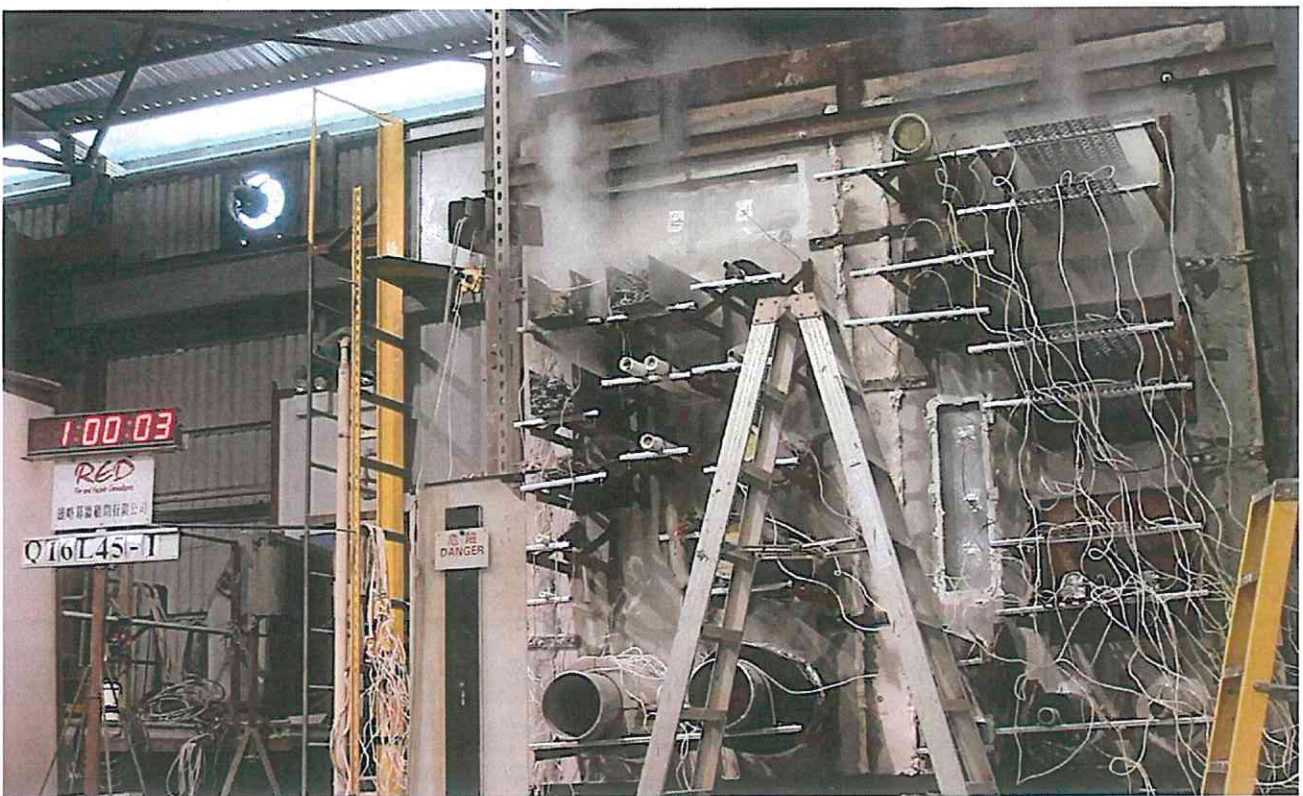
Photo 3: The unexposed face of the specimens after a heating period of 60 minutes.

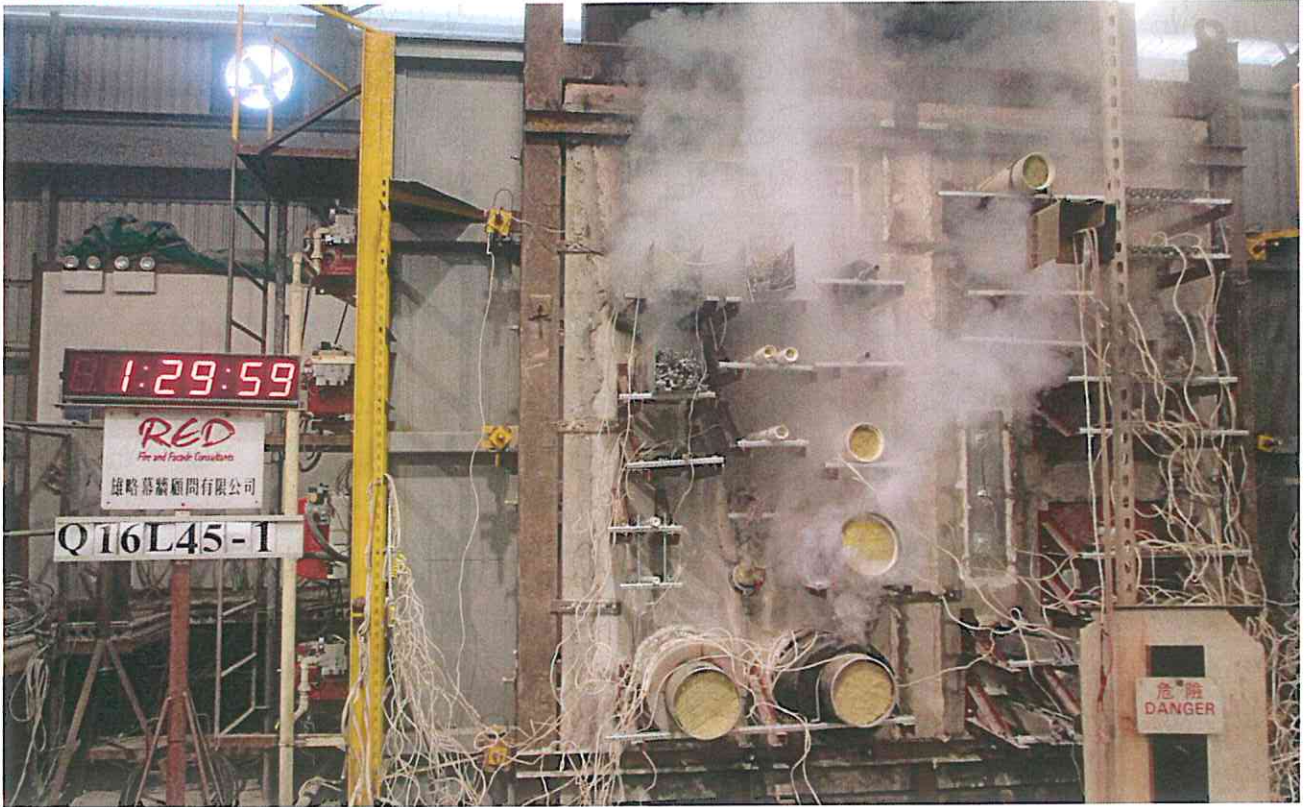
Photo 4: The unexposed face of the specimens after a heating period of 89 minutes.

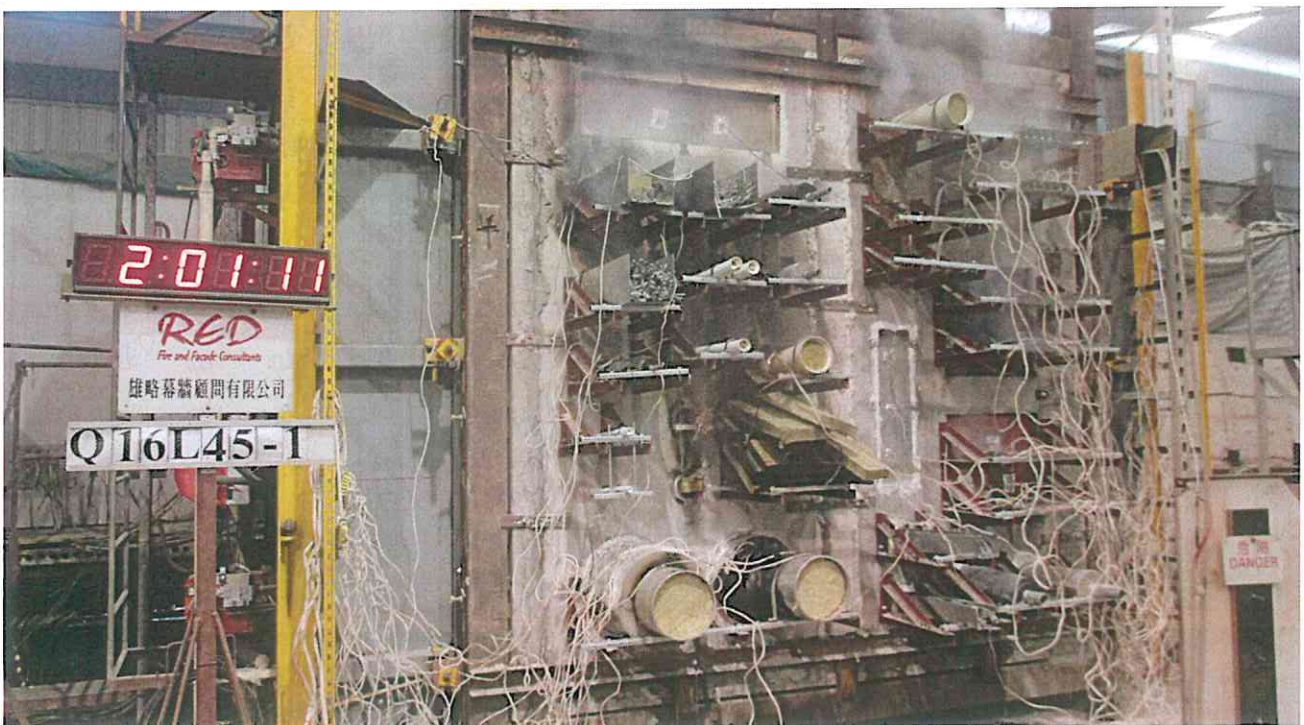
Photo 5: The unexposed face of the specimens after the test.

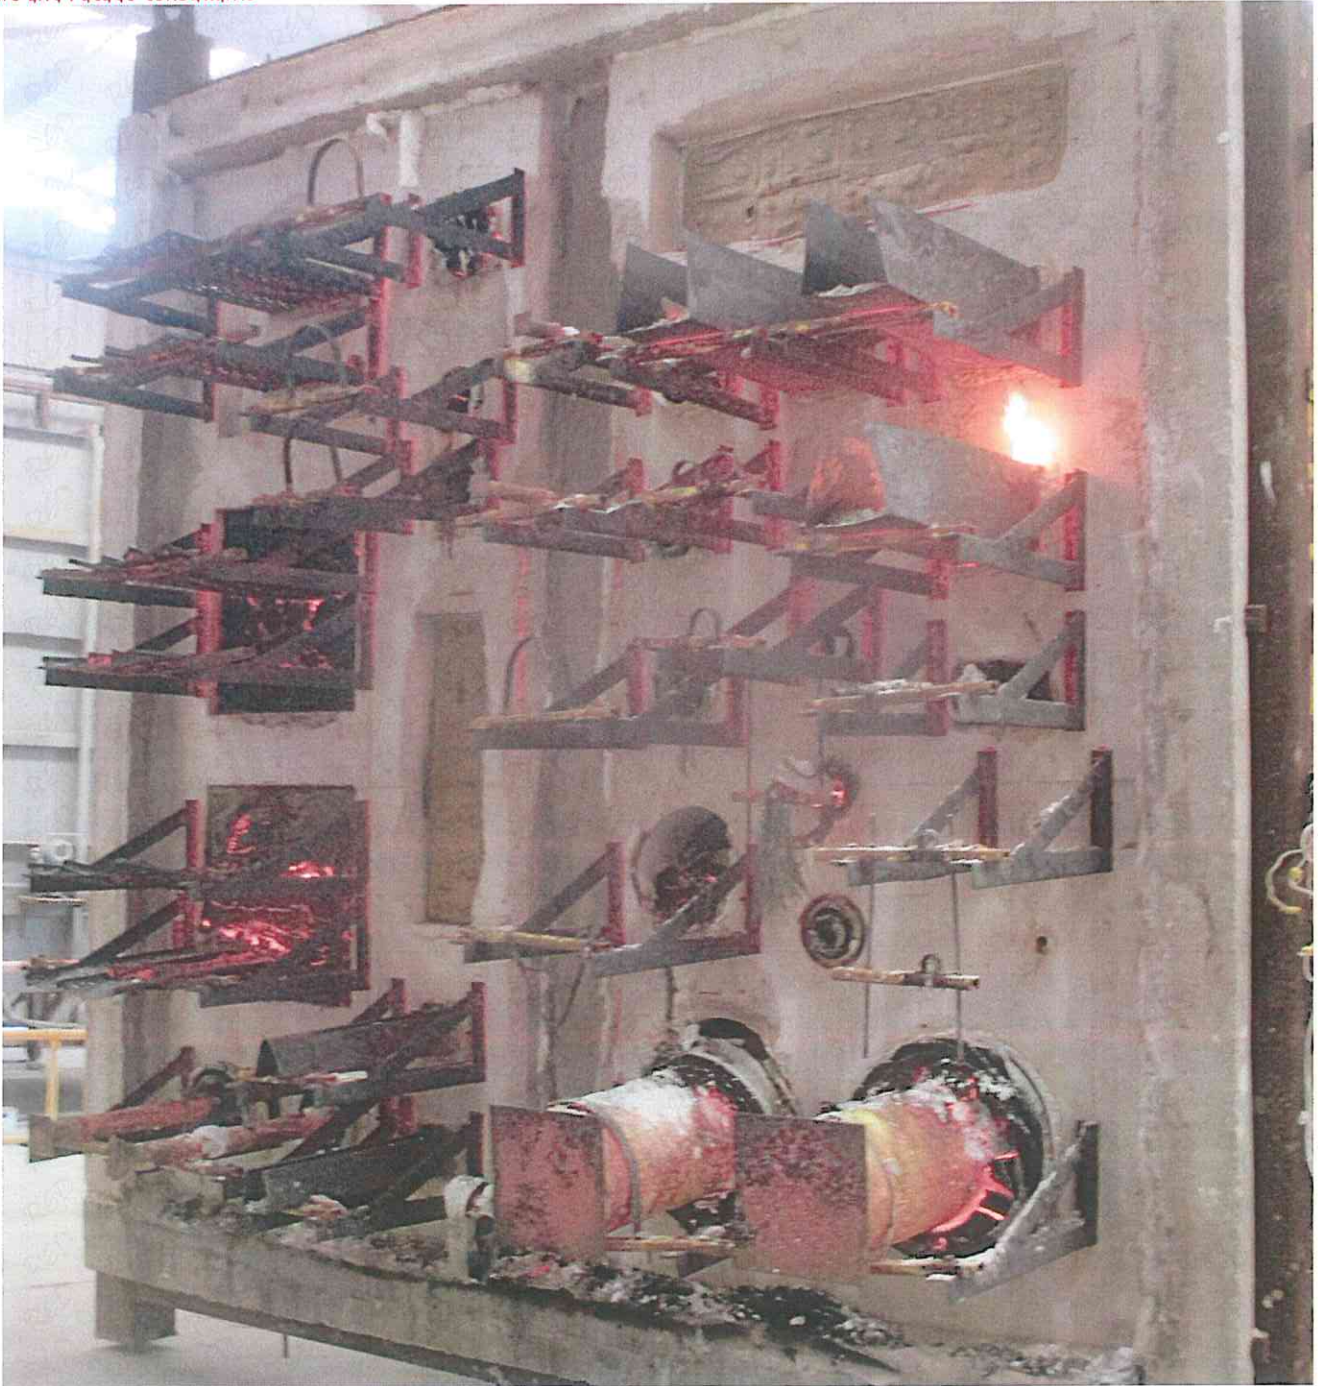
Photo 6: The exposed face of the specimens after the test.

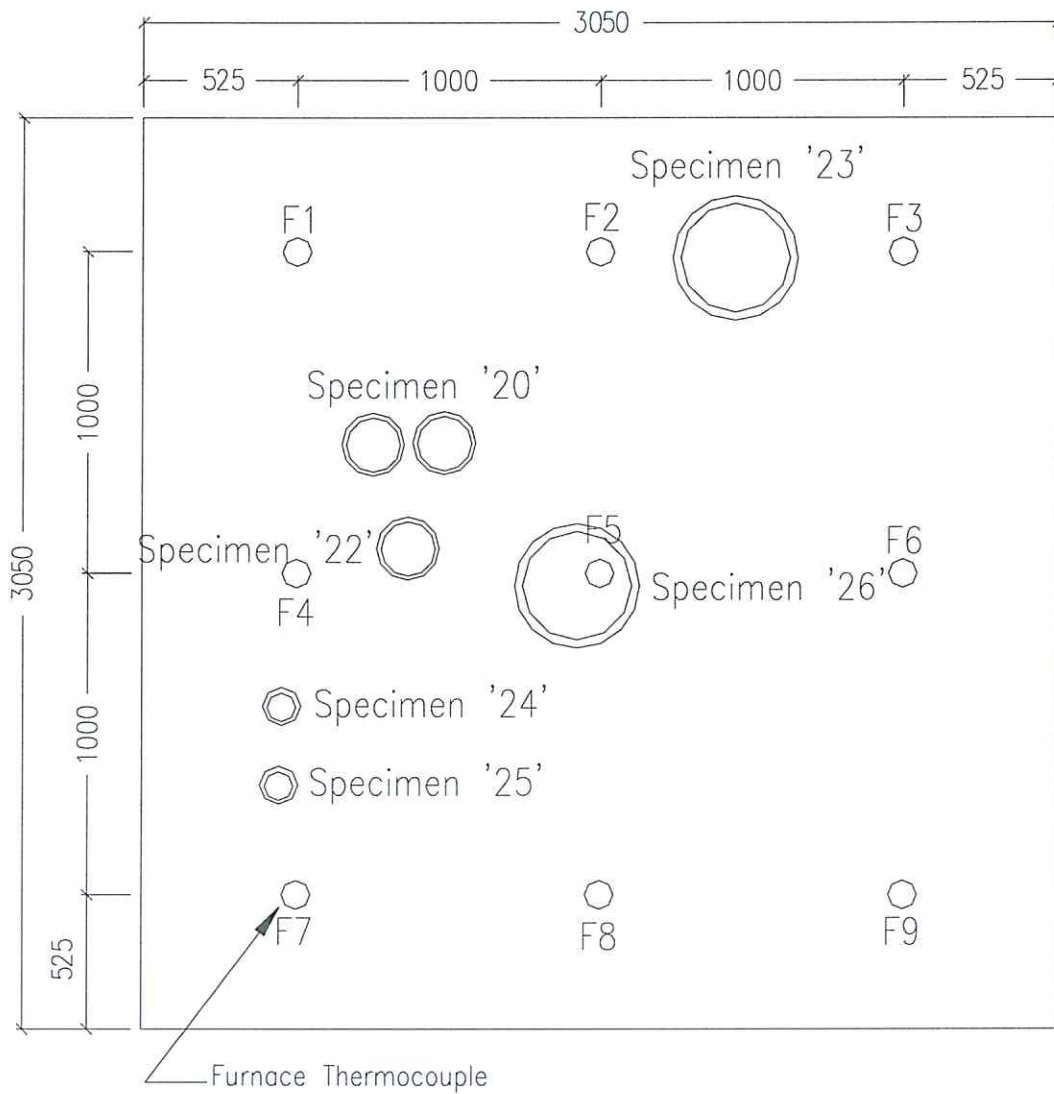
Figure 1 – Locations and reference numbers of furnace thermocouples.
(This figure is not to scale and all dimensions are in millimetres.)

Nine (9) 'type K' thermocouples to monitor the temperature of the furnace, which were kept at 100 mm from the exposed face of the specimen (see Figure 1).

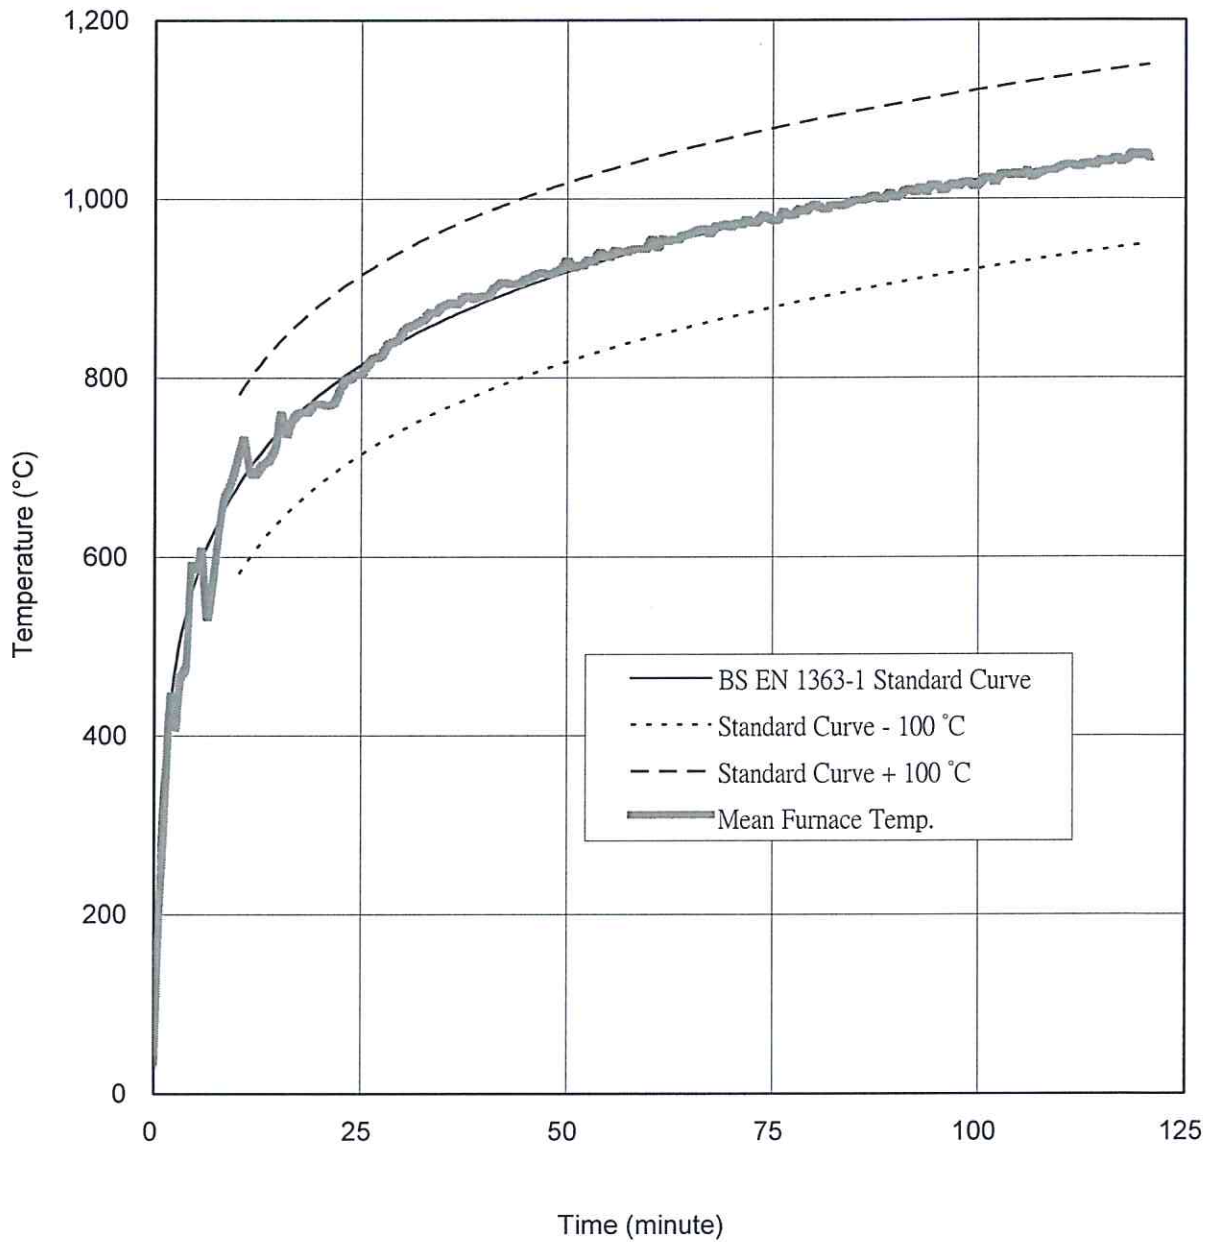
Figure 3 – Mean furnace temperature.

The furnace was controlled so that the mean furnace temperature complied with the requirements of BS 476: Part 20: 1987. The temperature record was shown graphically in Figure 3.

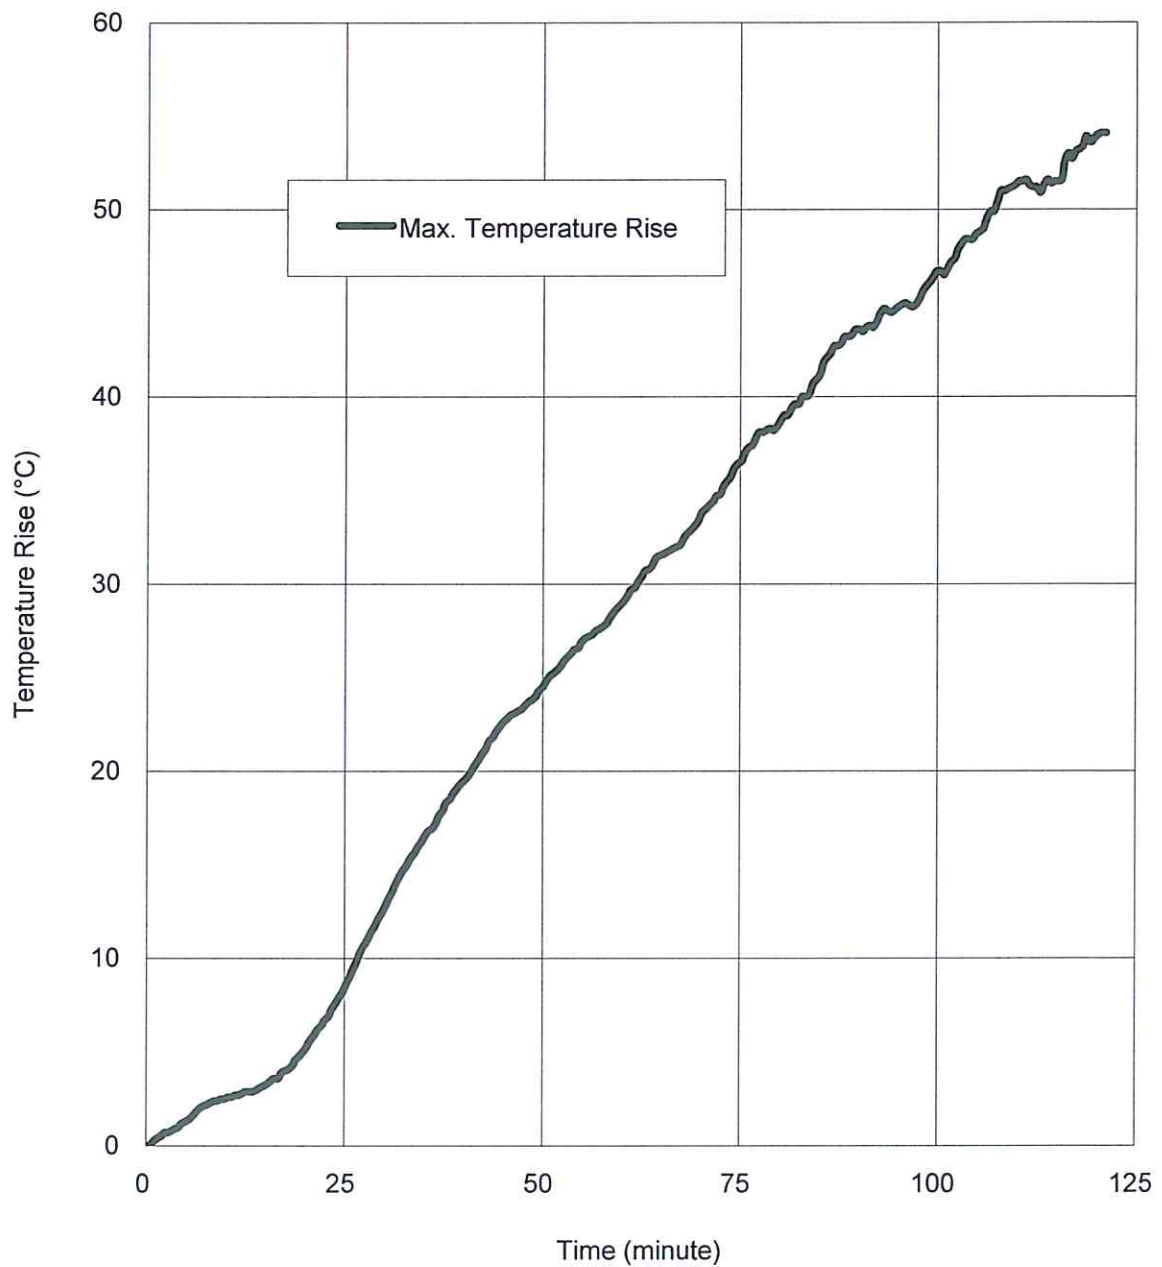
Figure 4 – Temperature rises of unexposed surface of specimen '22' (for additional information only).

The maximum temperatures of the unexposed surface of specimen '22' was shown graphically in Figure 4.

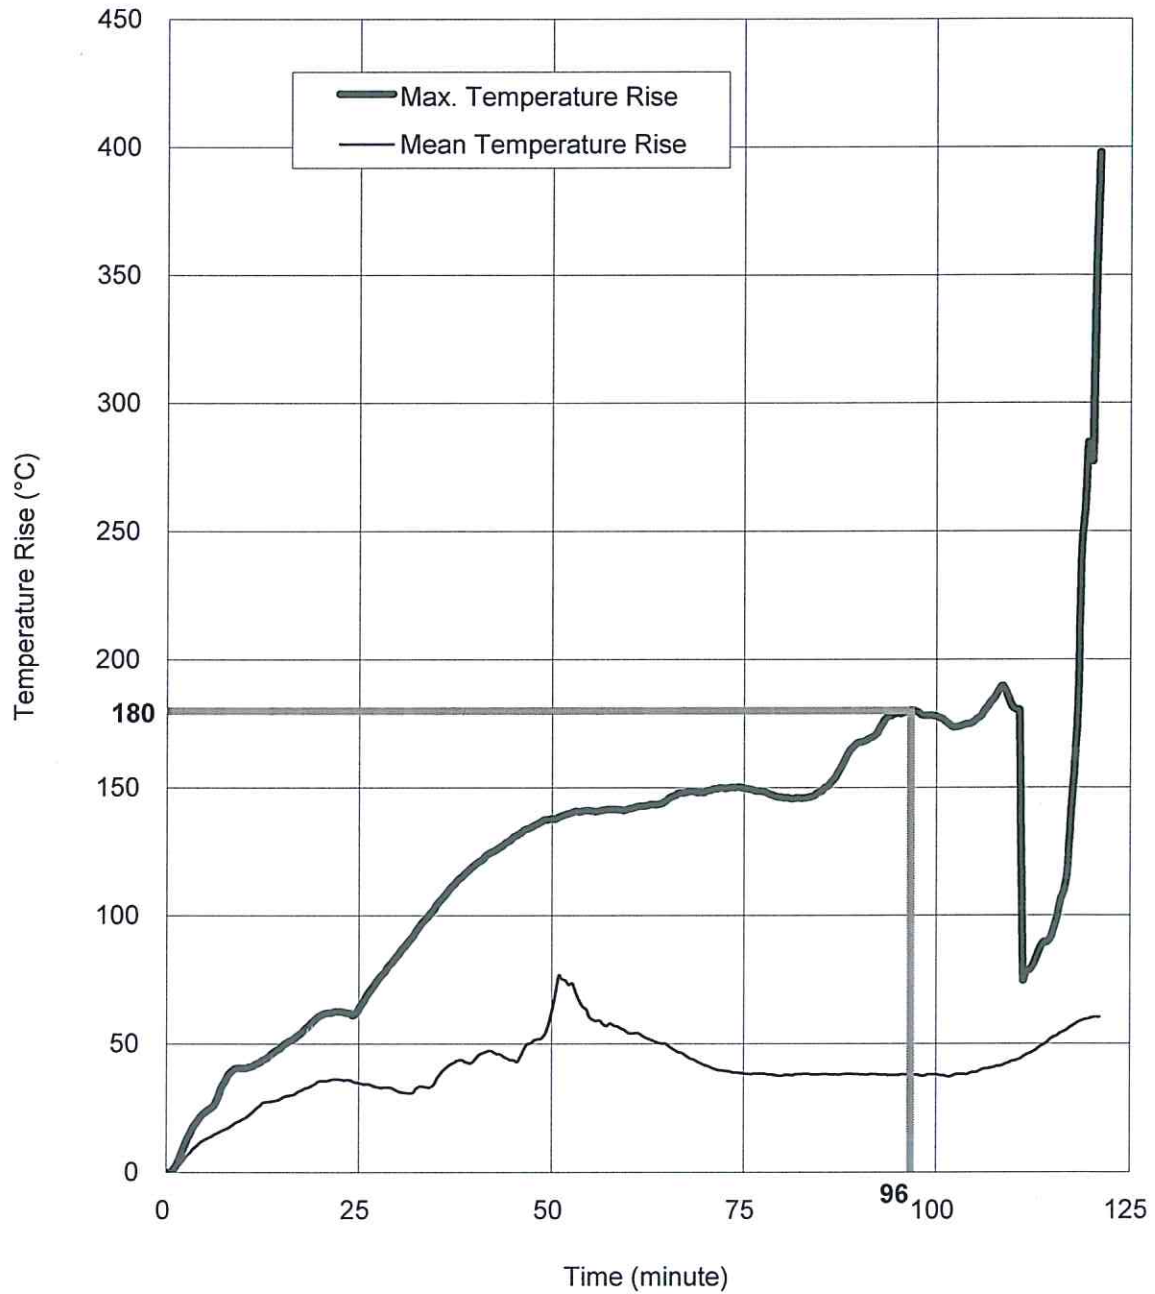
Figure 5 – Temperature rises of unexposed surface of specimen '23'.

Note: Thermocouple S30 detached after a heating period of 111 minutes.

The mean and maximum temperatures of the unexposed surface of specimen '23' were shown graphically in Figure 5.

The 140 °C rise of the mean temperature of the unexposed surface of specimen did not reach during the test. The 180 °C rise of the maximum temperature of the unexposed surface of specimen reached and measured by thermocouple S30 after a heating period of 96 minutes. The maximum temperature rise was 398 °C measured by thermocouple S31 after a heating period of 121 minutes.

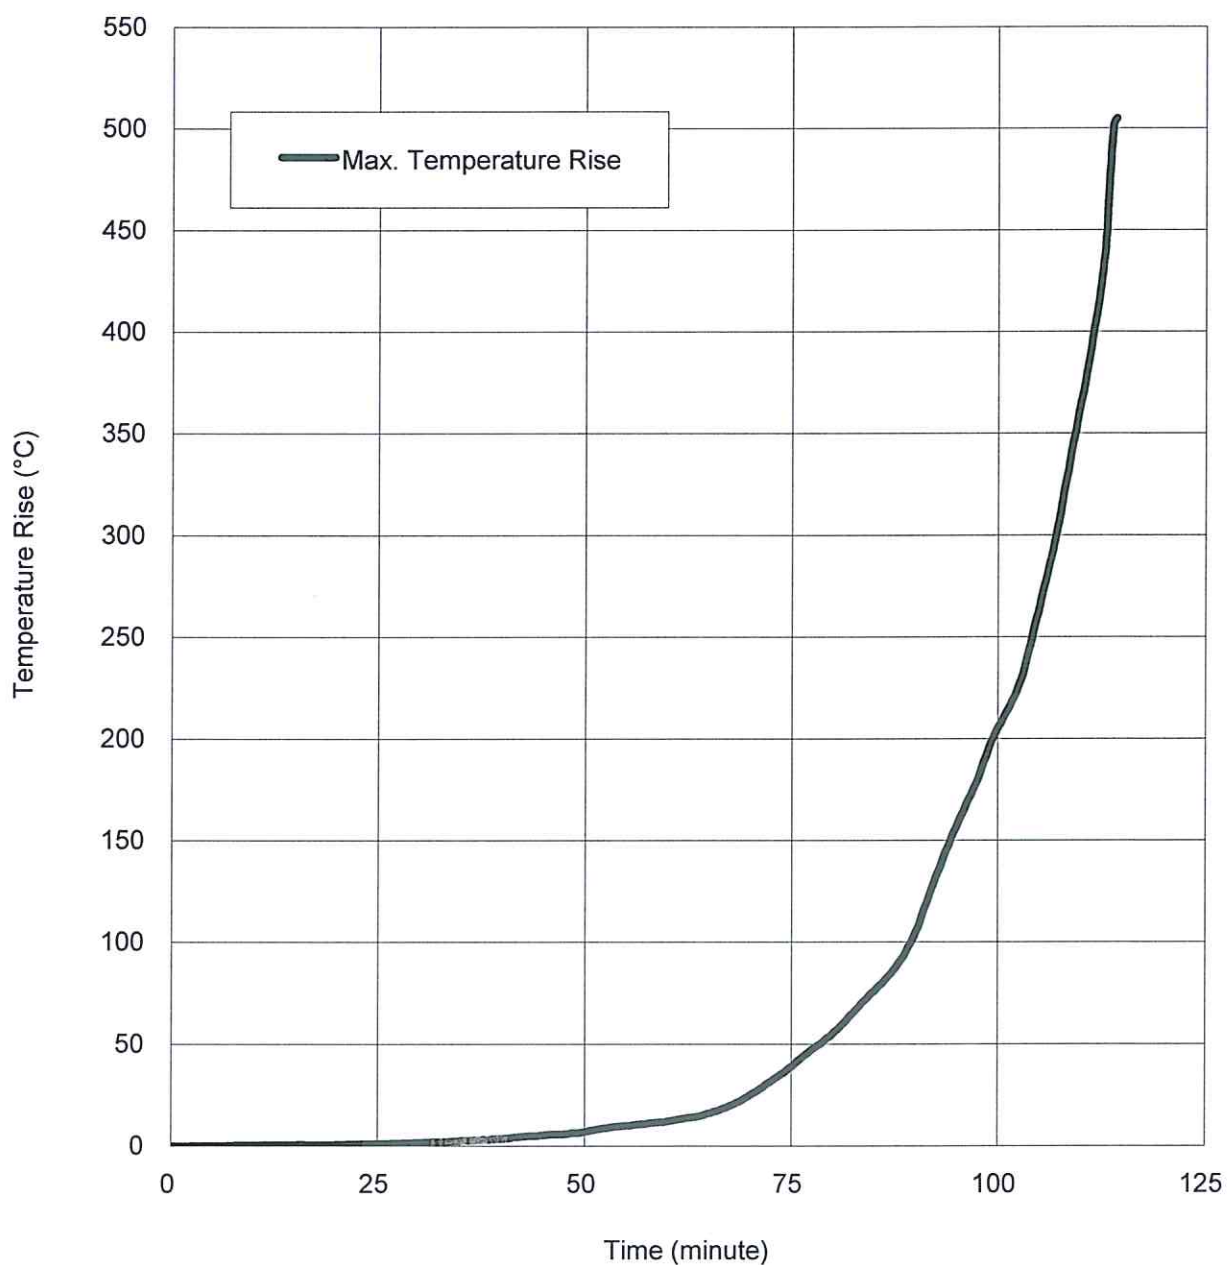
Figure 6 – Temperature rises of unexposed surface of specimen '25' (for additional information only).

Note: Thermocouple S13 was detached after a heating period of 114 minutes.

The maximum temperatures of the unexposed surface of specimen '25' was shown graphically in Figure 6.

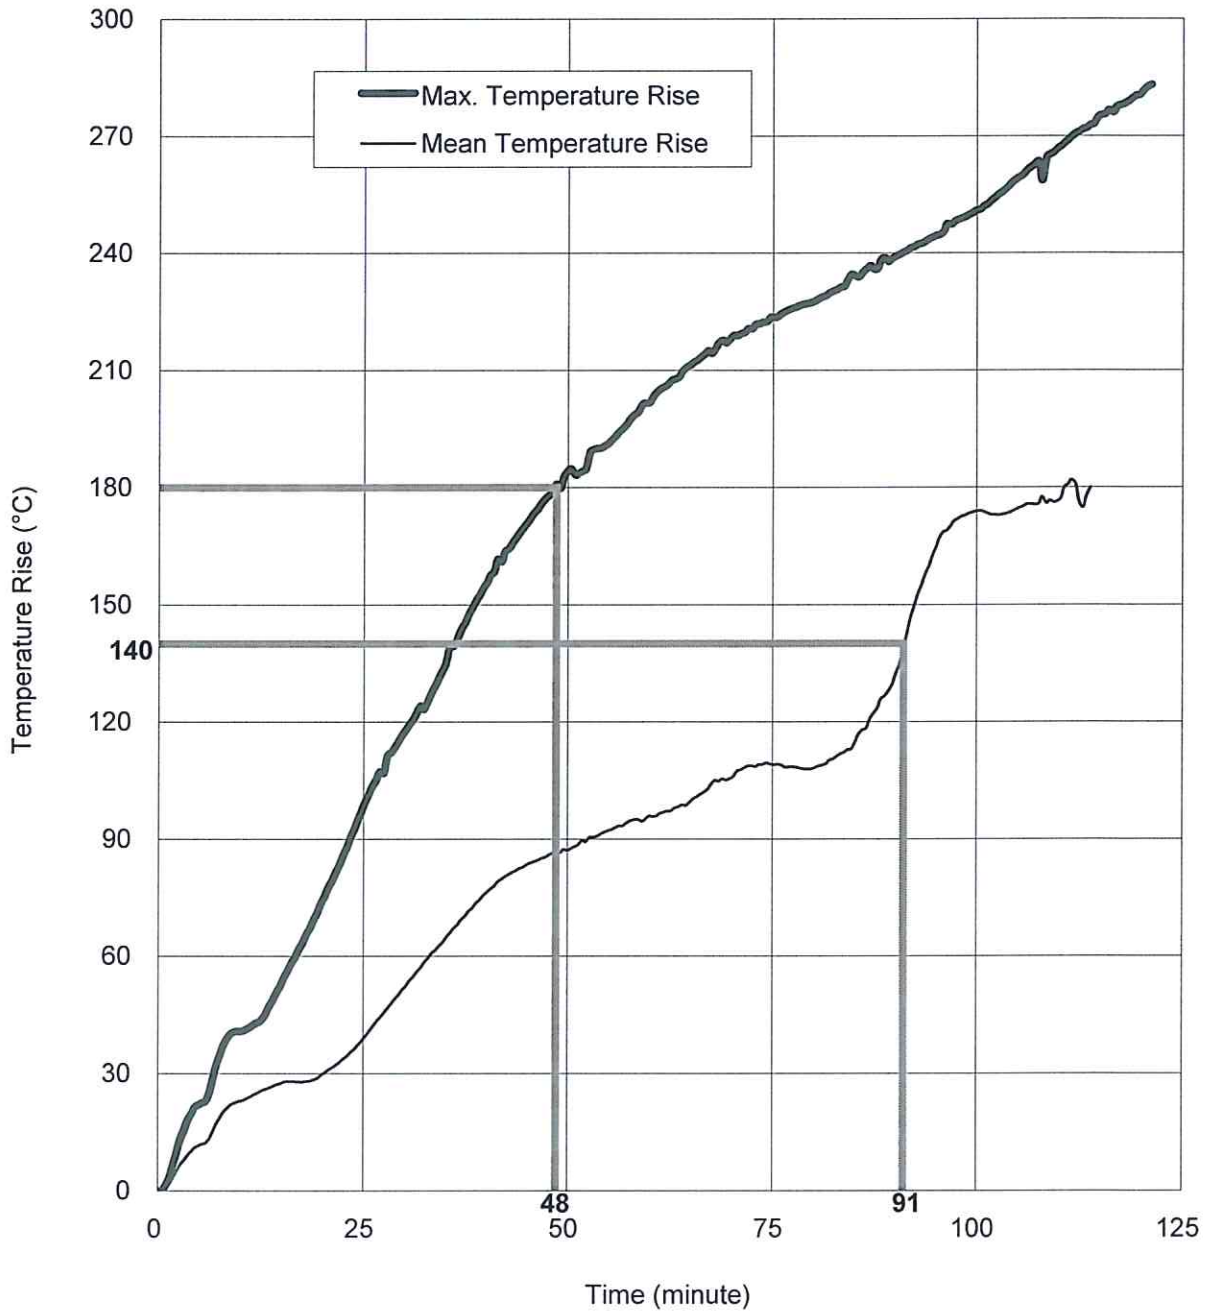
Figure 7 – Temperature rises of unexposed surface of specimen '26'.

Note: Thermocouples S27-S29 were detached after a heating period of 114 minutes.

The mean and maximum temperatures of the unexposed surface of specimen '26' were shown graphically in Figure 7.

The 140 °C rise of the mean temperature of the unexposed surface of specimen reached after a heating period of 91 minutes. The 180 °C rise of the maximum temperature of the unexposed surface of specimen reached and measured by thermocouple S26 after a heating period of 48 minutes. The maximum temperature rise was 283 °C measured by thermocouple S26 after a heating period of 121 minutes.

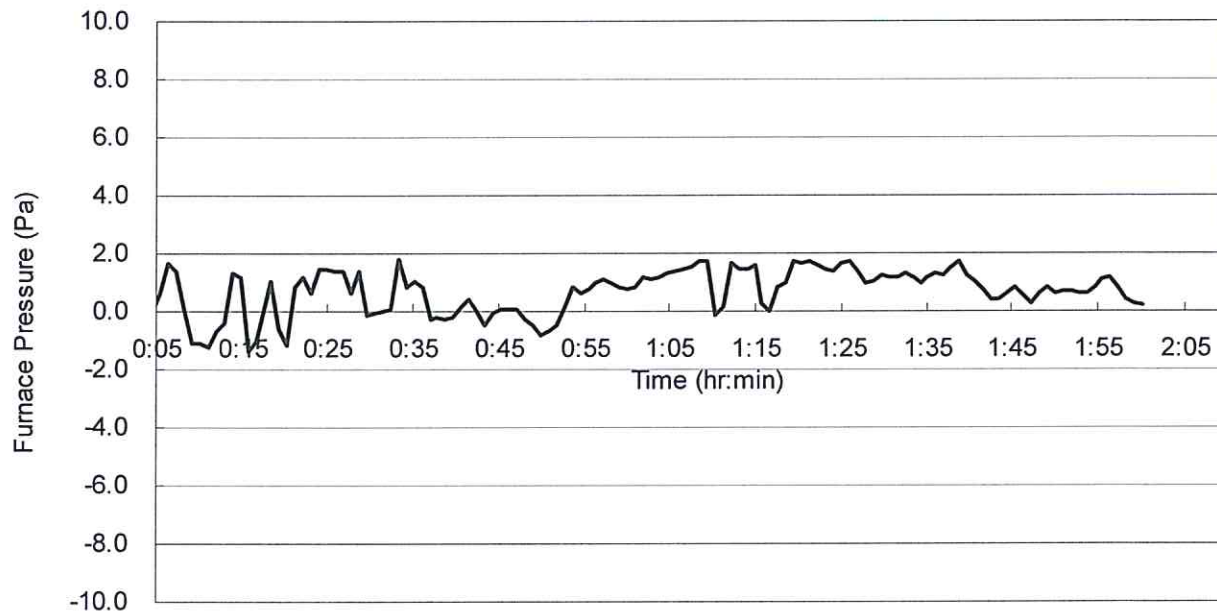
After the first 5 minutes of the test, the furnace pressure was maintained at 0 ± 2 Pa relative to atmosphere, at 1,000 mm from the notional floor level.

Figure 8 – Furnace pressure.

The furnace pressure was shown graphically in Figure 8.

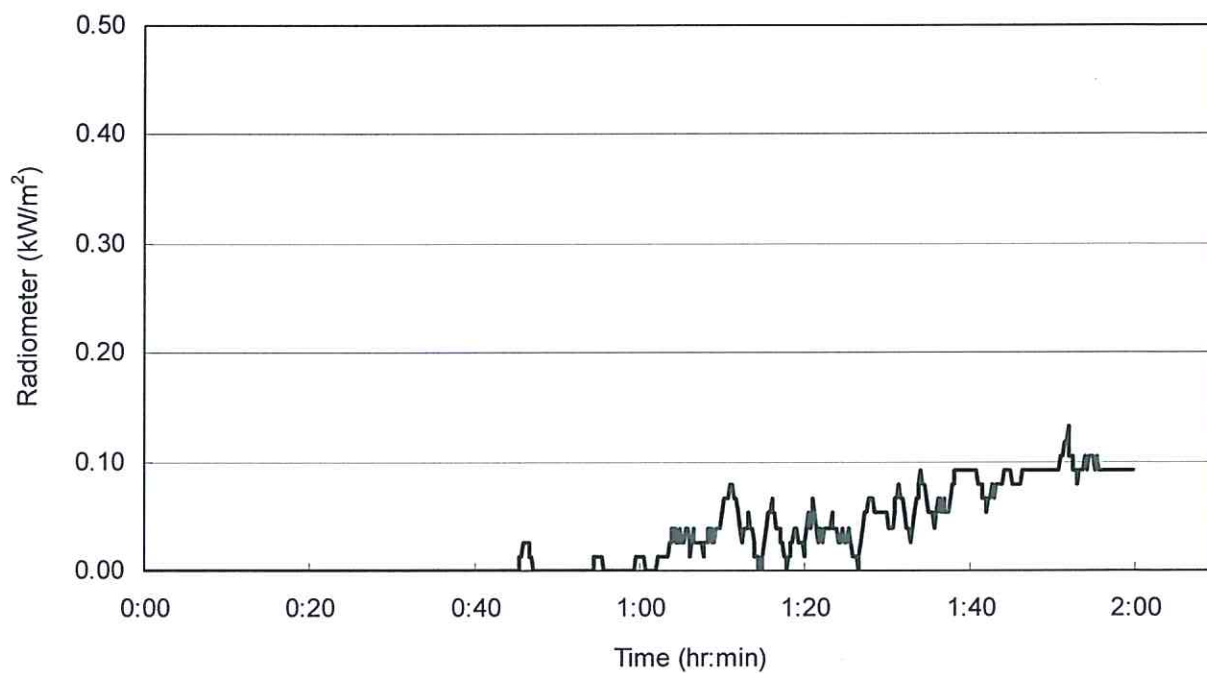
A radiometer placed at 1,000 mm away from the unexposed surface to measure the radiation of unexposed surface of the specimens.

Figure 9 – Radiation.

The radiation was shown graphically in Figure 9.

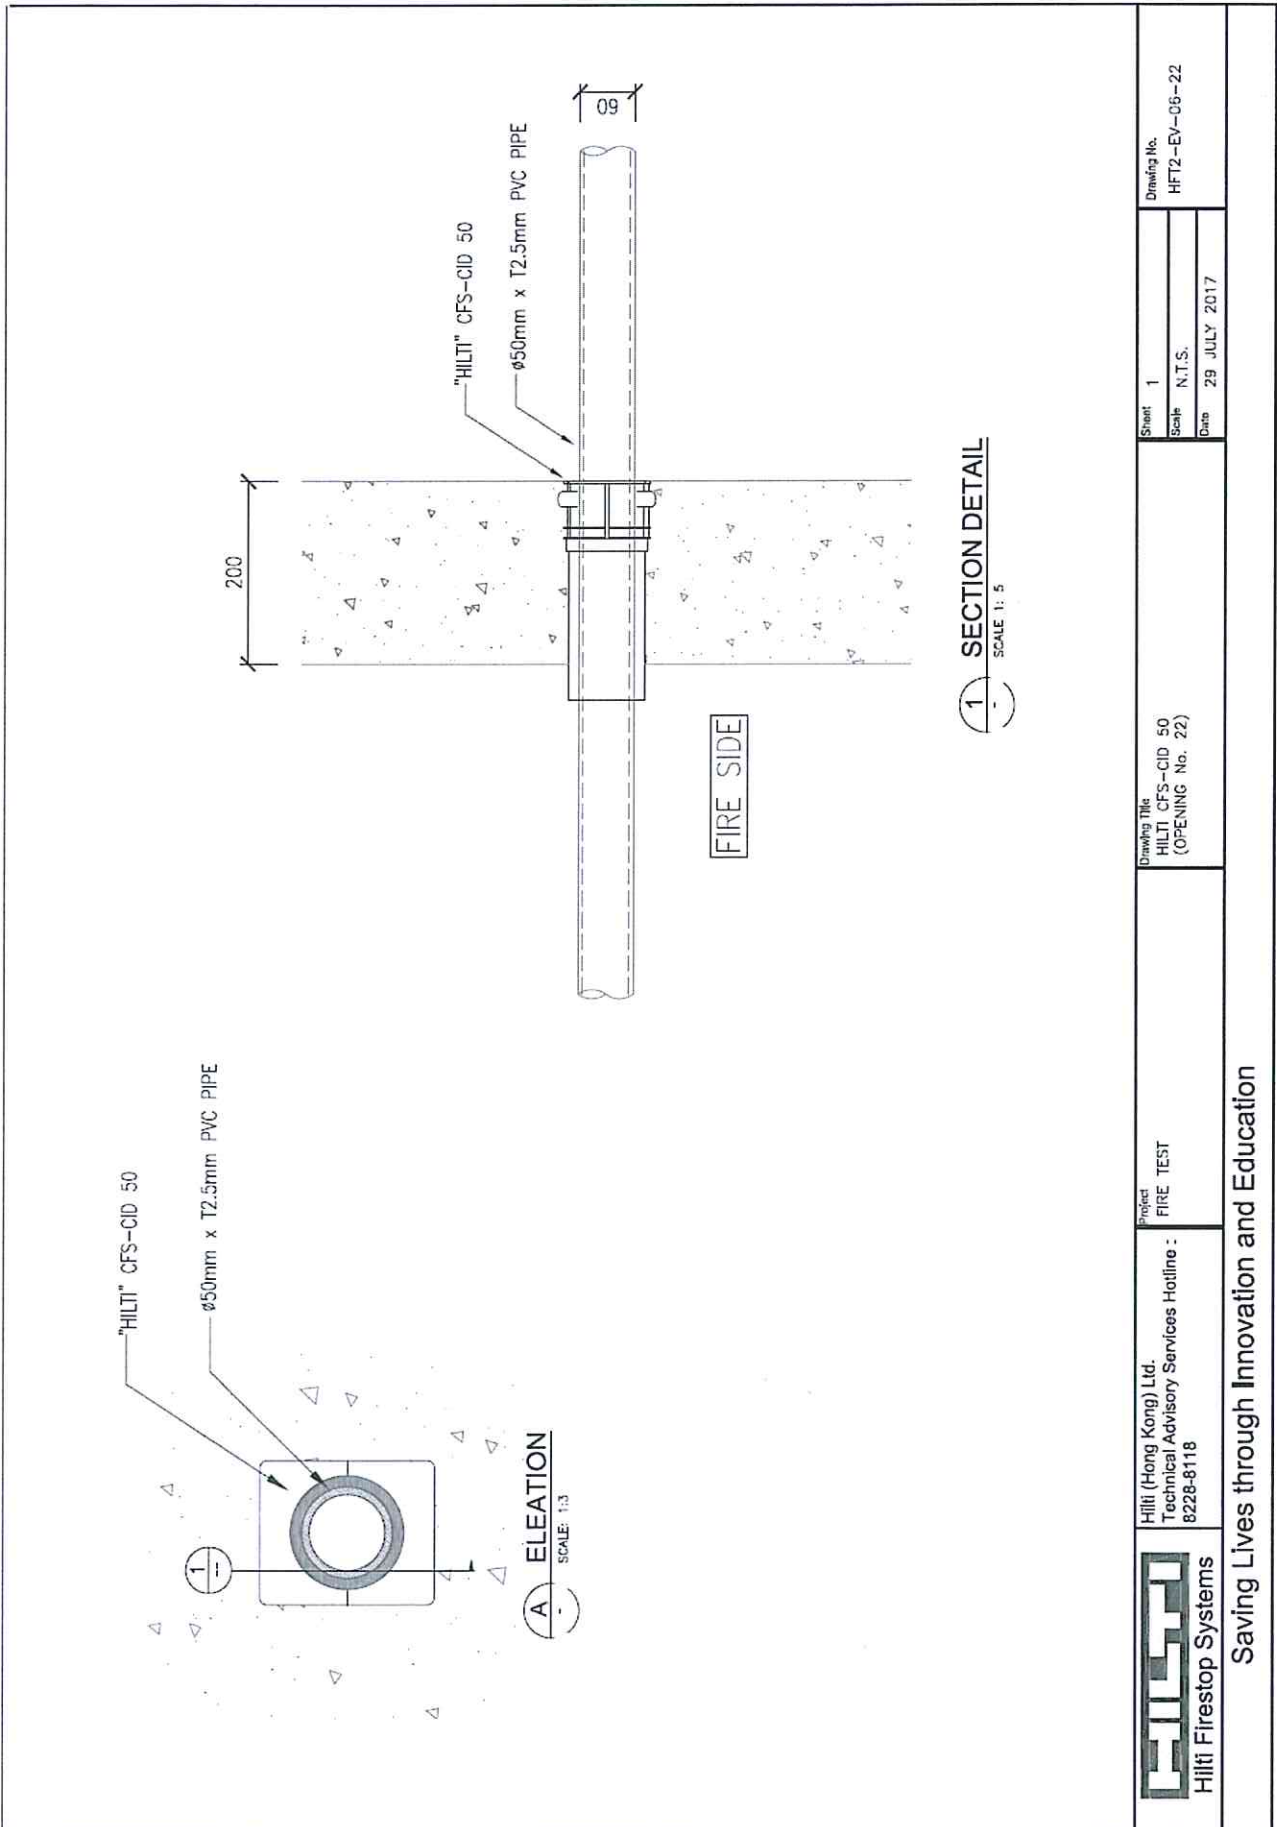
Hilti Firestop Systems	Hilti (Hong Kong) Ltd. Technical Advisory Services Hotline : 8228-8118	Project FIRE TEST	Drawing Title HILTI CFS-CID 50 (OPENING No. 22)	Sheet 1 Scale N.T.S. Date 29 JULY 2017	Drawing No. HFT2-EV-05-22
	Saving Lives through Innovation and Education
