Hilti CFS-CID Firestop Cast-In Device

FIRE RESISTANCE TEST IN ACCORDANCE WITH BS 476: PART 20: 1987

On 6 nos. of PVC Pipes and Conduits (Specimens '20', '22', '23', '24', '25' and '26')

Test Report No.: R16L28-1C

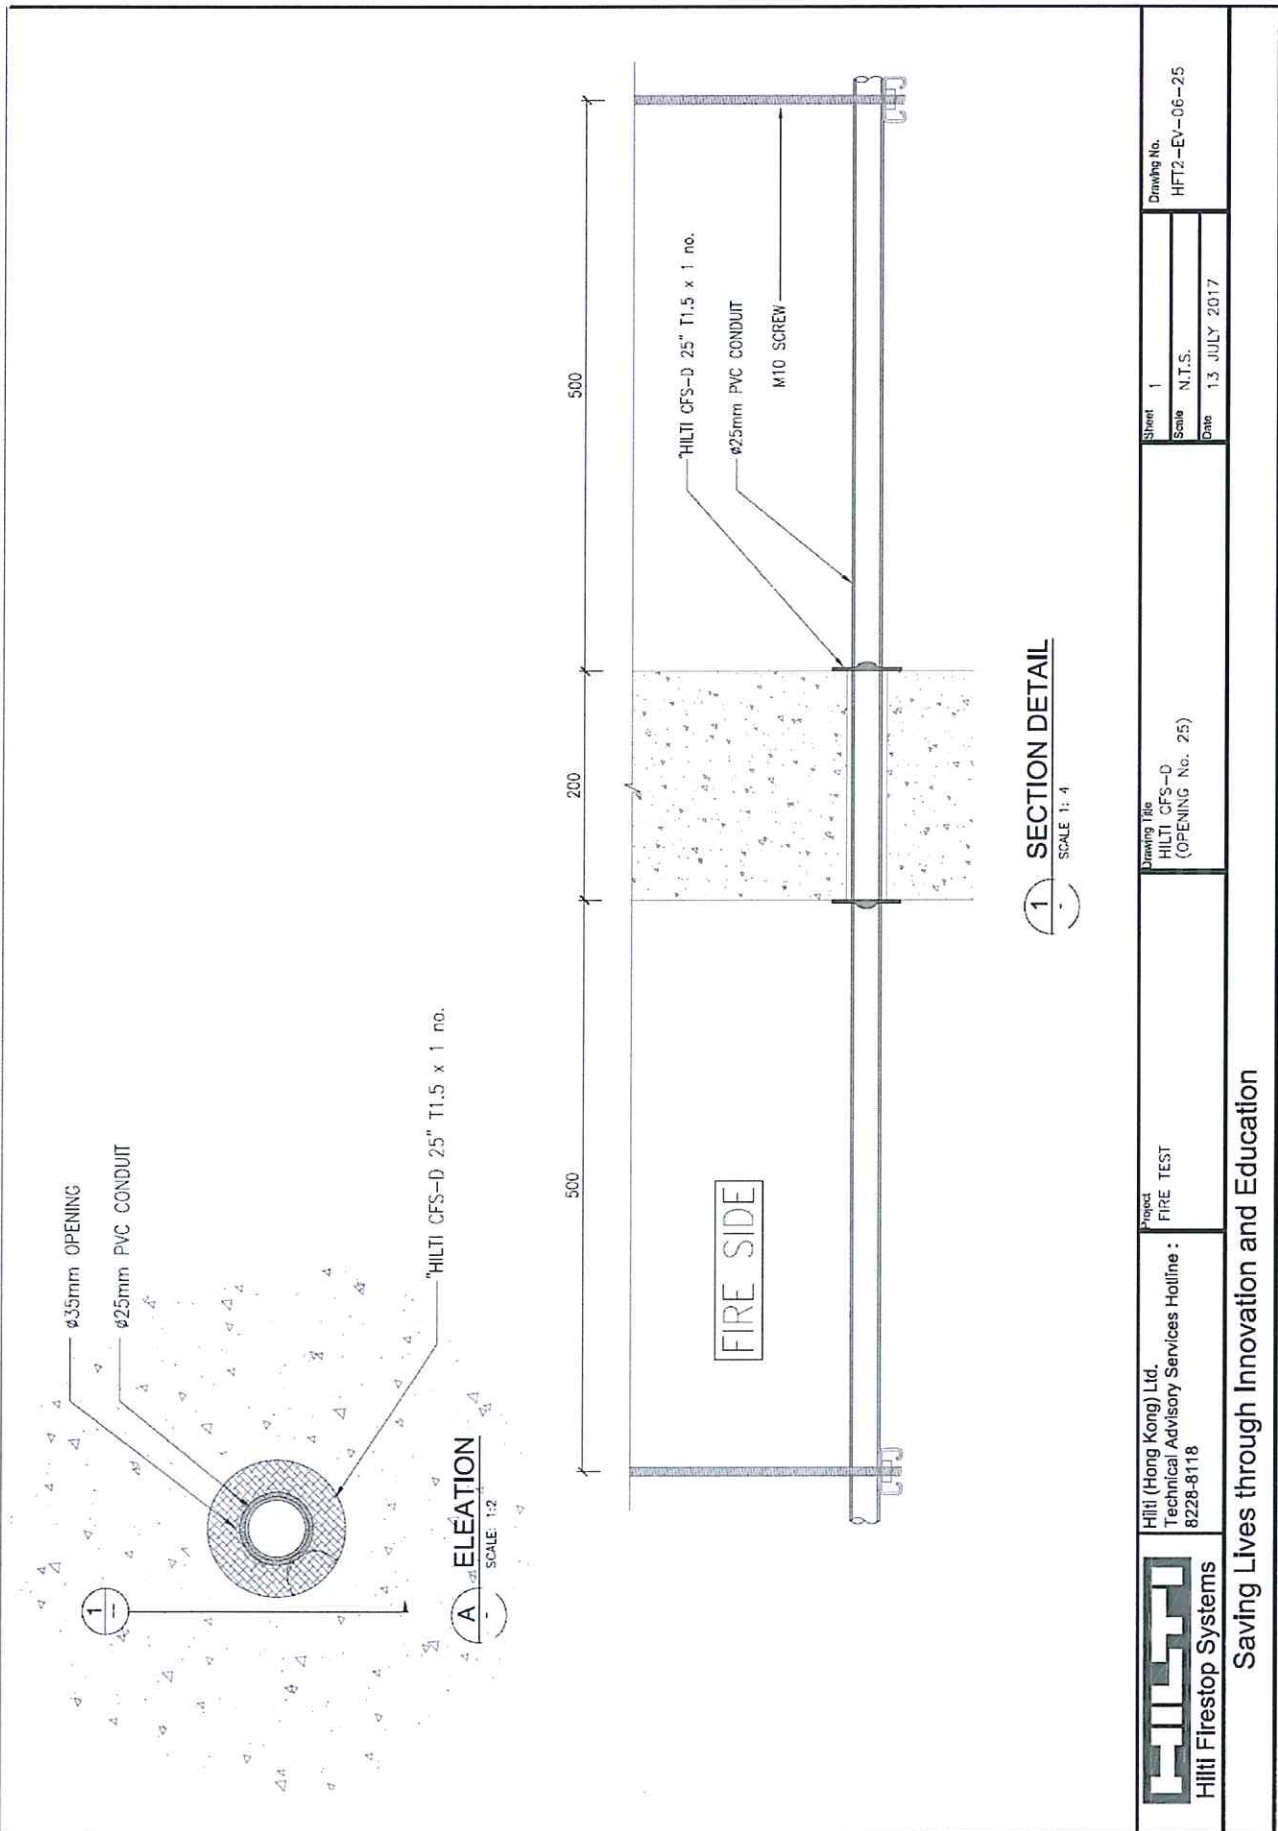
SECTION DETAIL
SCALE 1: 4

<p>HILTI Firestop Systems</p>	<p>Hilti (Hong Kong) Ltd. Technical Advisory Services Hotline : 8228-8118</p>	<p>Project FIRE TEST</p>	<p>Drawing File HILTI CFS-D (OPENING No. 25)</p>	<p>Sheet 1</p>	<p>Drawing No. HFT2-EV-06-25</p>
	<p>Hilti Firestop Systems</p> <p>Saving Lives through Innovation and Education</p>	<p>Scale N.T.S.</p>	<p>Date 13 JULY 2017</p>	<p>Scale N.T.S.</p>	<p>Date 13 JULY 2017</p>

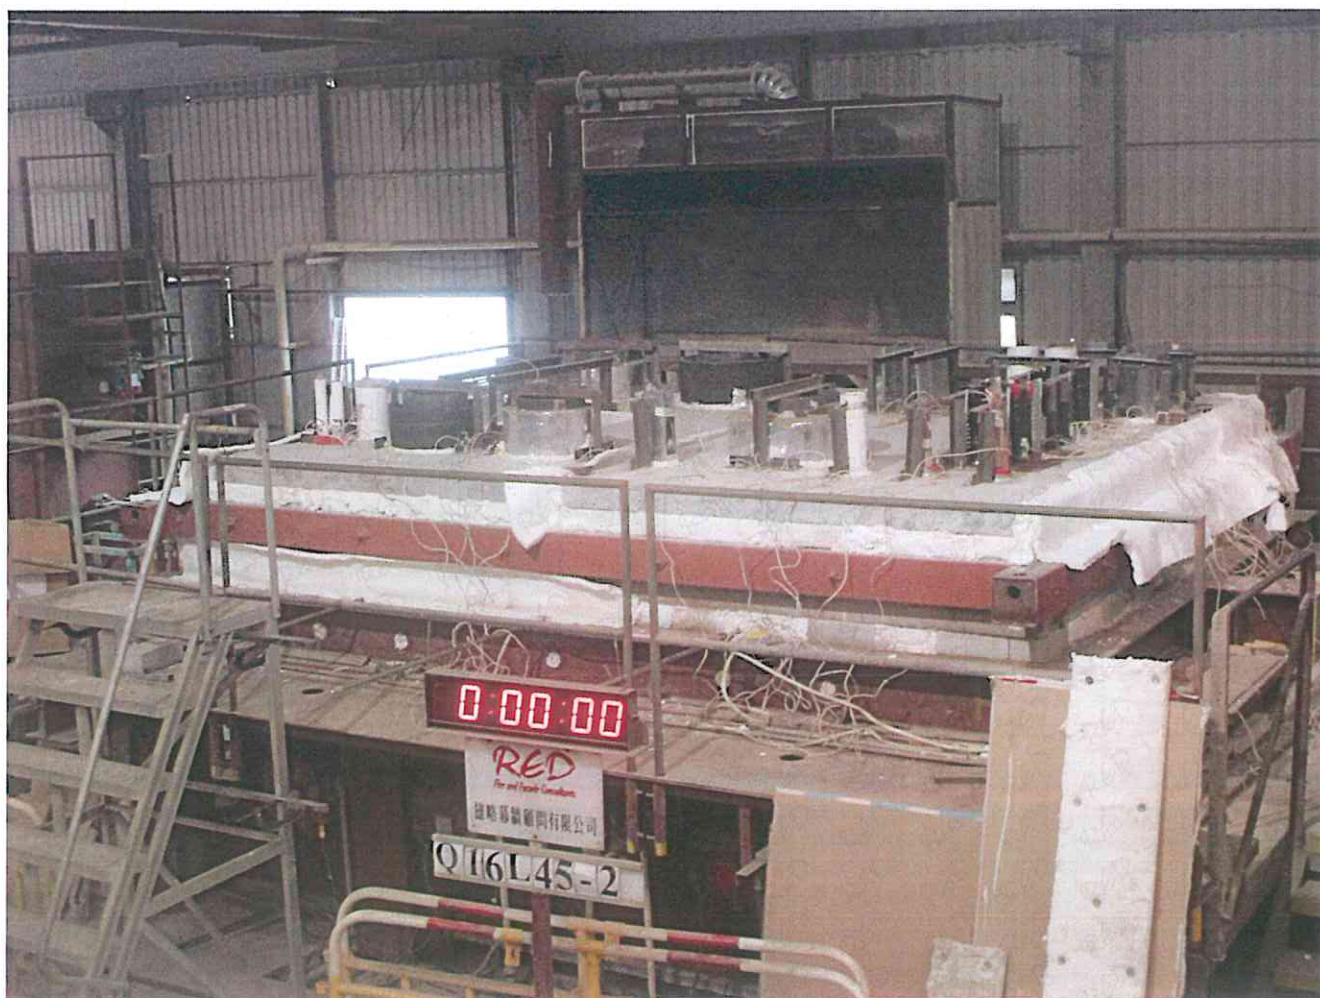
Photo 1: The unexposed face of the specimens before the test.

Note: In this test report, only specimens '9', '14', '19' and '20' were considered.

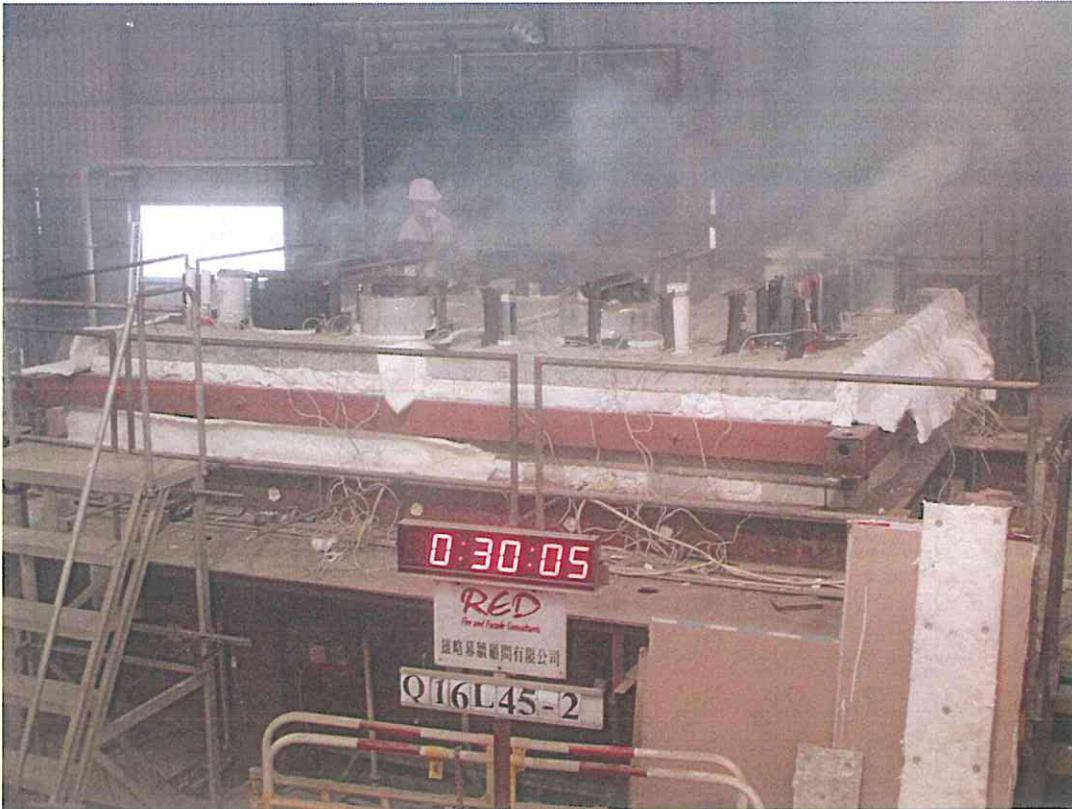
Photo 2: The unexposed face of the specimens after a heating period of 30 minutes.

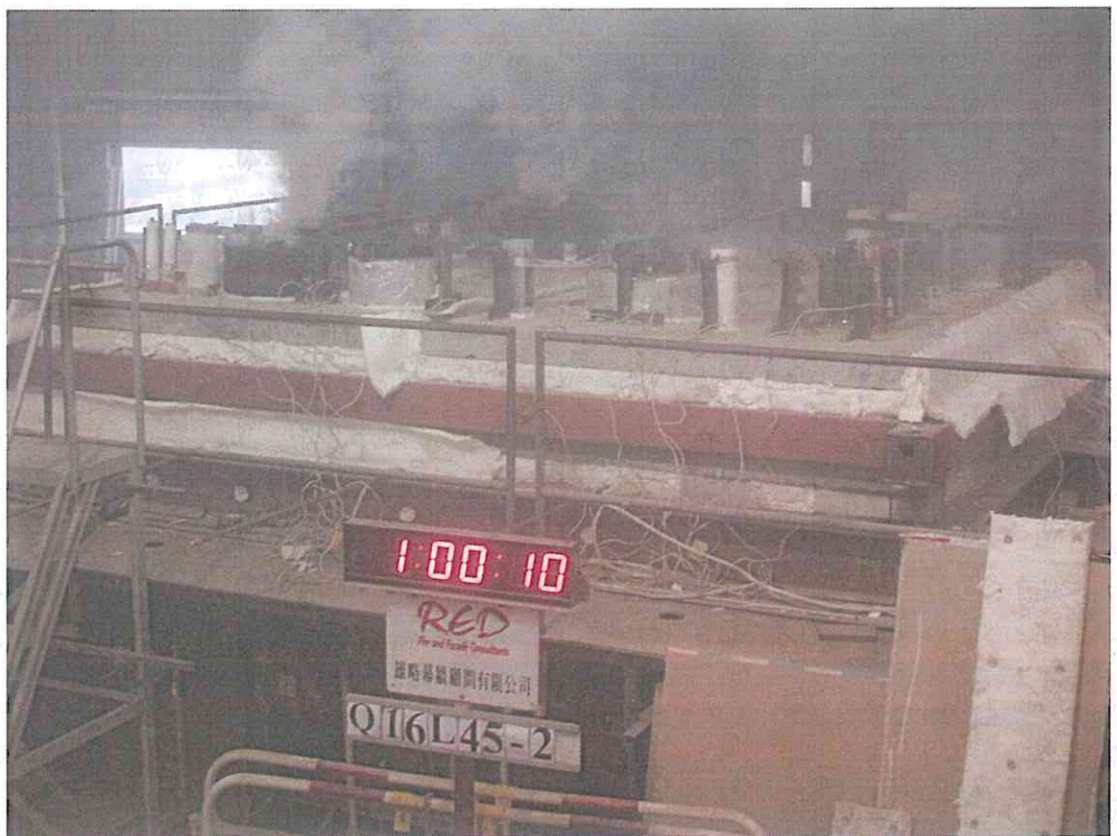
Photo 3: The unexposed face of the specimens after a heating period of 60 minutes.

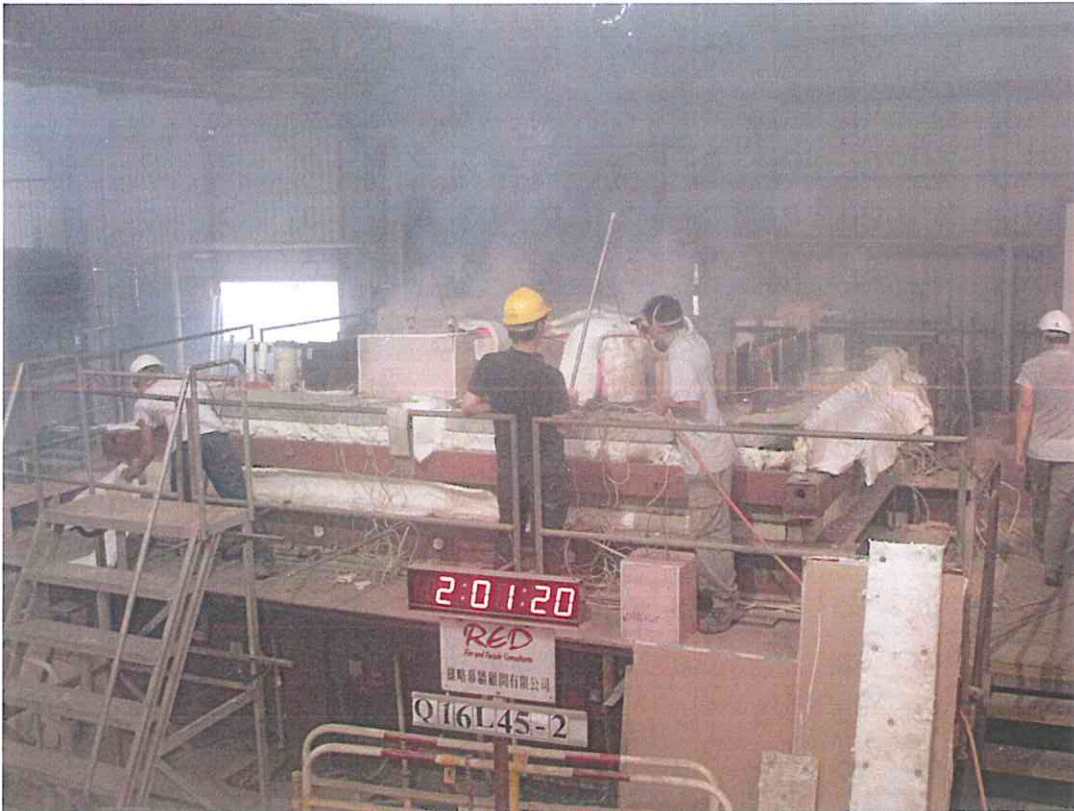
Photo 4: The unexposed face of the specimens after a heating period of 121 minutes.

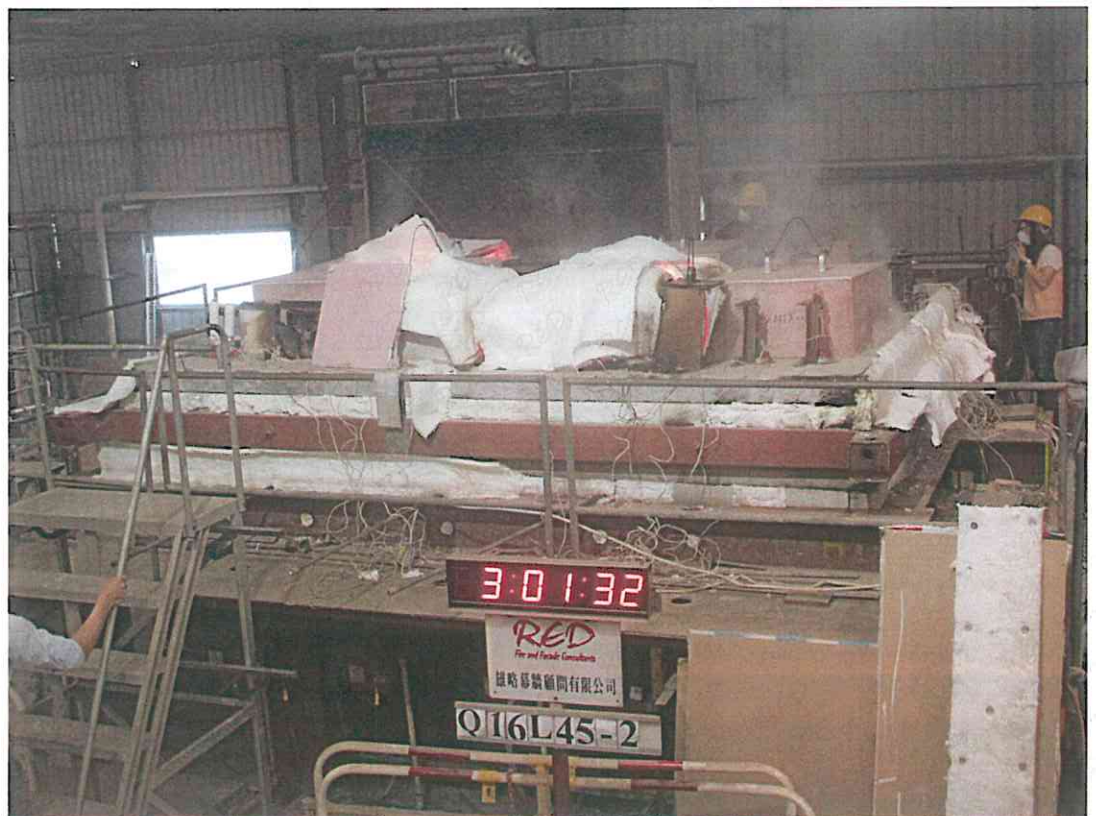
Photo 5: The unexposed face of the specimens after a heating period of 181 minutes.

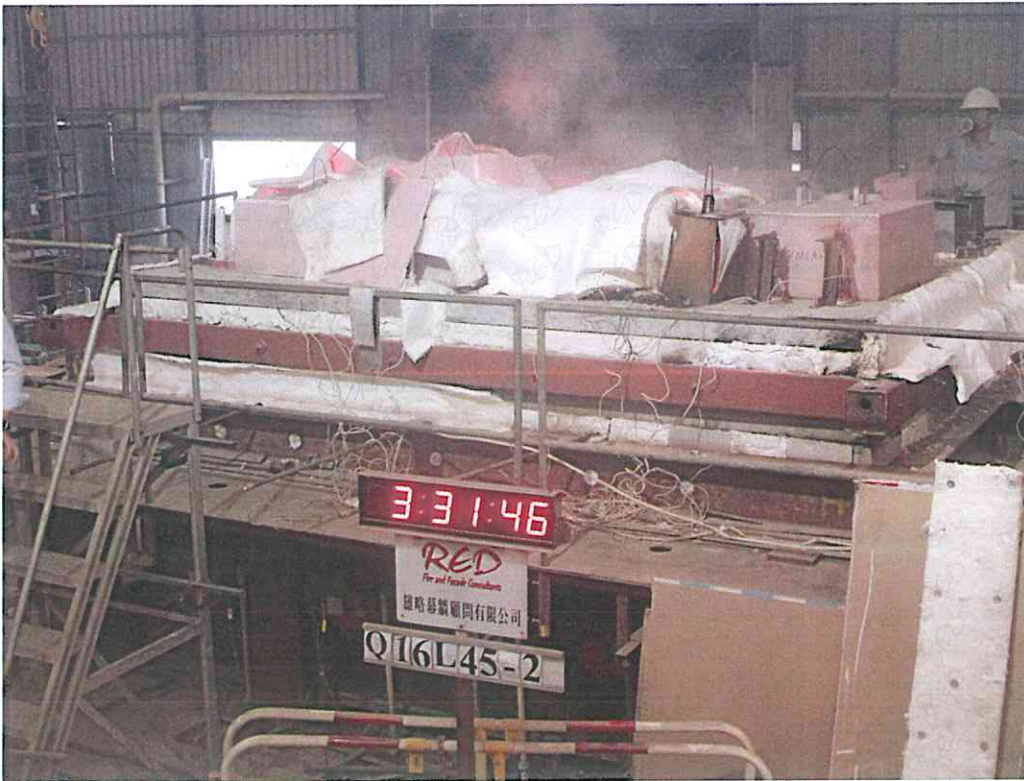
Photo 6: The unexposed face of the specimens after a heating period of 211 minutes.

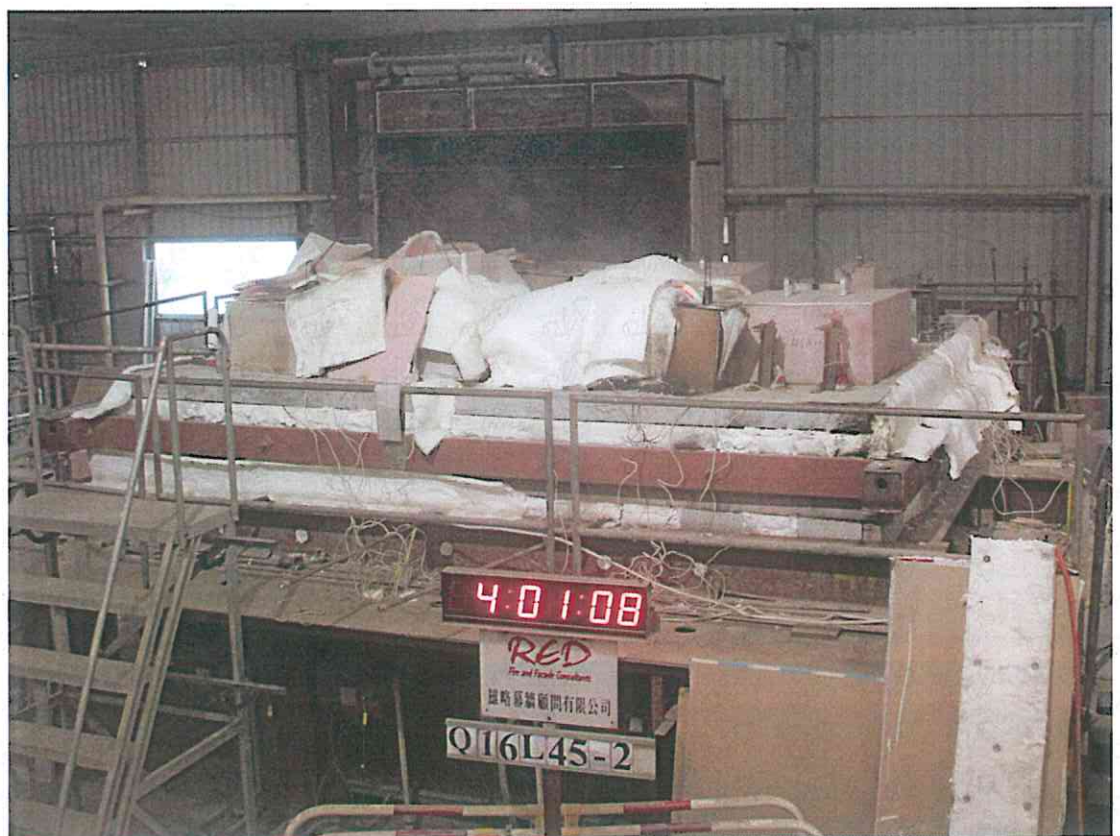
Photo 7: The unexposed face of the specimens after the test.

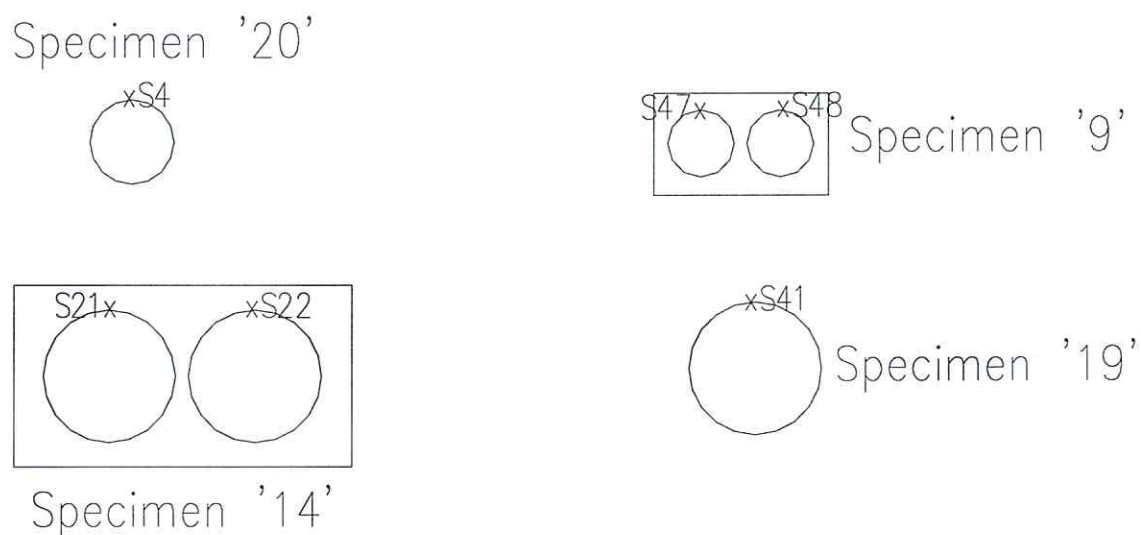
Figure 2 – Locations and reference number of thermocouples to monitor the temperature of unexposed surface of the specimens.

Notes: Thermocouples S4, S21, S22, S41, S47 and S48 were fixed for additional information only.

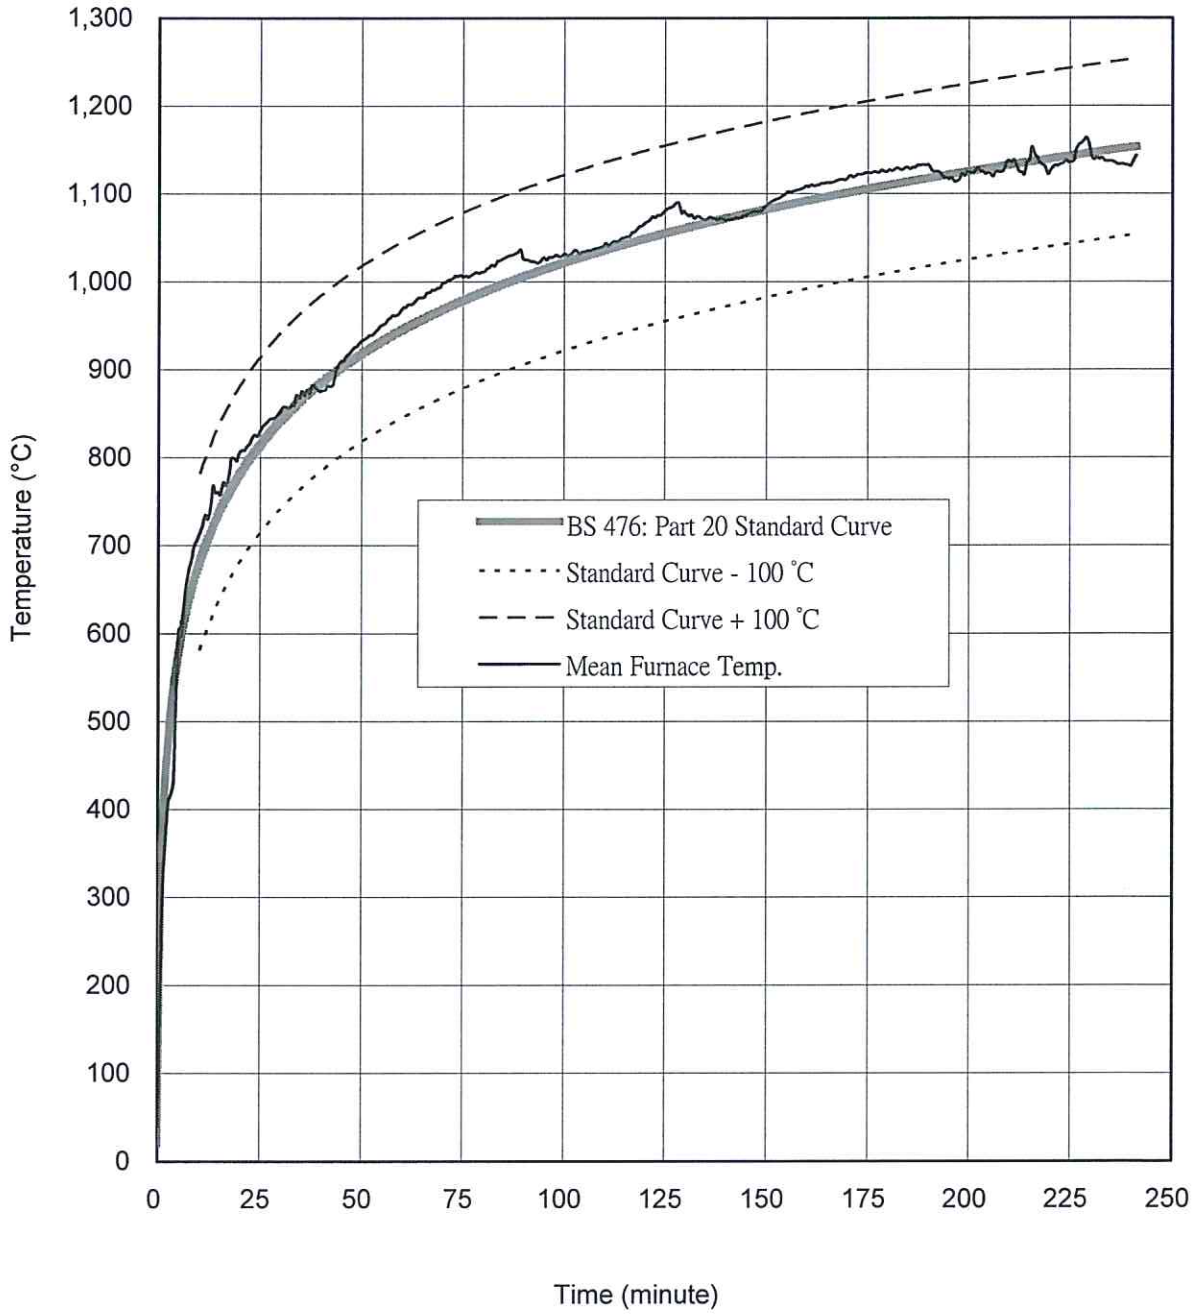
Figure 3 – Mean furnace temperature.

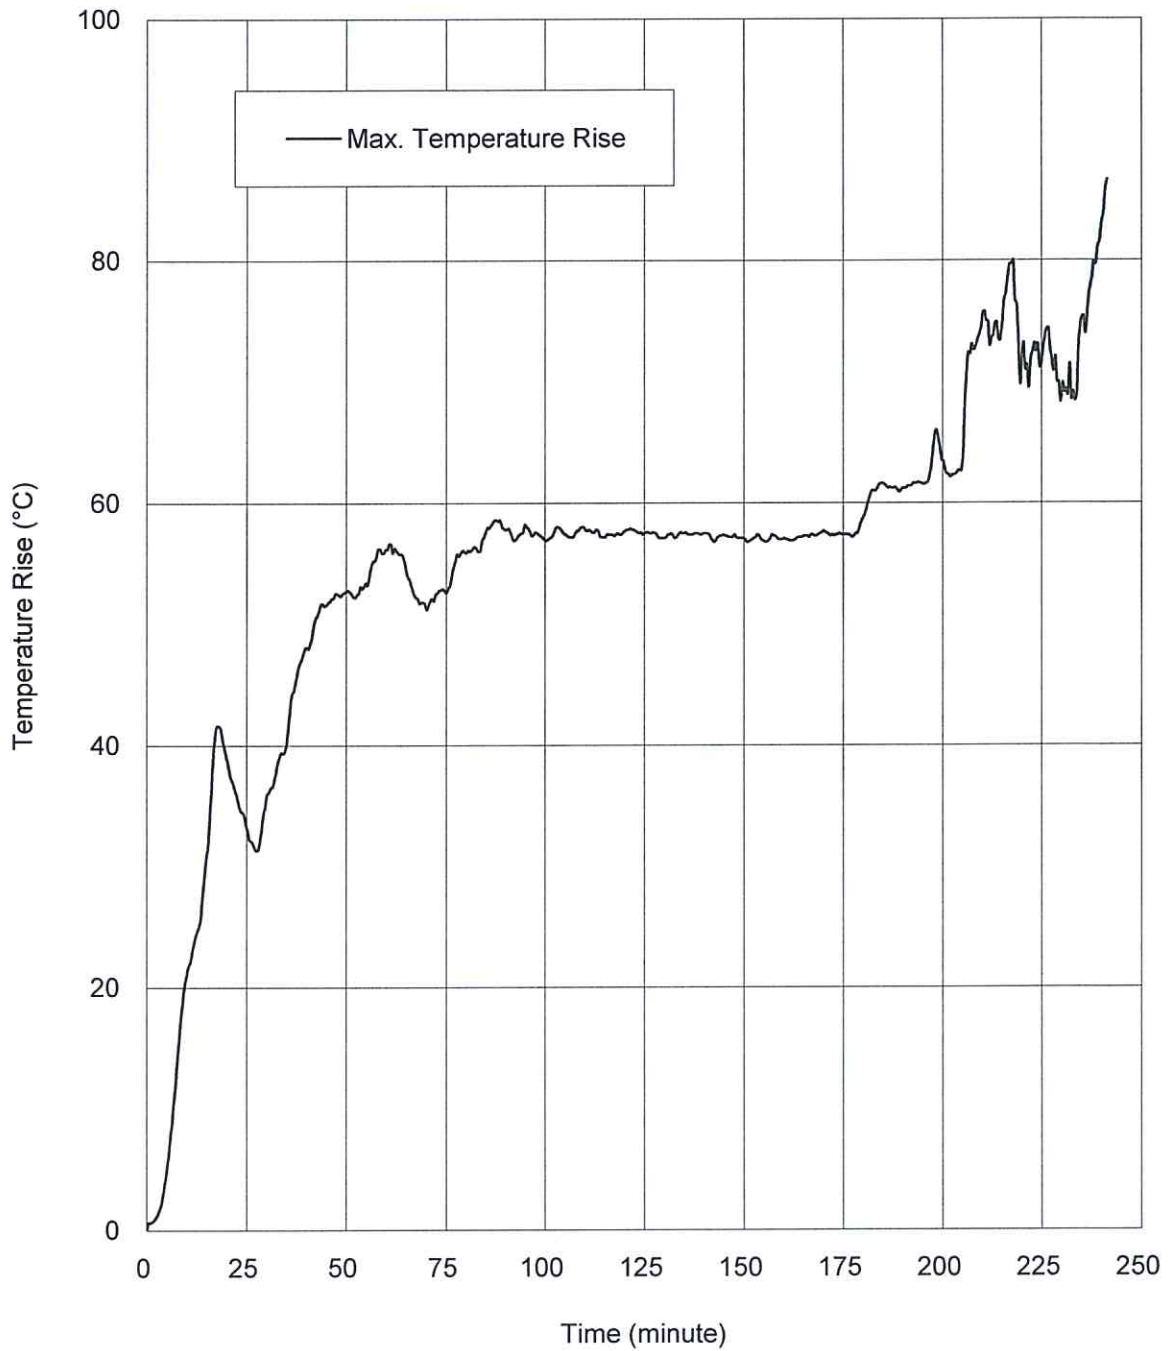
Figure 4 – Temperature rises of unexposed surface of specimen '9'.
(for additional information only)

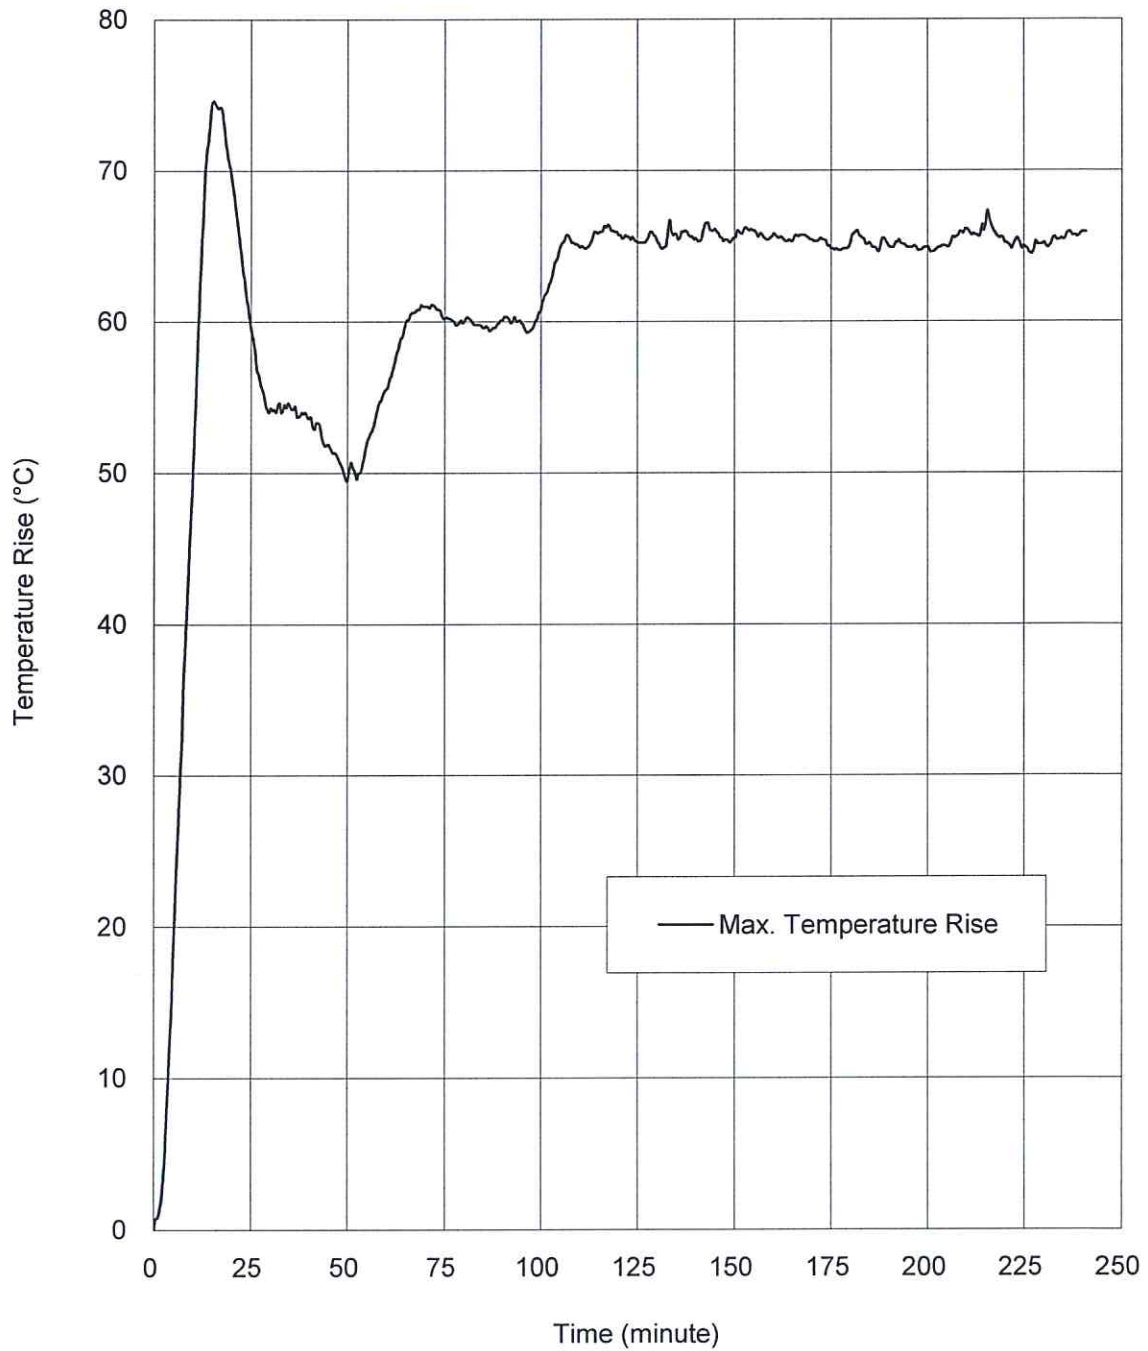
Figure 5 – Temperature rises of unexposed surface of specimen '14'.
(for additional information only)

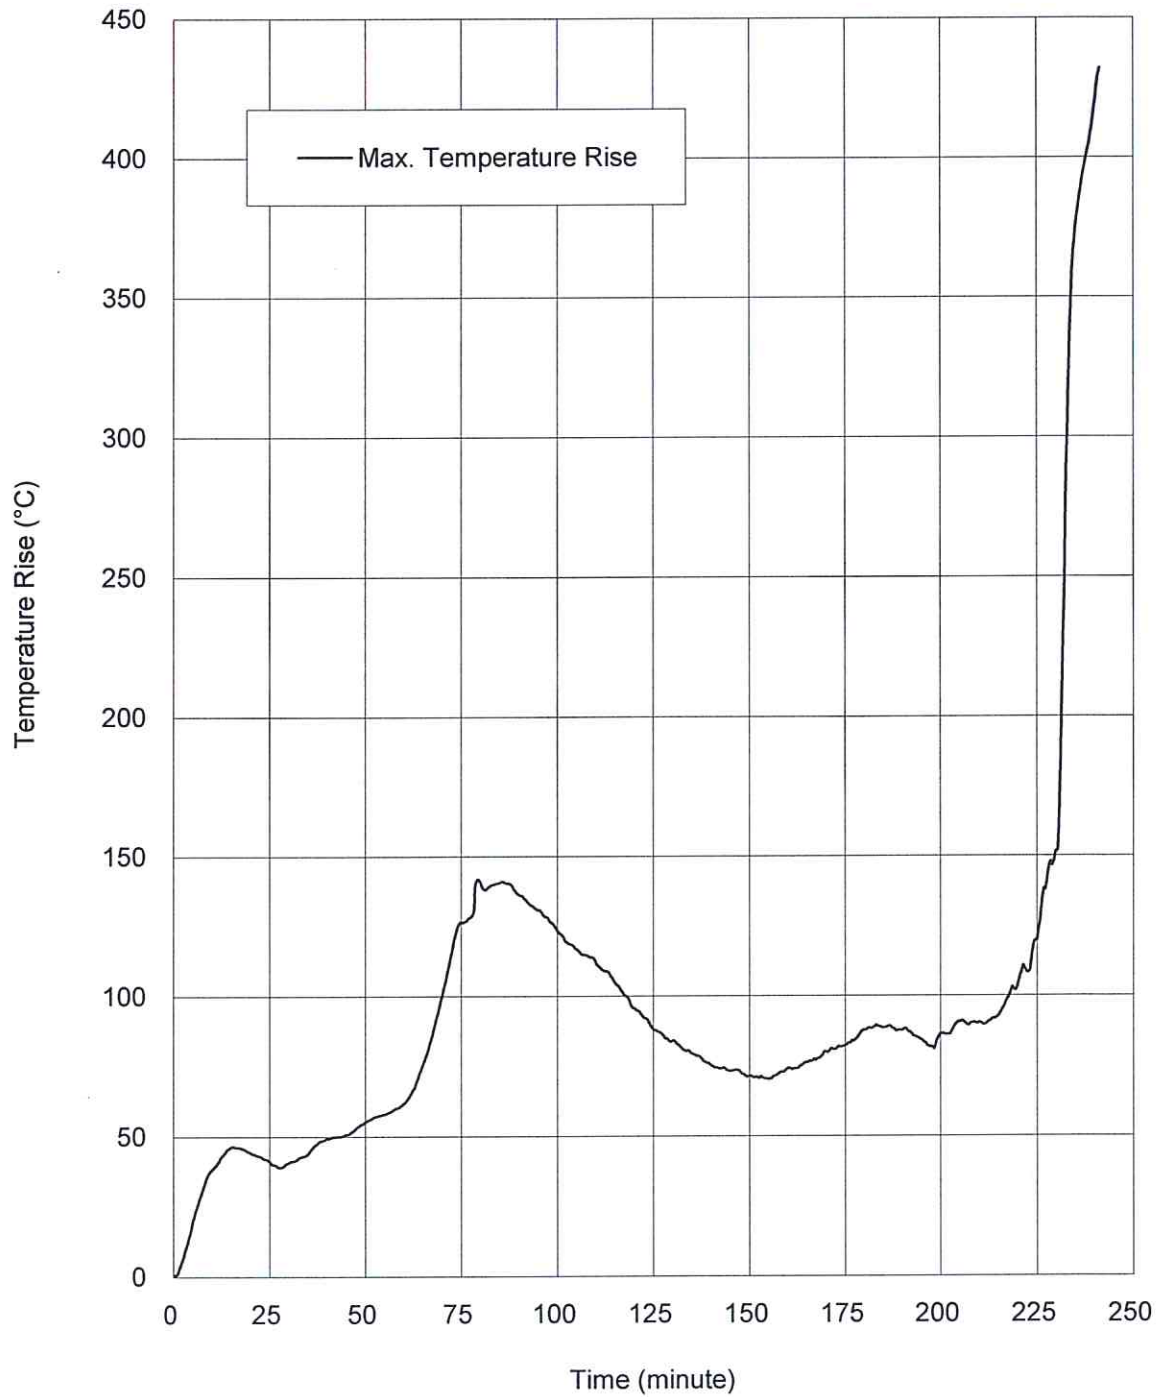
Figure 6 – Temperature rises of unexposed surface of specimen '19'.
(for additional information only)

Sustained flaming was observed from specimen '19' after a heating period of 230 minutes.

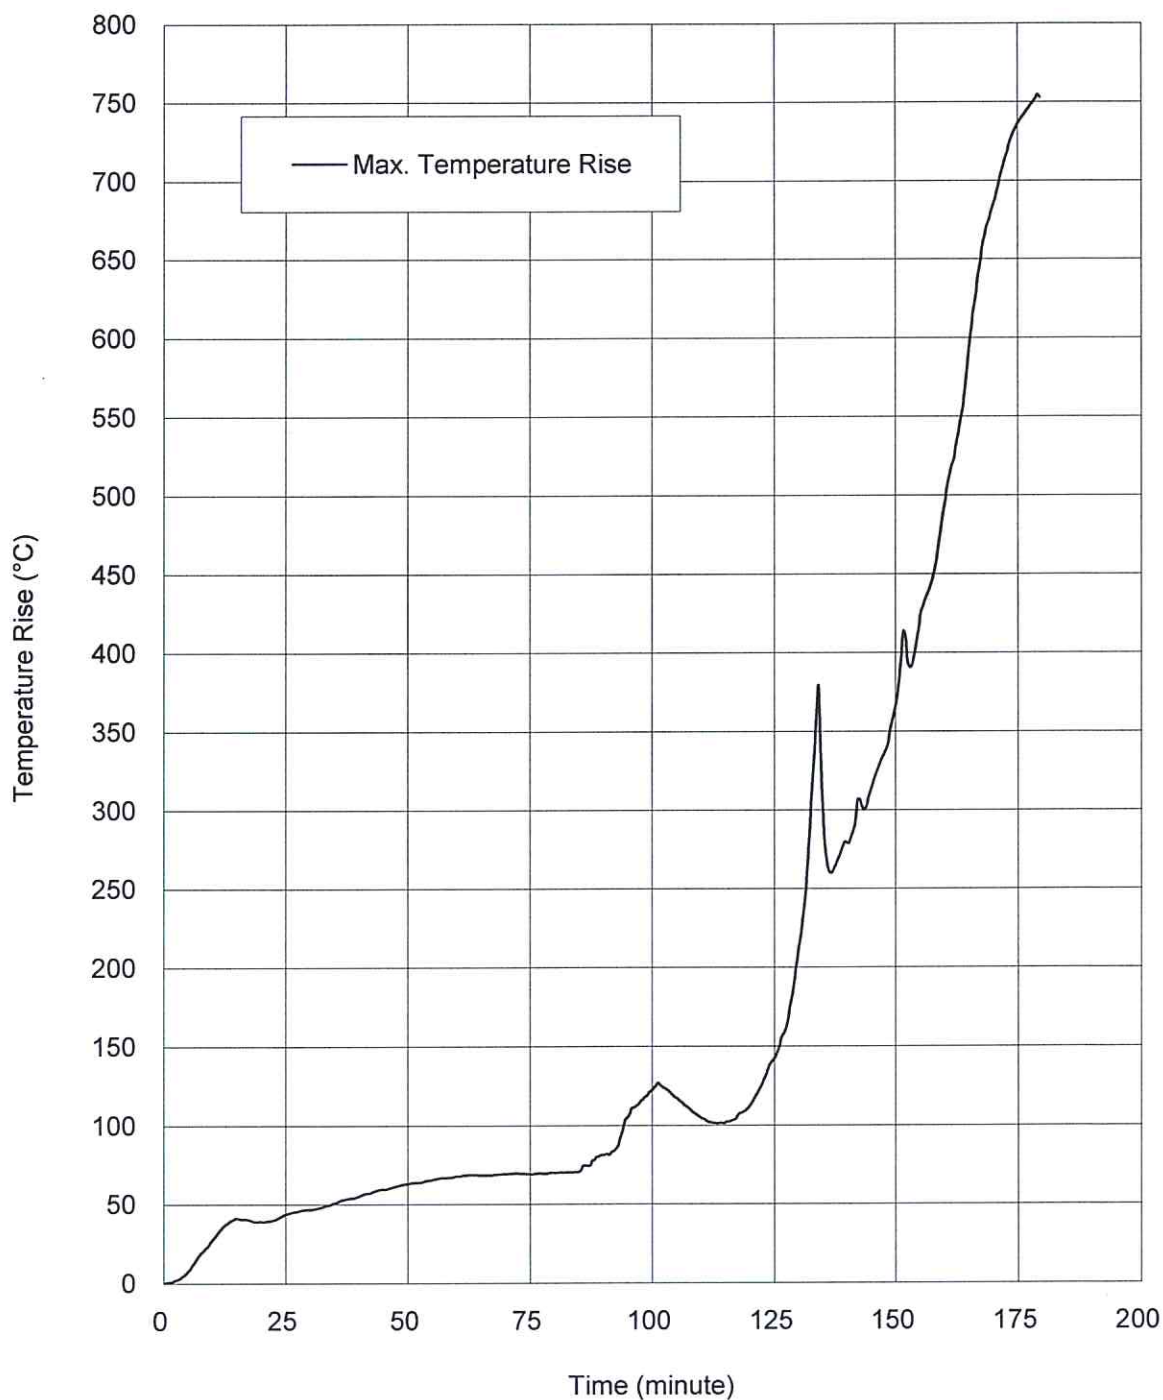
Figure 7 – Temperature rises of unexposed surface of specimen '20'.
(for additional information only)

Note: Thermocouple S4 detached after a heating period of 180 minutes.

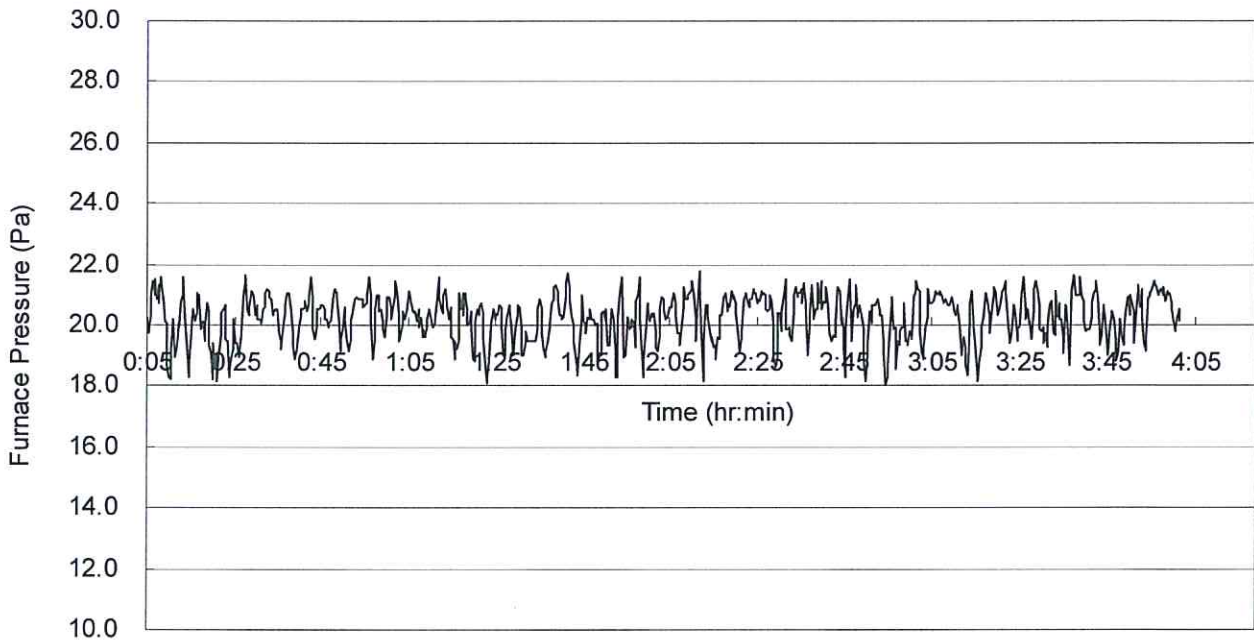
After the first 5 minutes of the test, the furnace pressure was maintained at 20 ± 2 Pa relative to atmosphere, at 100 mm from the exposed side of specimen.

Figure 8 – Furnace pressure.
