# Hilti CFS-HFF Firestop Flute Filler

## FIRE RESISTANCE TEST IN ACCORDANCE WITH BS 476: PART 20: 1987

On 3 nos. of Cavity Barriers

**Test Report No.:** R19L23-1A

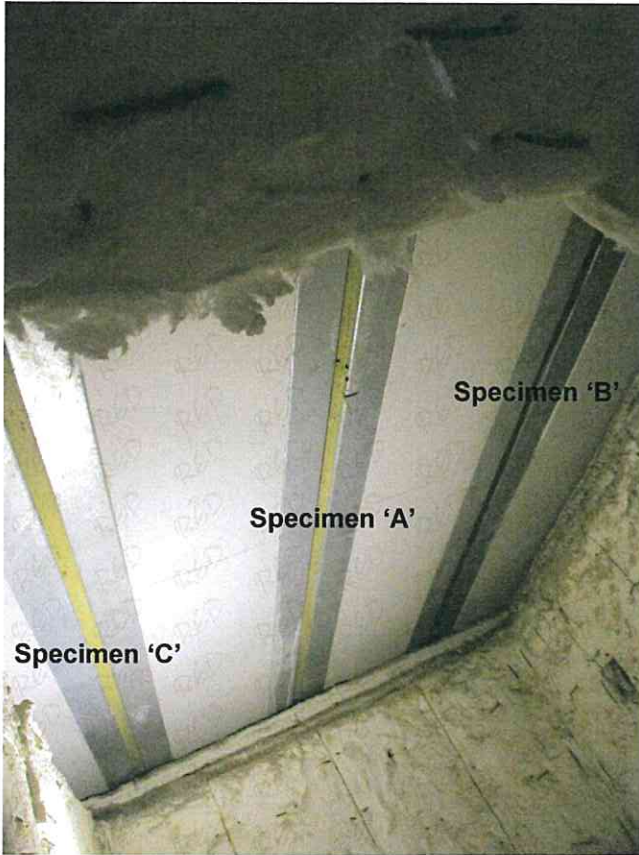
Photo 1: The exposed face of the specimens before the test.

Three specimens of Cavity Barriers, namely specimens 'A', 'B' and 'C' (refer to photos 1 and 2), had been subjected to a test in accordance with BS 476: Part 20: 1987, in order to determine their fire resistance performances. As requested by the test sponsor, the specimens were mounted within concrete line specimens holder as shown in the test sponsor's drawings (see the appendix). The specimens were symmetrical and only one side of specimens was tested.

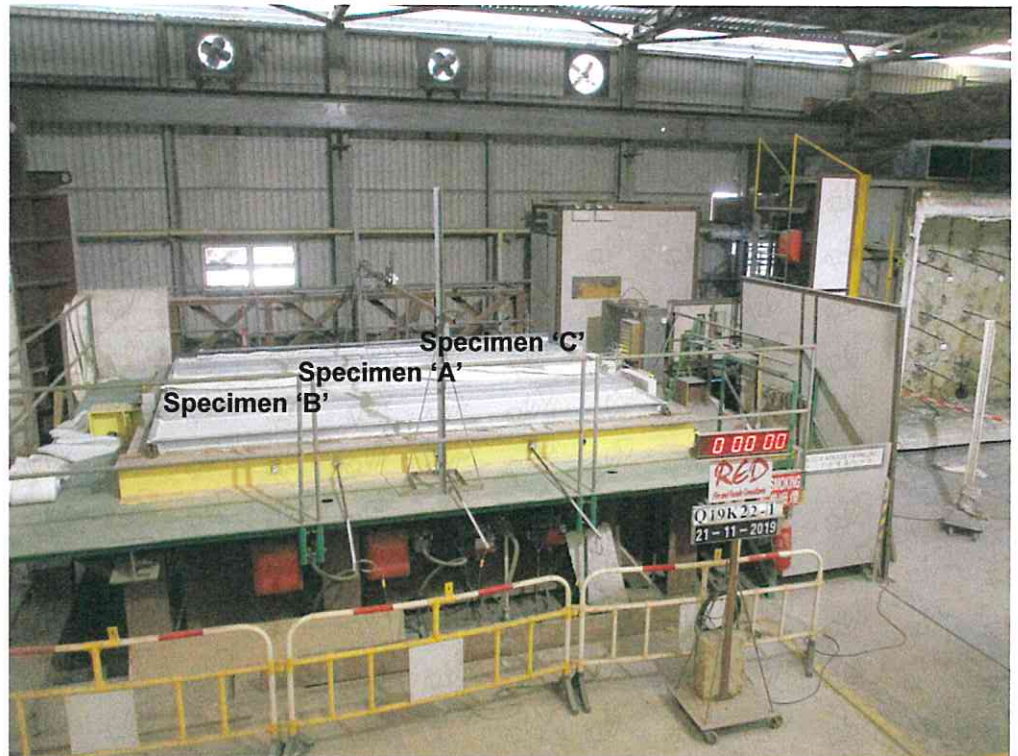
Photo 2: The unexposed face of the specimens before the test.

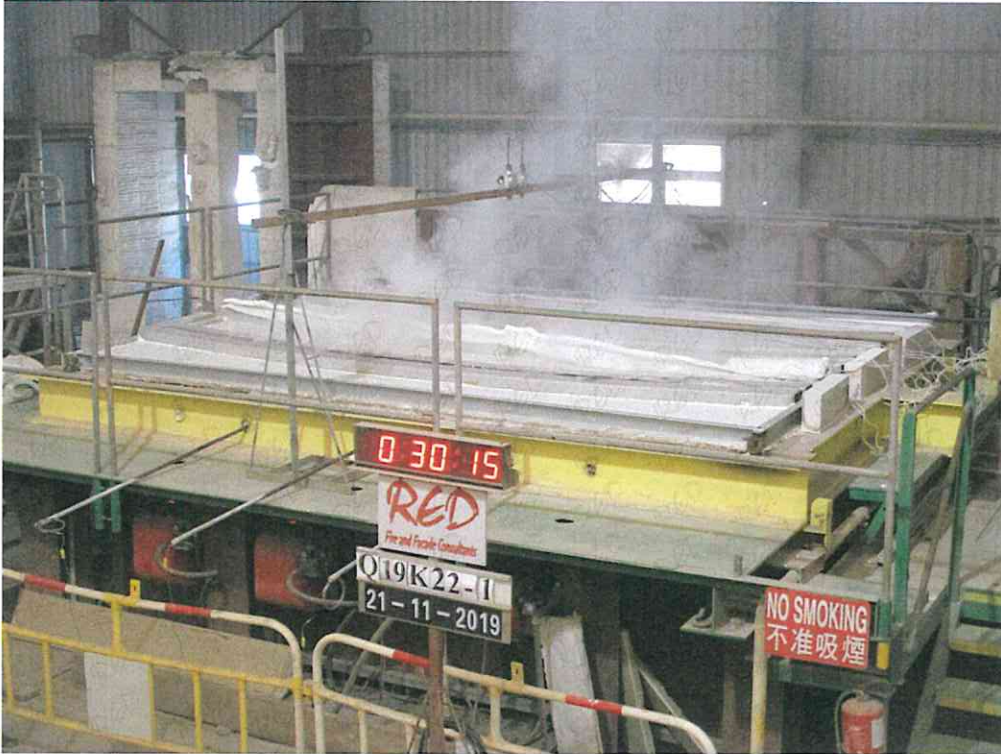
Photo 3: The unexposed face of the specimens after a heating period of 30 minutes.

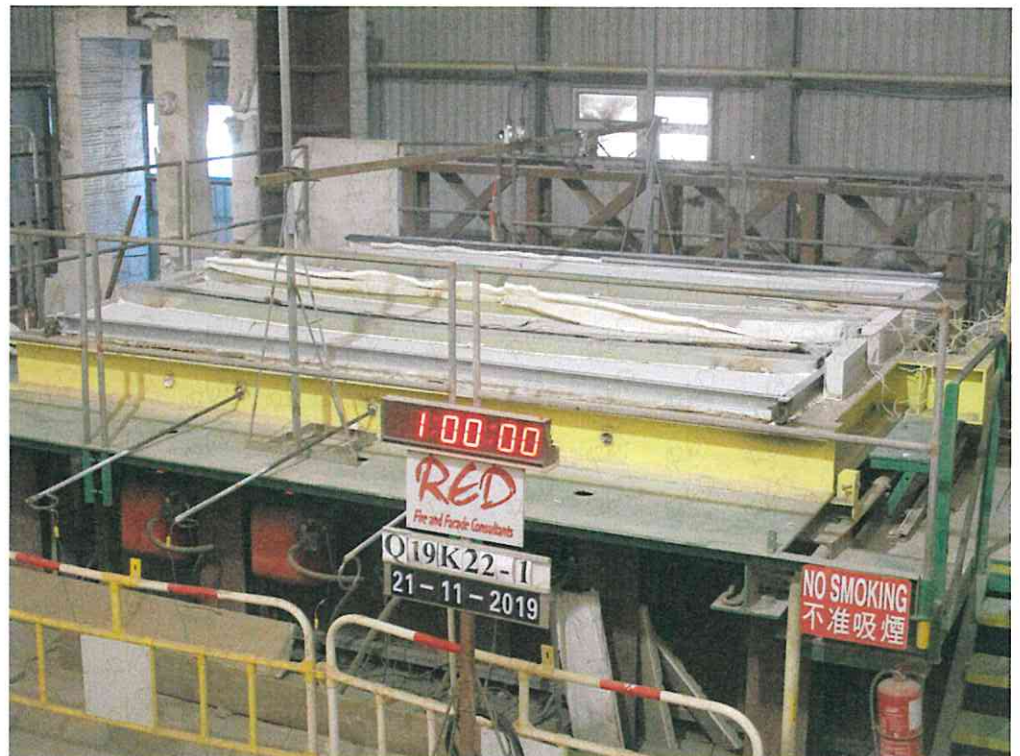
Photo 4: The unexposed face of the specimens after a heating period of 60 minutes.

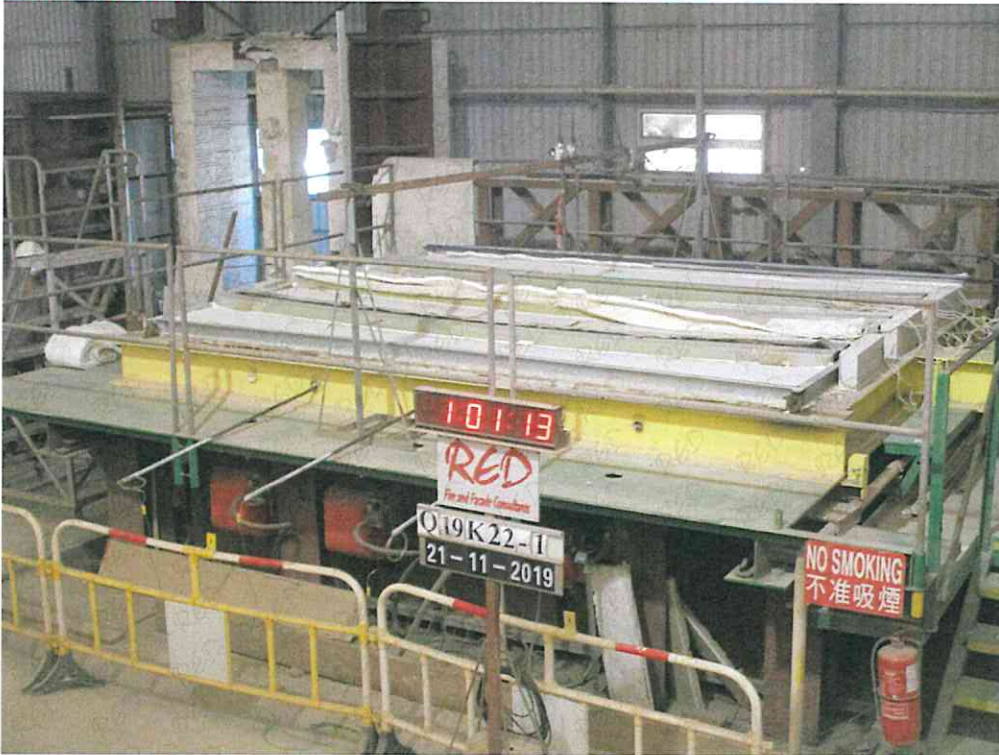
Photo 5: The unexposed face of the specimens after the test.

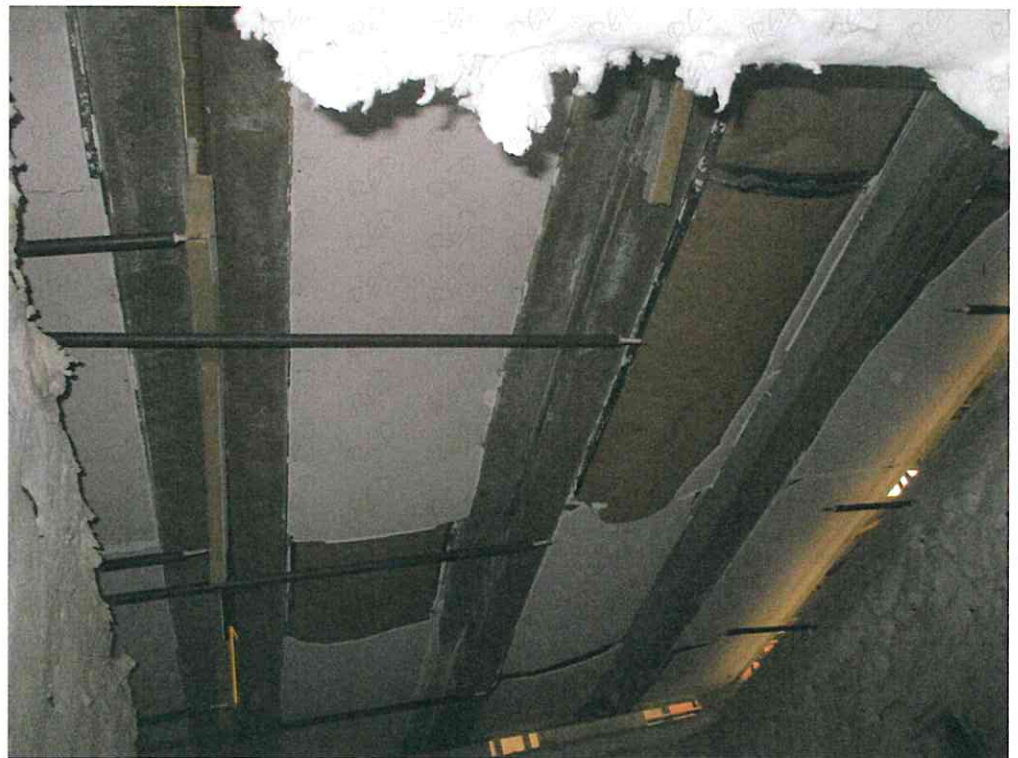
Photo 6: The exposed face of the specimens after the test.

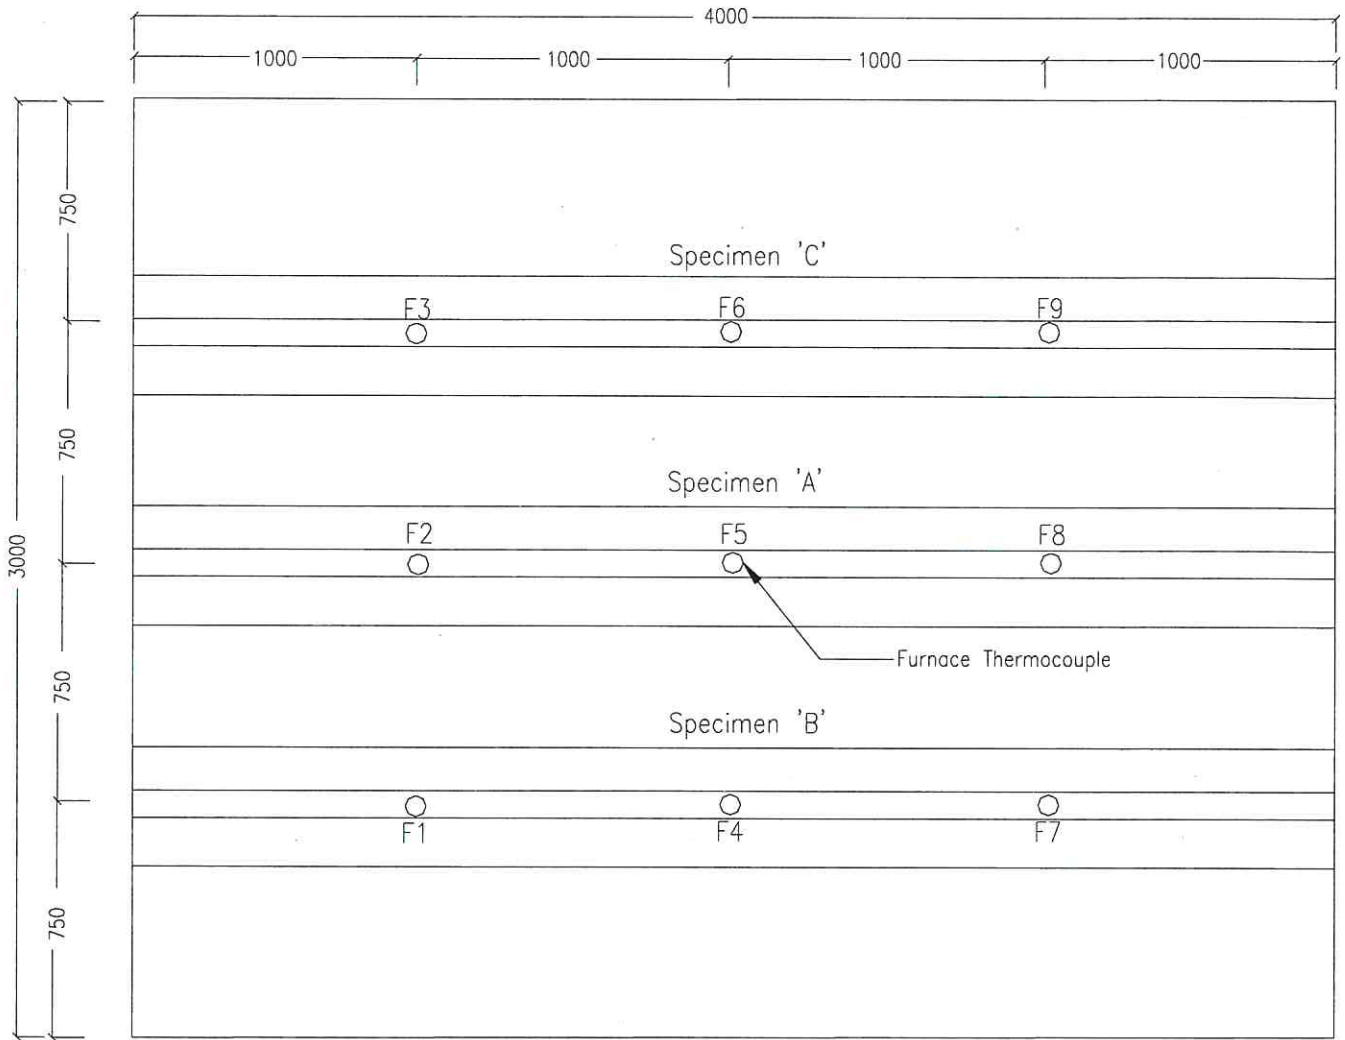
Figure 1 – Locations and reference numbers of furnace thermocouples.

(This figure is not to scale and all dimensions are in millimetres.)

Nine (9) 'type K' thermocouples to monitor the temperature of the furnace, which were kept at 100 mm from the exposed face of the specimens (see Figure 1).

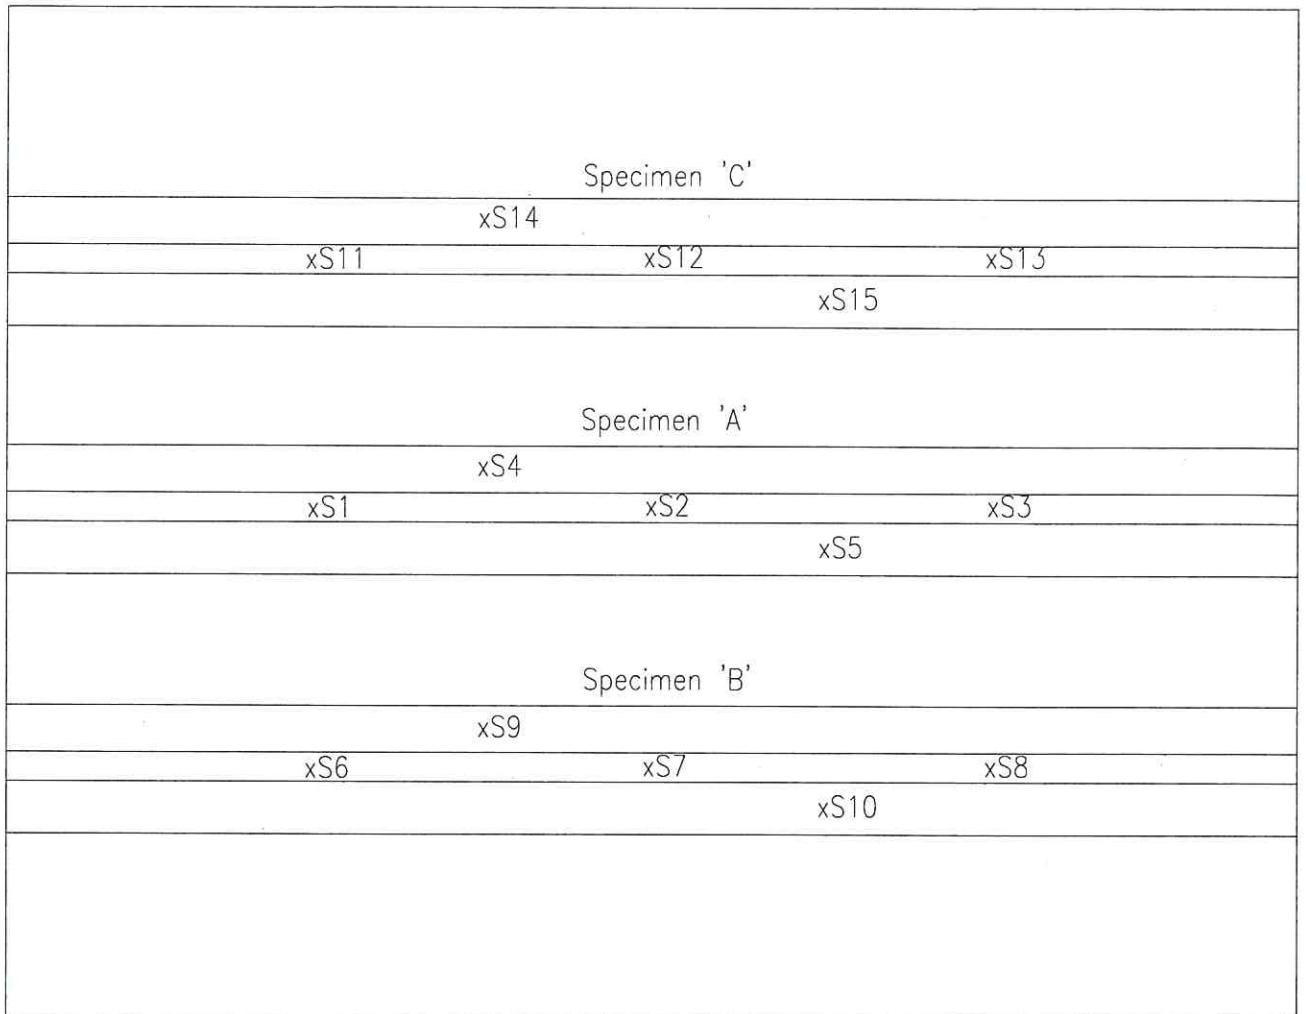
Figure 2 – Locations and reference numbers of thermocouples to monitor the temperature of unexposed surface of the specimens.

(This figure is not to scale.)

Fifteen (15) 'type K' thermocouples to monitor the temperature of the unexposed face of the specimens (see Figure 2).

The temperature of the unexposed face was monitored by means of fifteen (15) thermocouples fixed to the unexposed surface (see Figure 2 for the locations and reference numbers of the thermocouples). Thermocouples S1 – S3 were fixed on the Rockwool of specimen 'A' for mean and maximum temperatures of the unexposed surface of Rockwool of specimen 'A'. Thermocouples S4 – S5 were fixed on the steel hollows of specimen 'A' for mean and maximum temperatures of the unexposed surface of steel hollows of specimen 'A'. Thermocouples S6 – S8 were fixed on the Hilti CFS-HFF of specimen 'B' for mean and maximum temperatures of the unexposed surface of Hilti CFS-HFF of specimen 'B'. Thermocouples S9 – S10 were fixed on the steel hollows of specimen 'B' for mean and maximum temperatures of the unexposed surface of steel hollows of specimen 'B'. Thermocouples S11 – S13 were fixed on the Rockwool of specimen 'C' for mean and maximum temperatures of the unexposed surface of Rockwool of specimen 'C'. Thermocouples S14 – S15 were fixed on the steel hollows of specimen 'C' for mean and maximum temperatures of the unexposed surface of steel hollows of specimen 'C'. The mean and maximum temperatures were recorded.

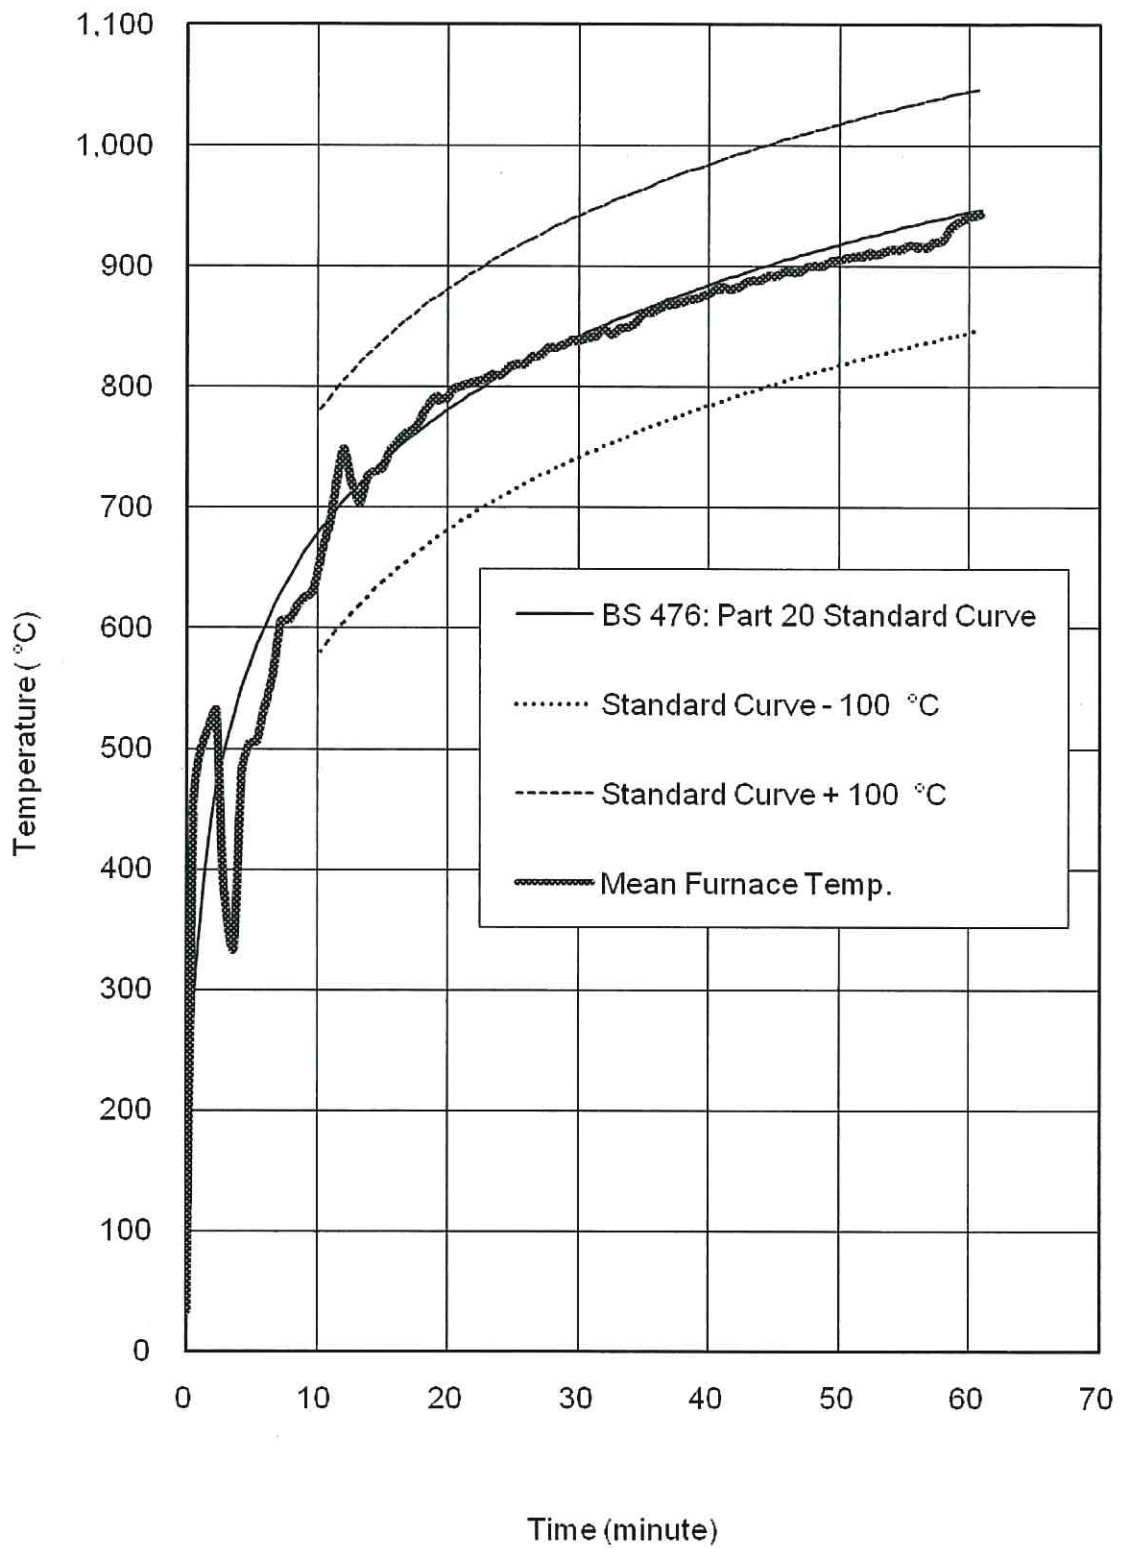
Figure 4 – Mean furnace temperature.

The furnace was controlled so that the mean furnace temperature complied with the requirements of BS 476: Part 20: 1987. The temperature recorded was shown graphically in Figure 4.

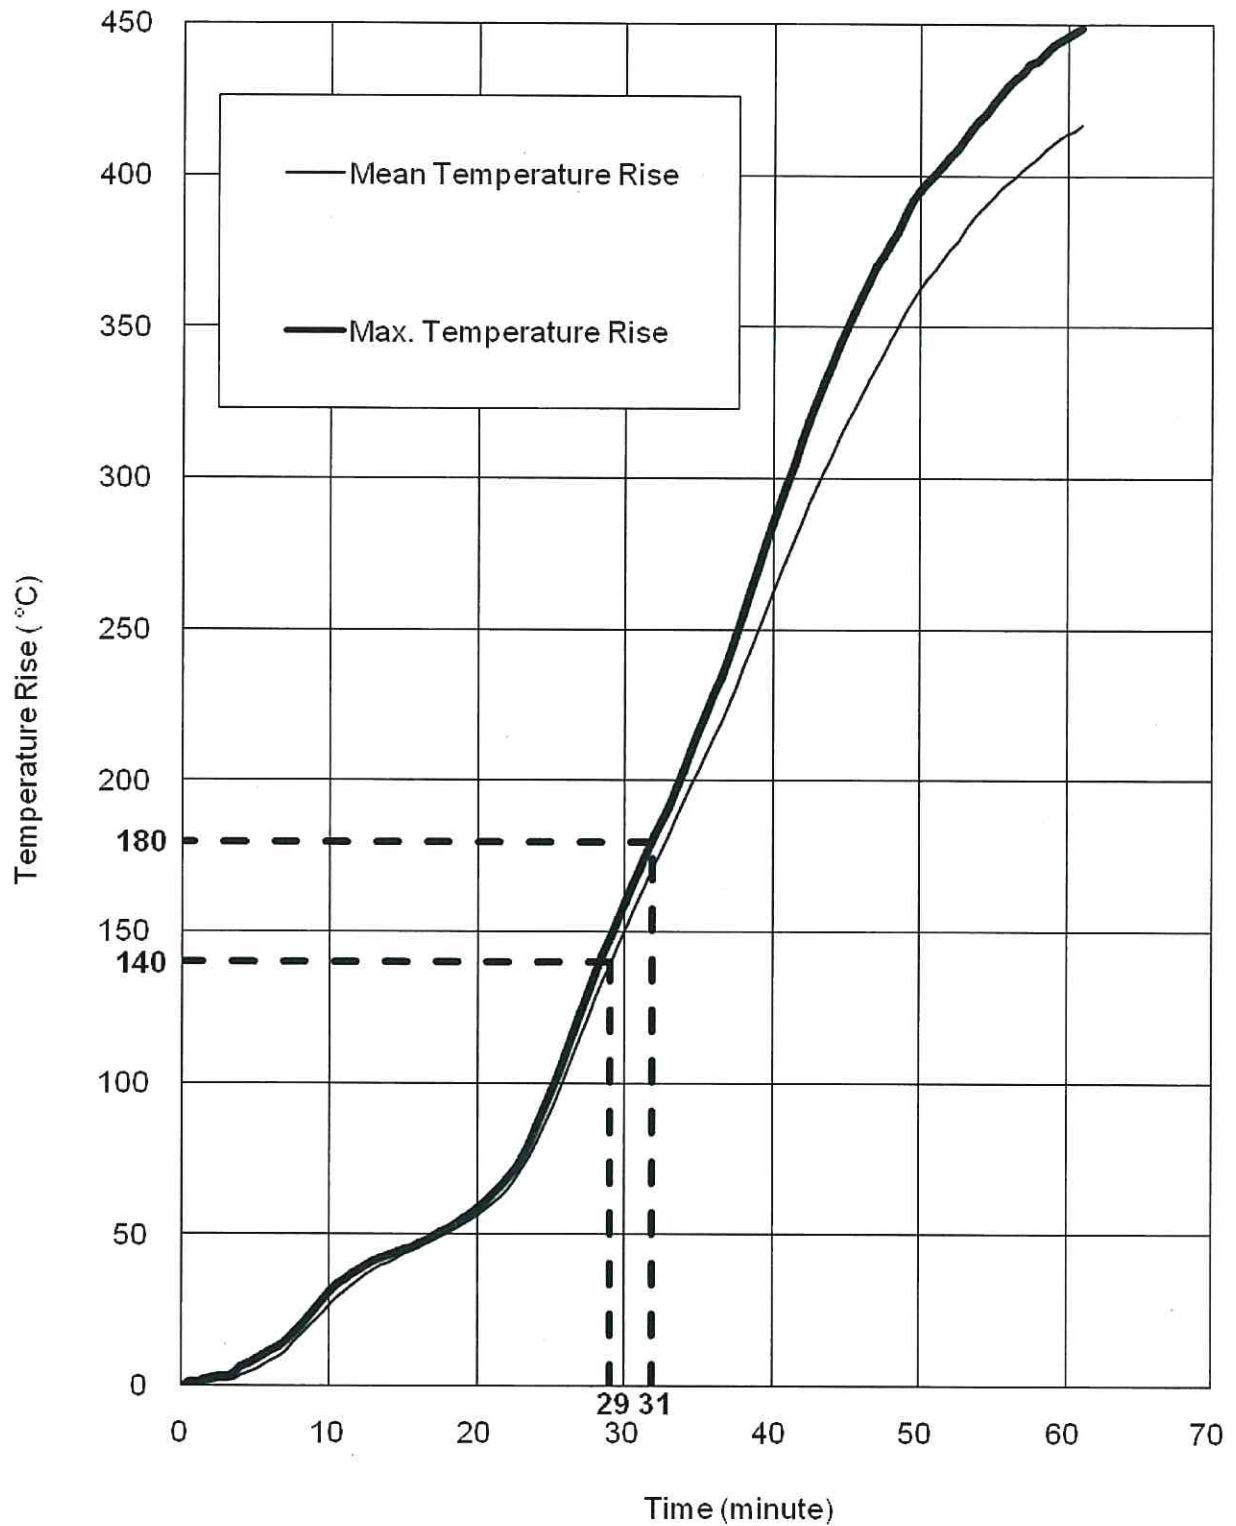
Figure 5 – Temperature rises of unexposed surface of Rockwool of specimen 'A'.

The mean and maximum temperatures of the unexposed surface of Rockwool of specimen 'A' were shown graphically in Figure 5.

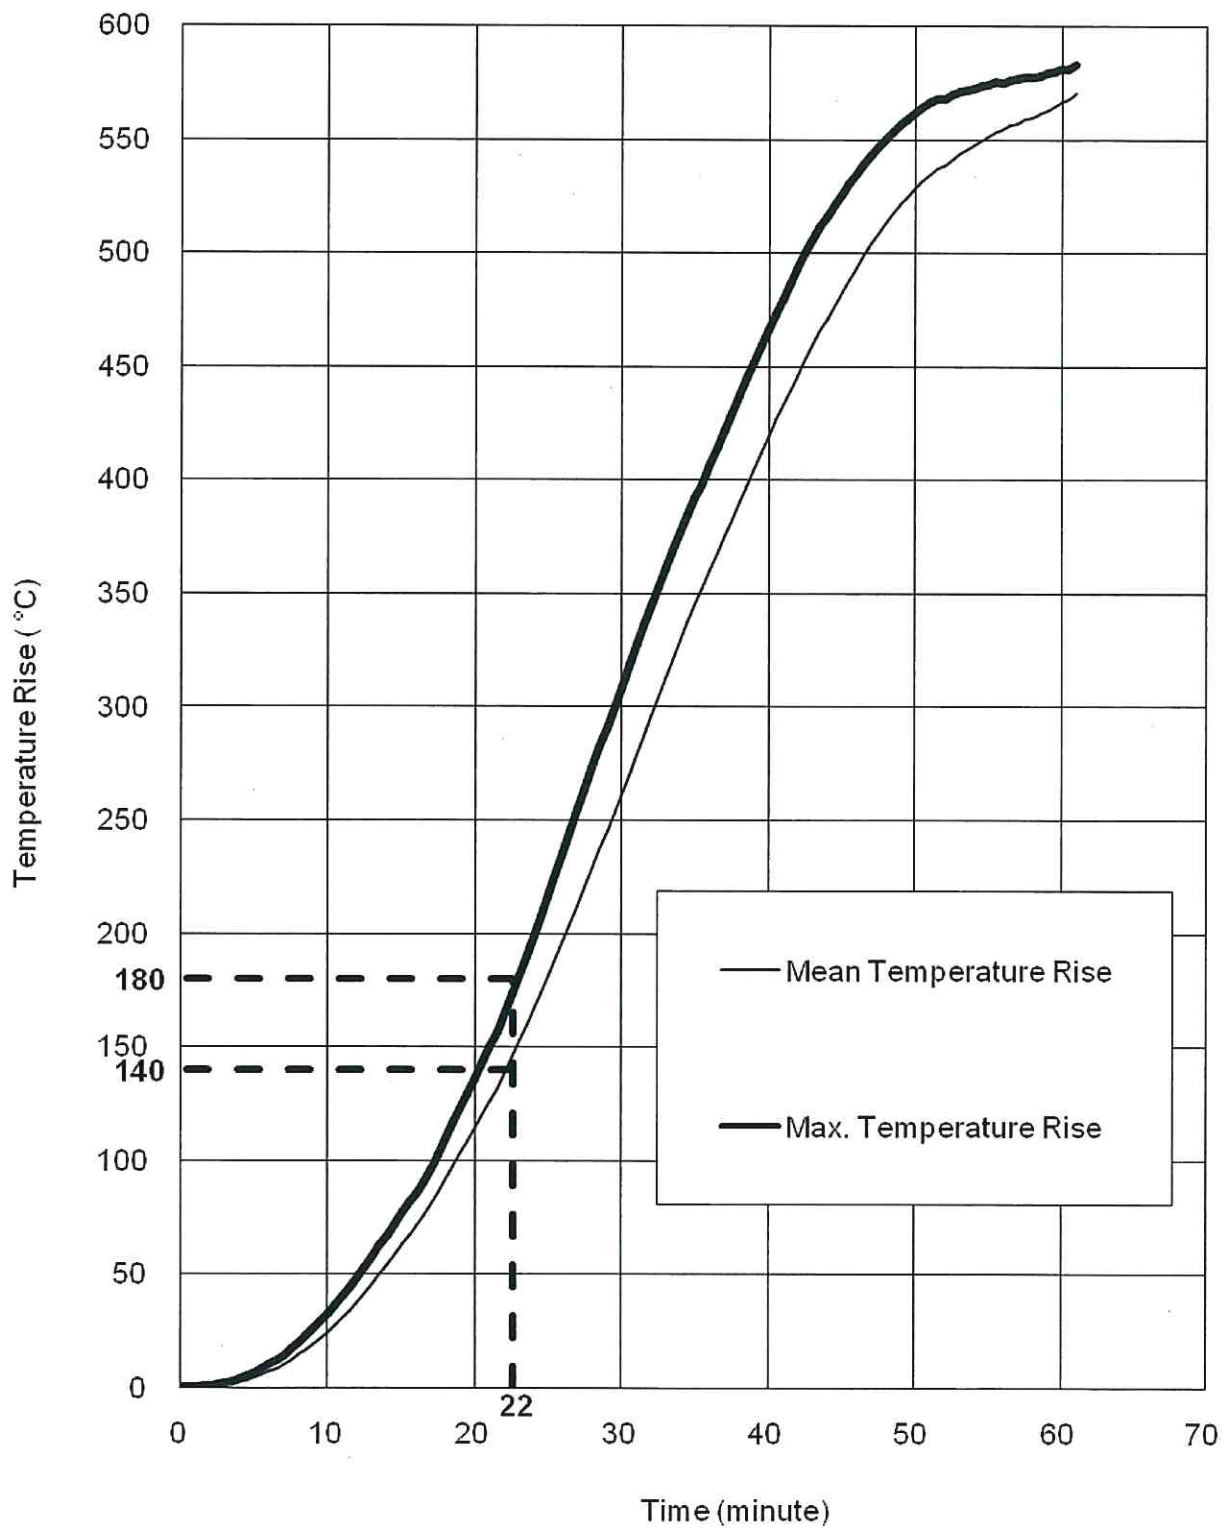
Figure 6 – Temperature rises of unexposed surface of steel hollows of specimen 'A'.

The mean and maximum temperatures of the unexposed surface of steel hollows of specimen 'A' were shown graphically in Figure 6.

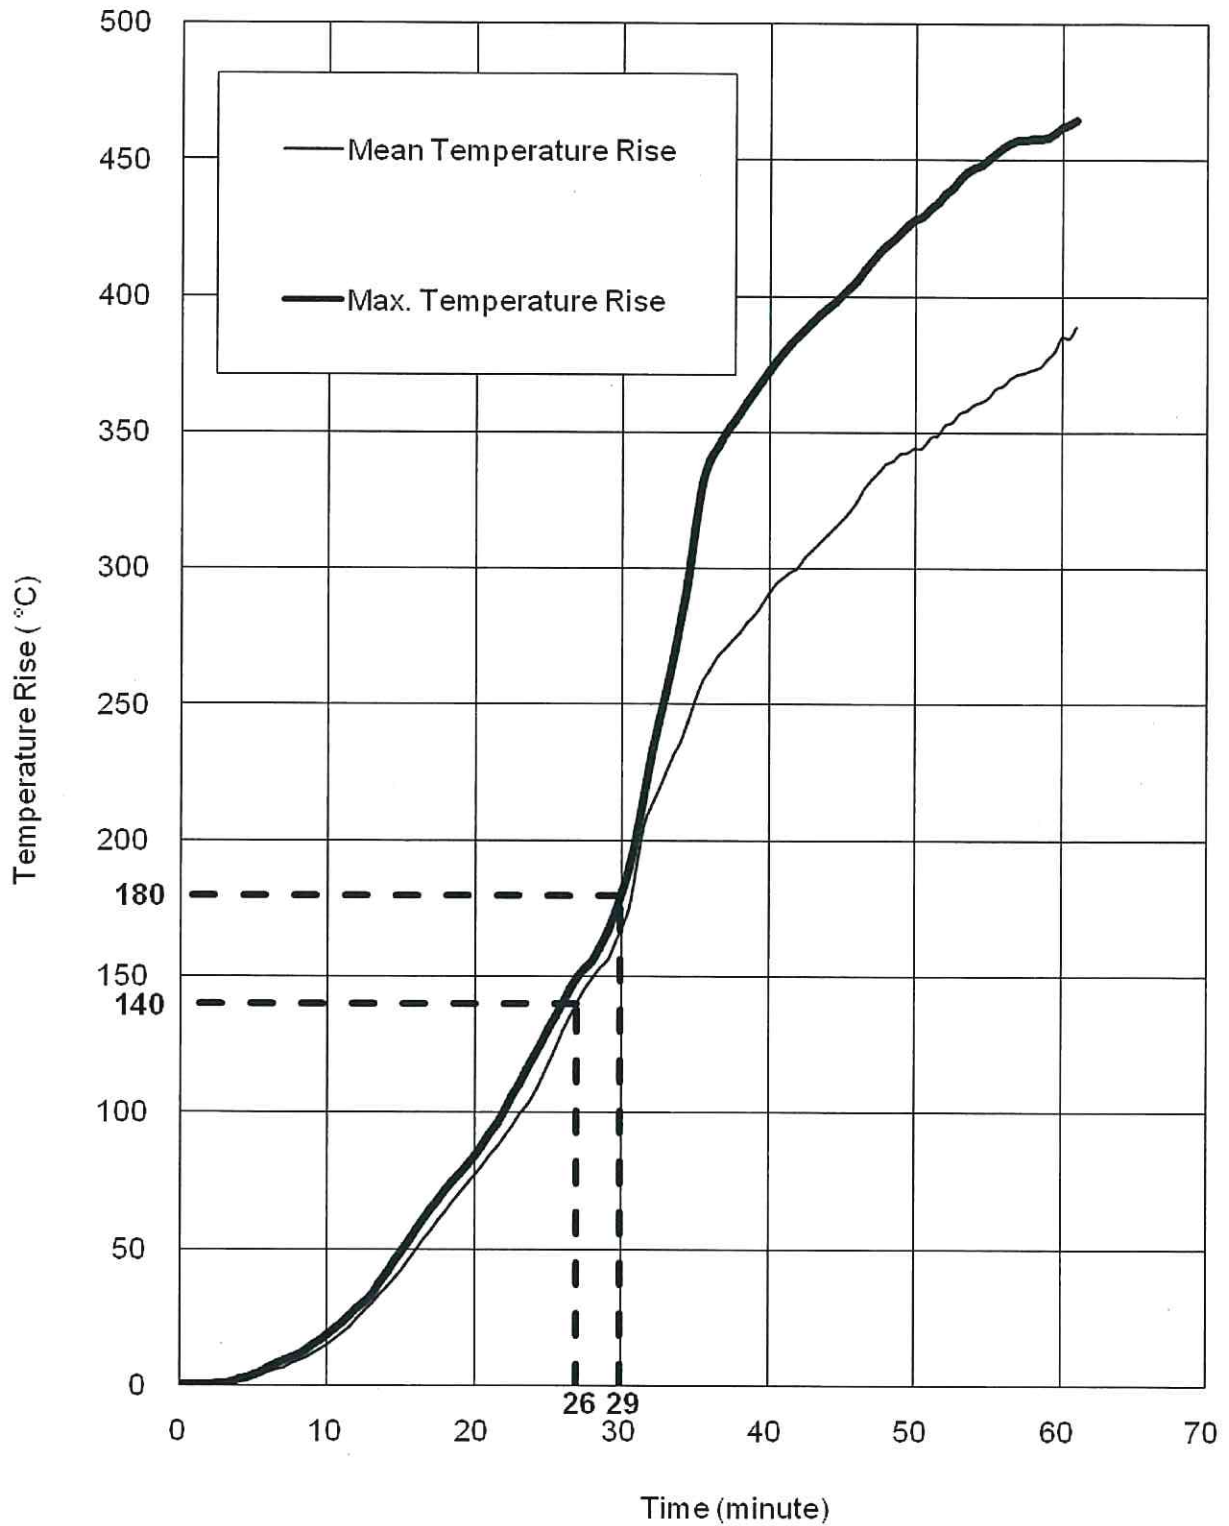
Figure 7 – Temperature rises of unexposed surface of Hilti CFS-HFF of specimen 'B'.

The mean and maximum temperatures of the unexposed surface of Hilti CFS-HFF of specimen 'B' were shown graphically in Figure 7.

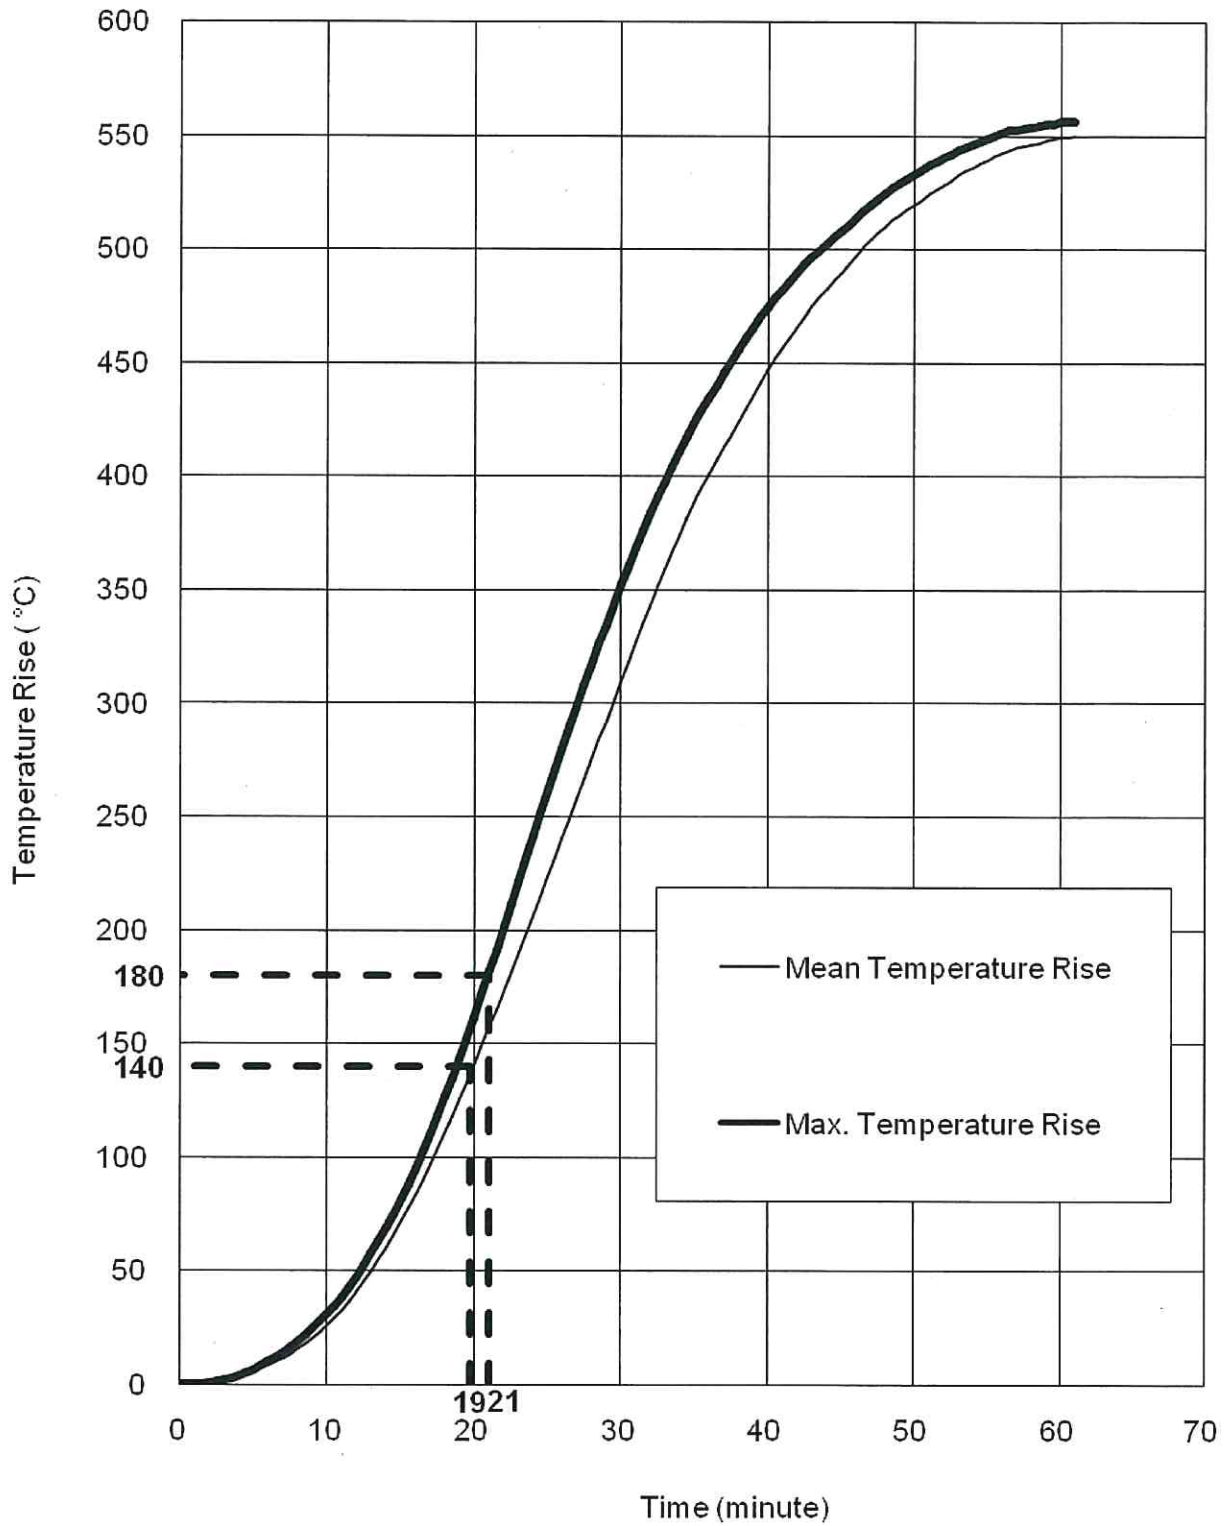
Figure 8 – Temperature rises of unexposed surface of steel hollows of specimen 'B'.

The mean and maximum temperatures of the unexposed surface of steel hollows of specimen 'B' were shown graphically in Figure 8.

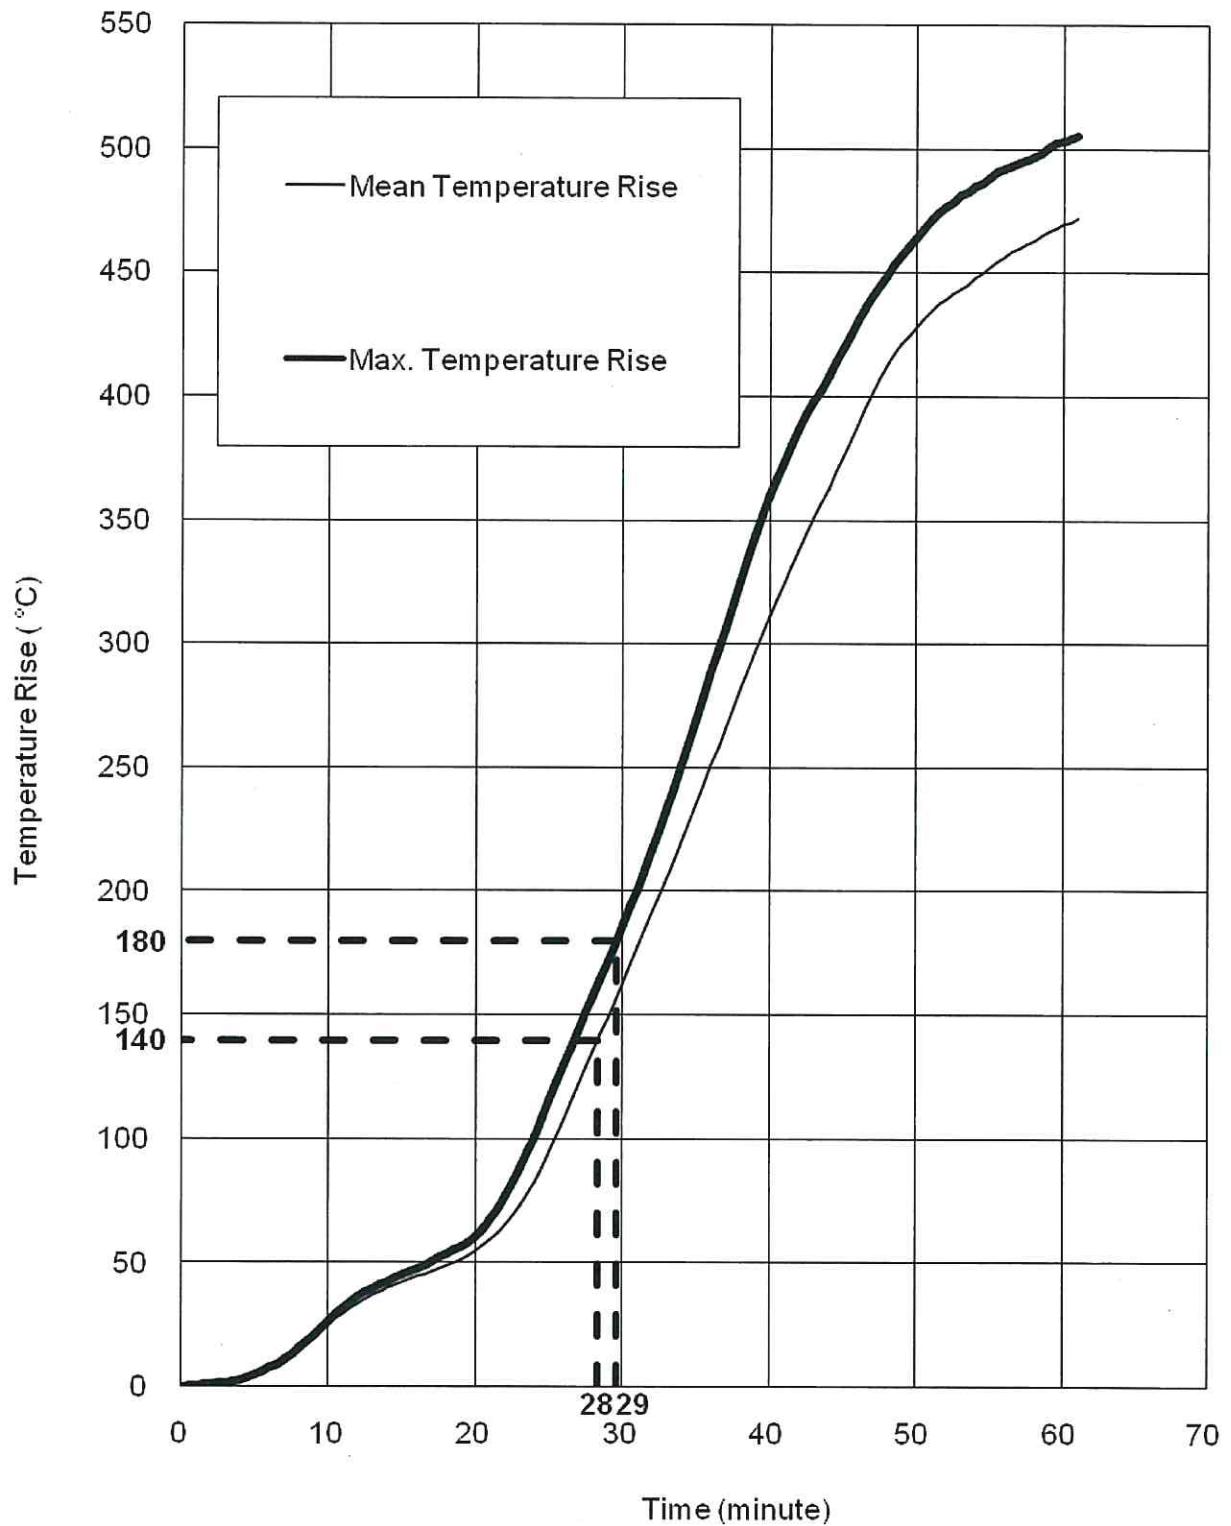
Figure 9 – Temperature rises of unexposed surface of Rockwool of specimen 'C'.

The mean and maximum temperatures of the unexposed surface of Rockwool of specimen 'C' were shown graphically in Figure 9.

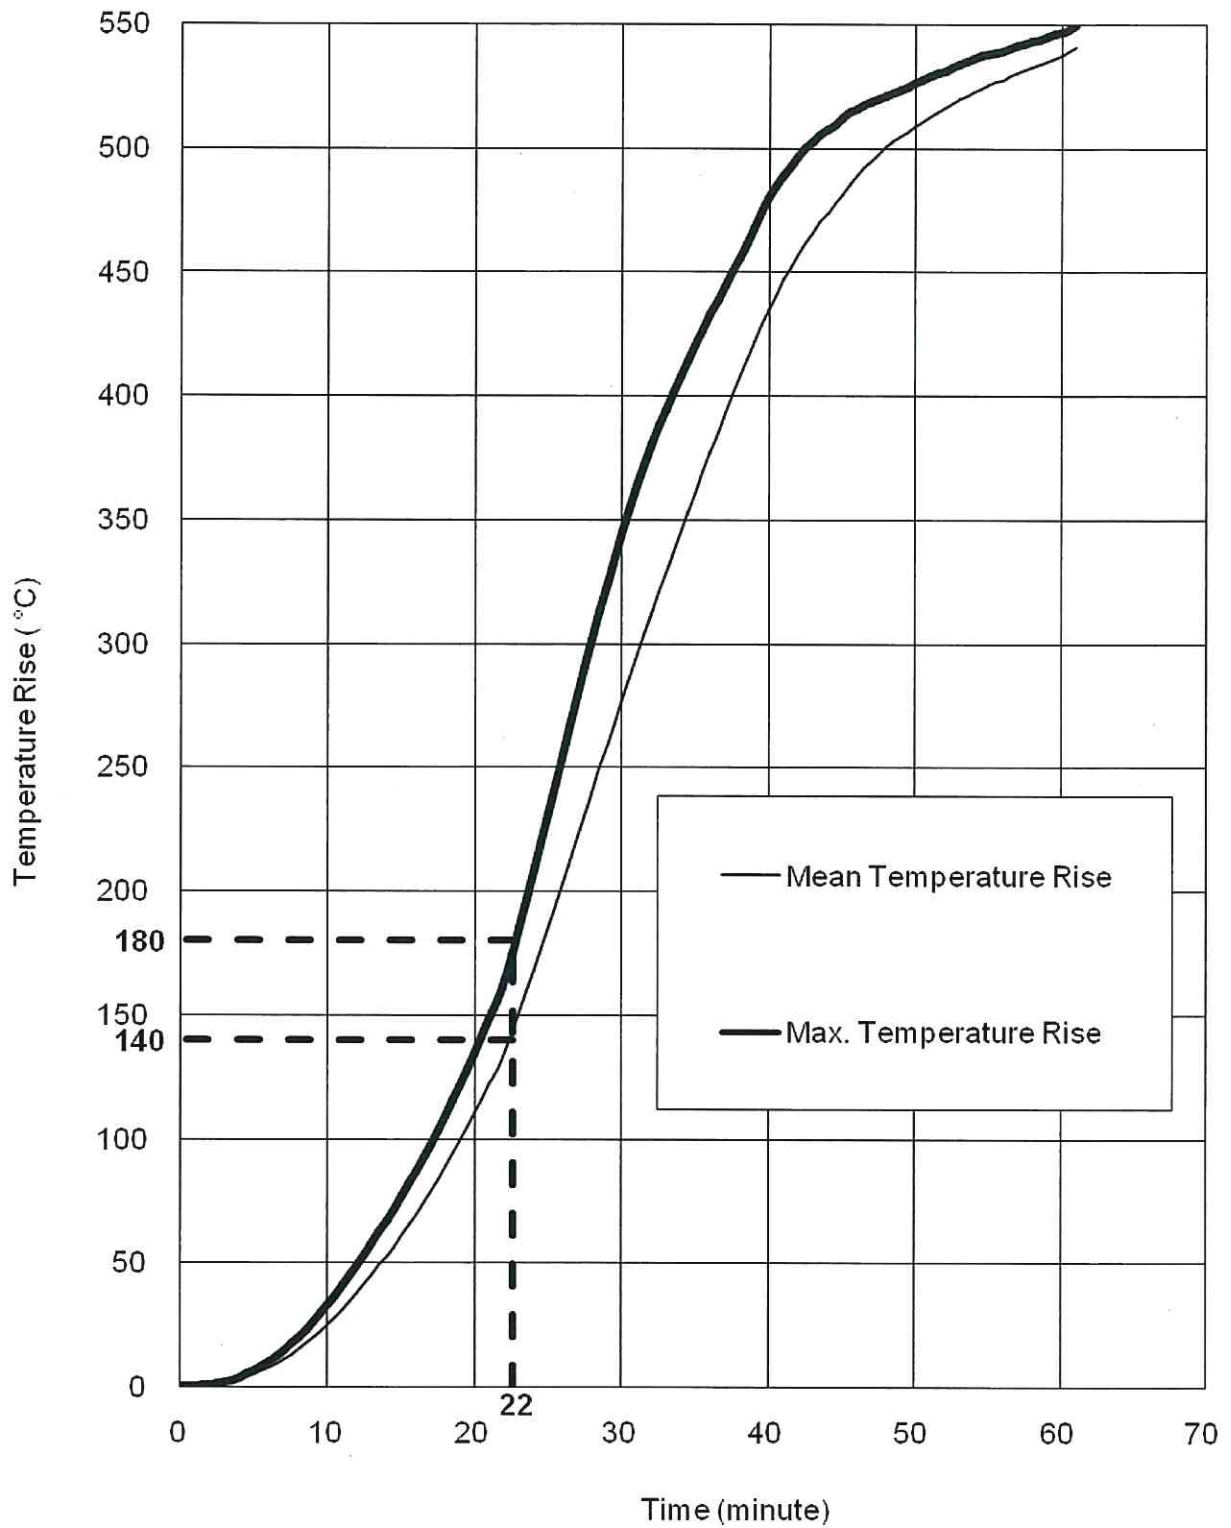
Figure 10 – Temperature rises of unexposed surface of steel hollows of specimen 'C'.

The mean and maximum temperatures of the unexposed surface of steel hollows of specimen 'C' were shown graphically in Figure 10.

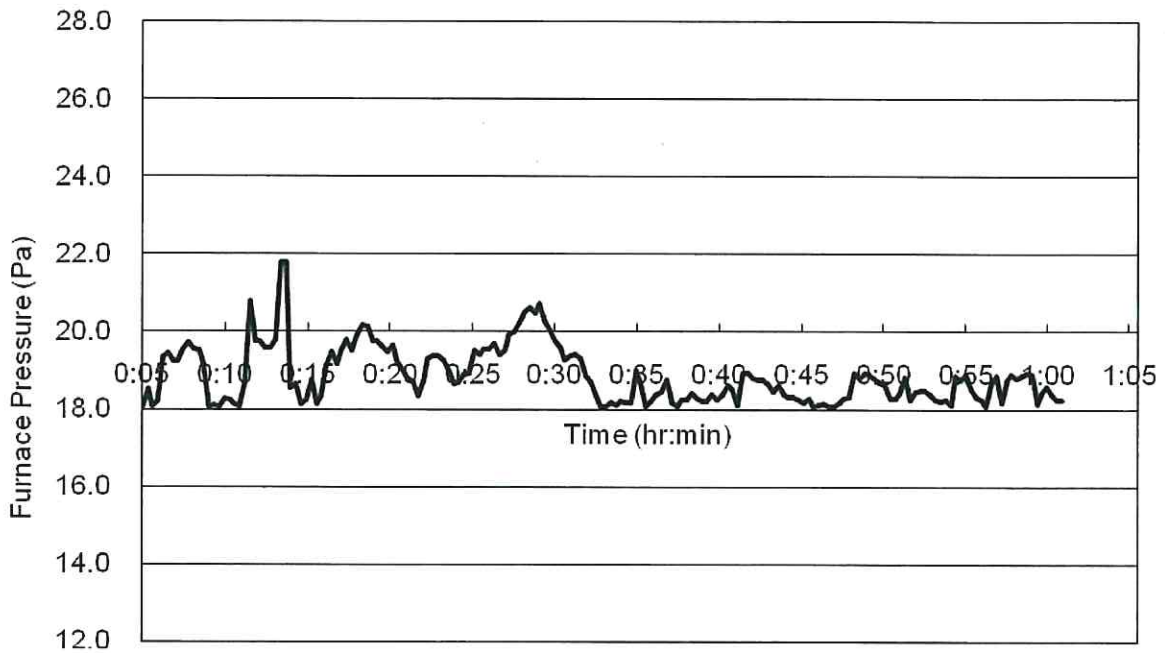
After the first 5 minutes of the test, the furnace pressure was maintained at  $20 \pm 2$  Pa relative to atmosphere, at 100 mm from the exposed side of specimens.

Figure 11 – Furnace pressure.

The furnace pressure obtained was shown graphically in Figure 11.

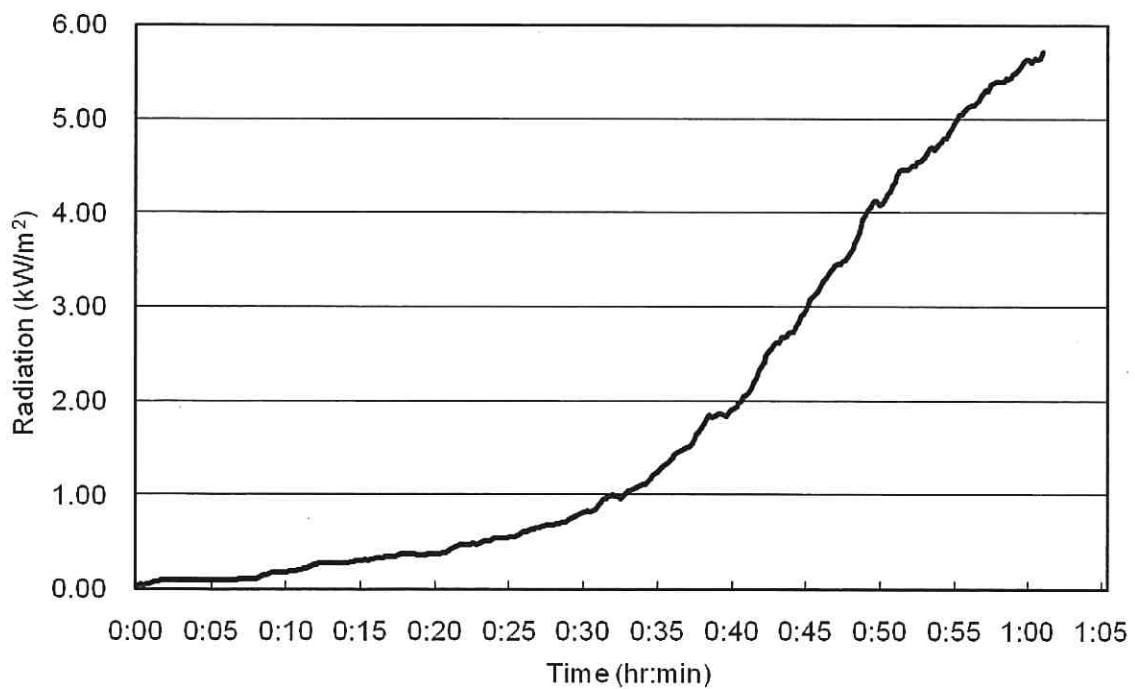
A radiometer placed at 1,000 mm away from the unexposed surface to measure the radiation of unexposed surface of specimens.

Figure 12 – Radiation.

The radiation obtained was shown graphically in Figure 12.
