# Hilti CFS-HFF Firestop Flute Filler

## FIRE RESISTANCE TEST IN ACCORDANCE WITH BS 476: PART 20: 1987

On 3 nos. of Cavity Barriers

**Test Report No.:** R19L23-1A

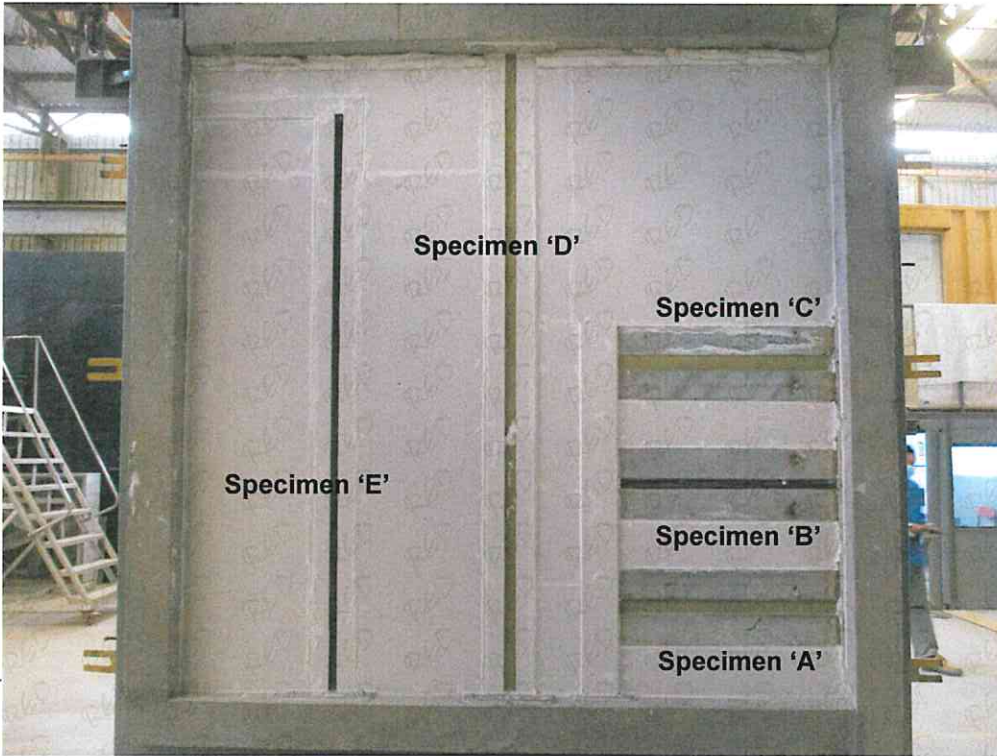
Photo 1: The exposed face of the specimens before the test.

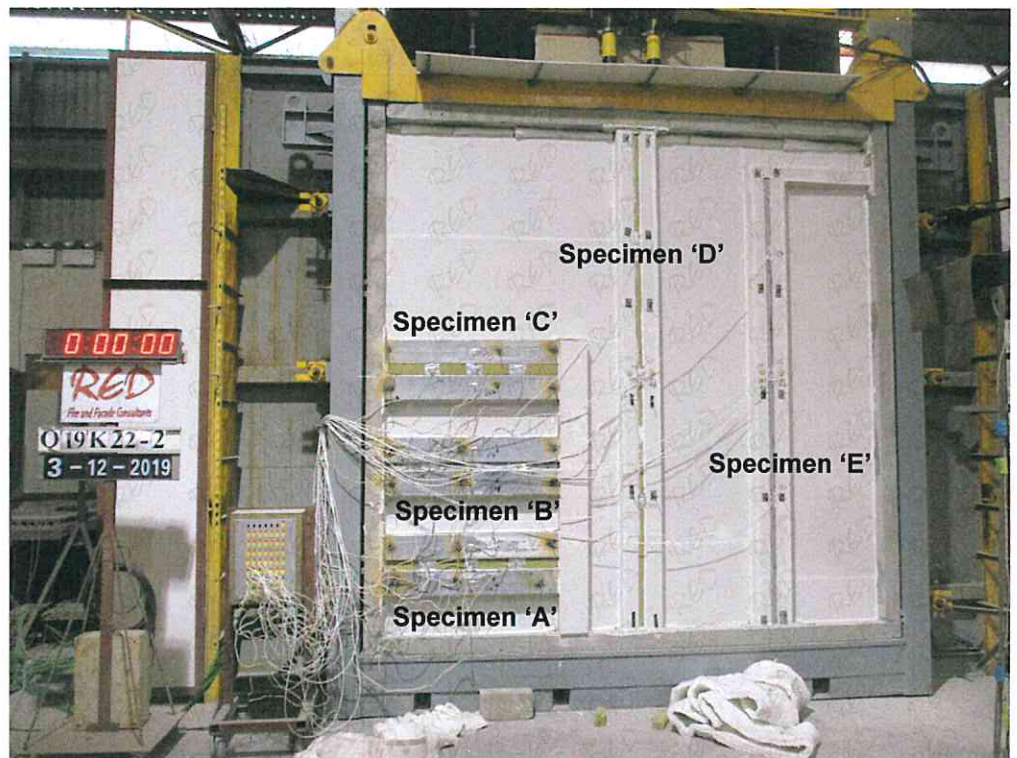
Photo 2: The unexposed face of the specimens before the test.

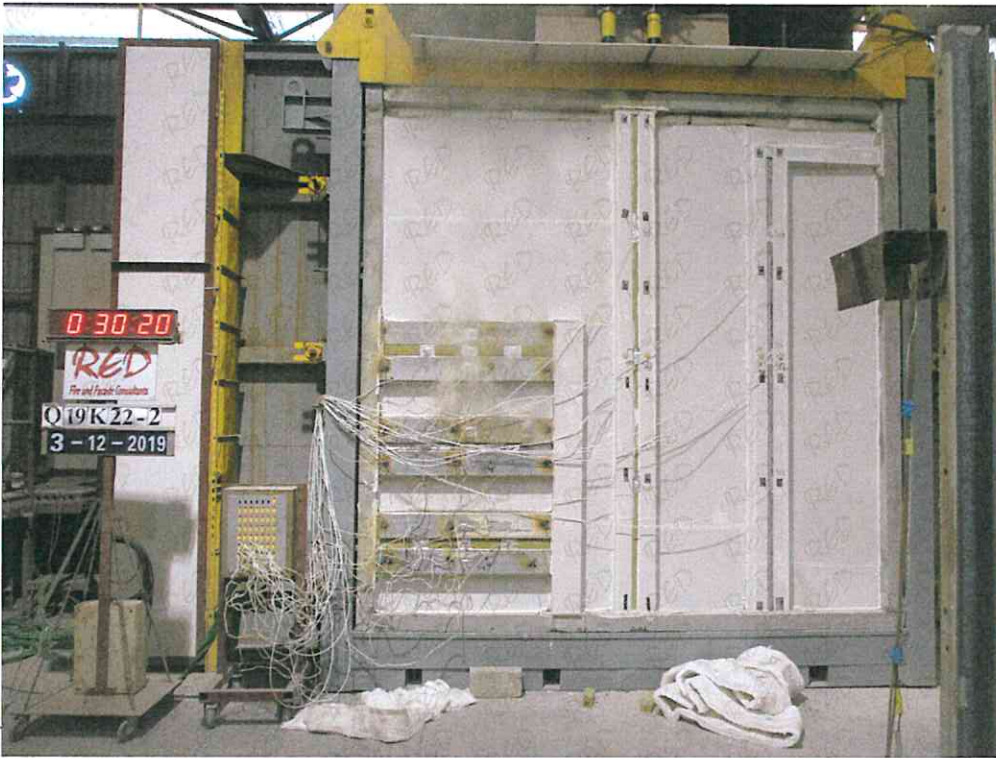
Photo 3: The unexposed face of the specimens after a heating period of 30 minutes.

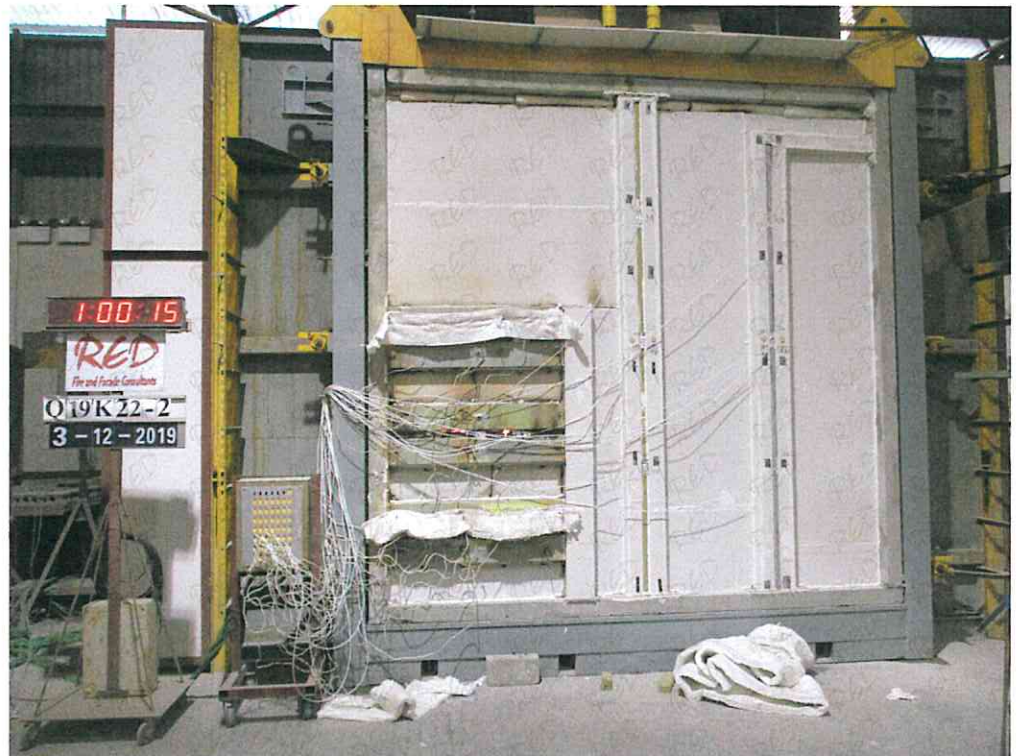
Photo 4: The unexposed face of the specimens after a heating period of 60 minutes.

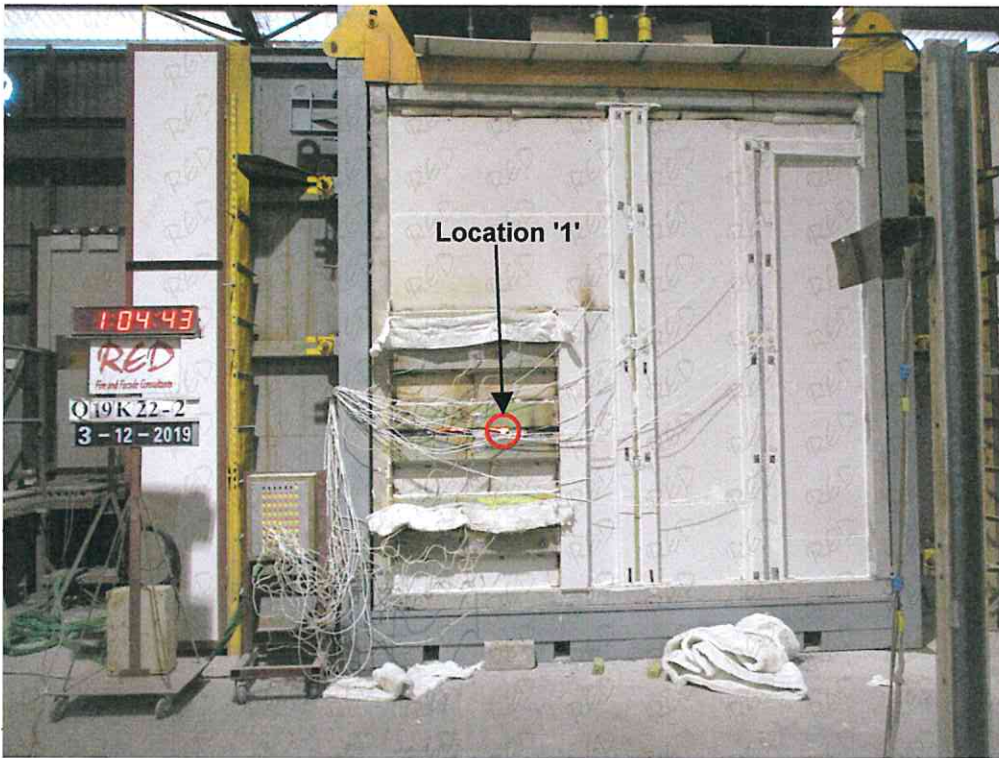
Photo 5: The unexposed face of the specimens after the test.

64.12	U	25 mm gap gauge was applied at the gap of steel hollows of specimen 'B', near Hilti CFS-HFF and passed through into the furnace (refer to location '1' in photo 5). <b>Integrity failure.</b>

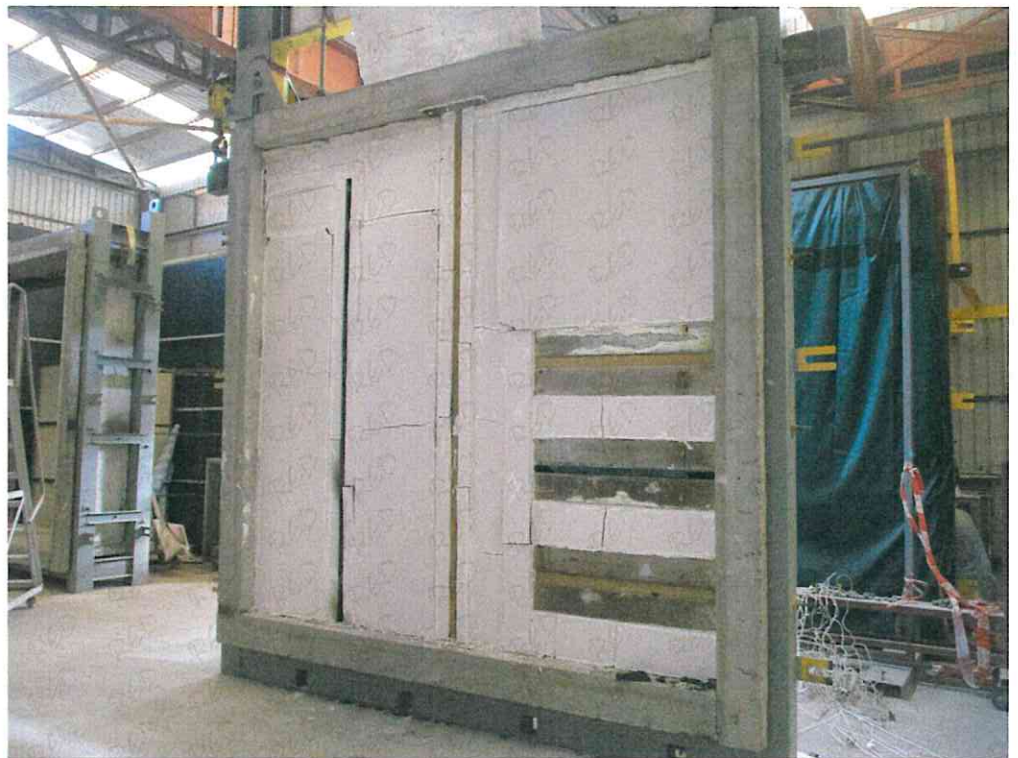
Photo 6: The exposed face of the specimens after the test.

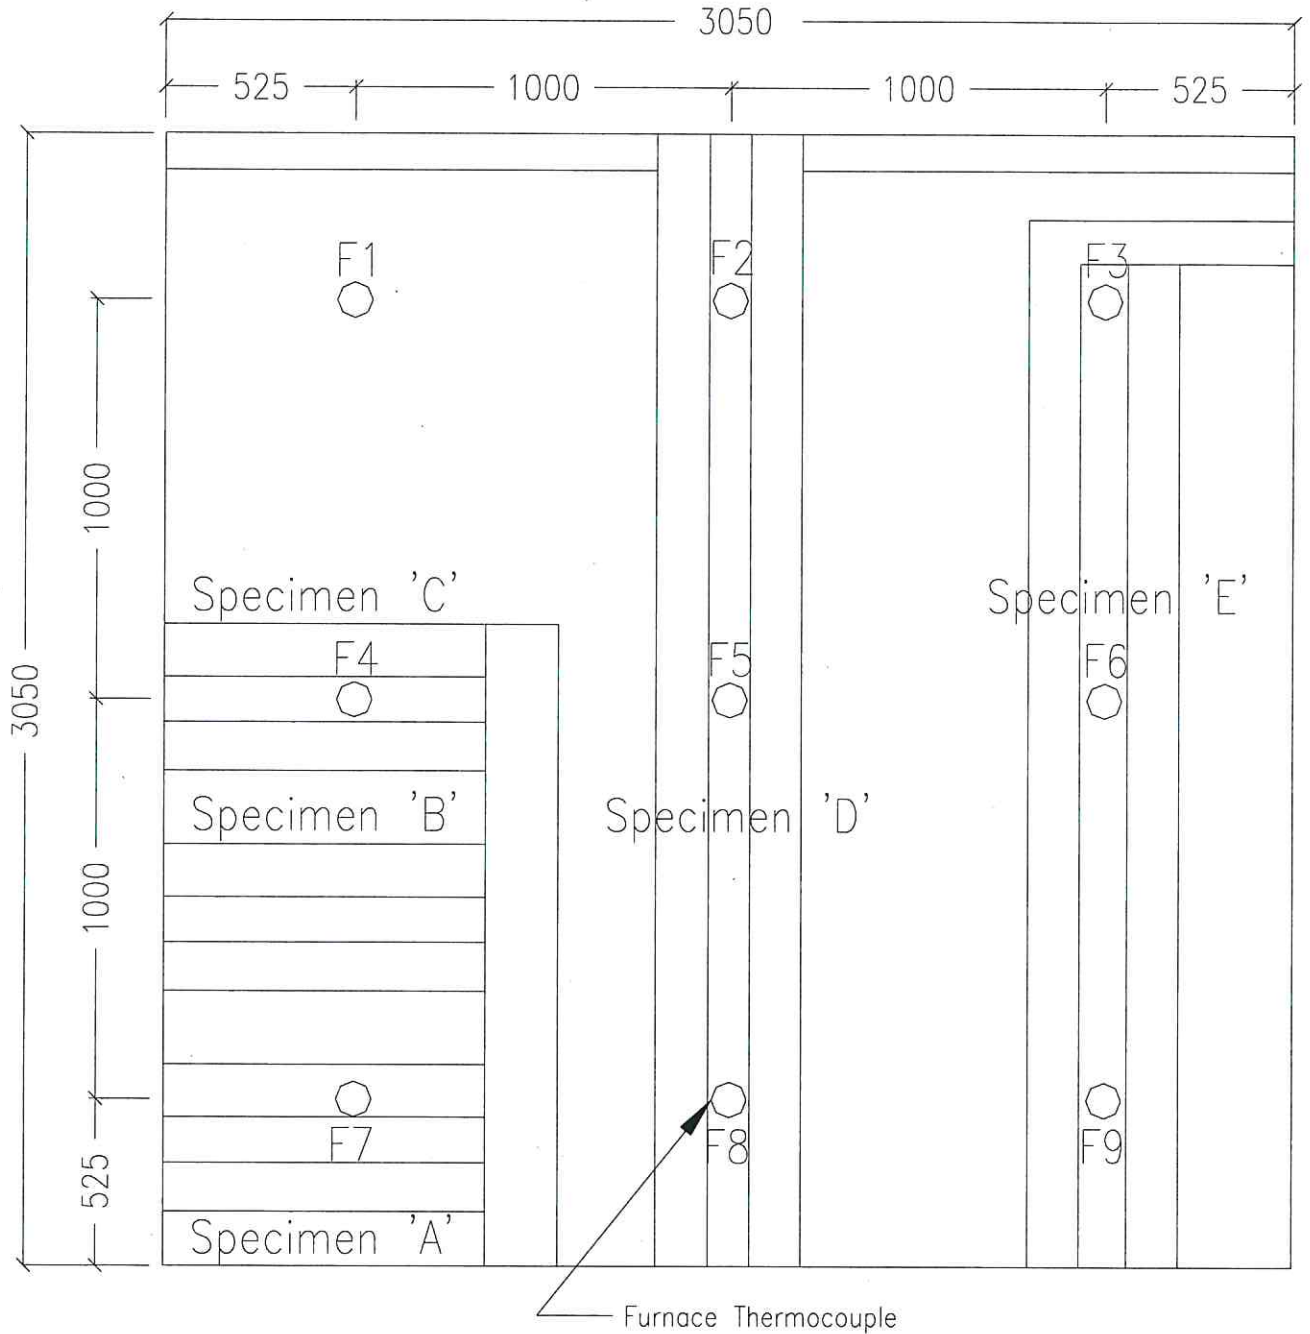
Figure 1 – Locations and reference numbers of furnace thermocouples.

(This figure is not to scale and all dimensions are in millimetres.)

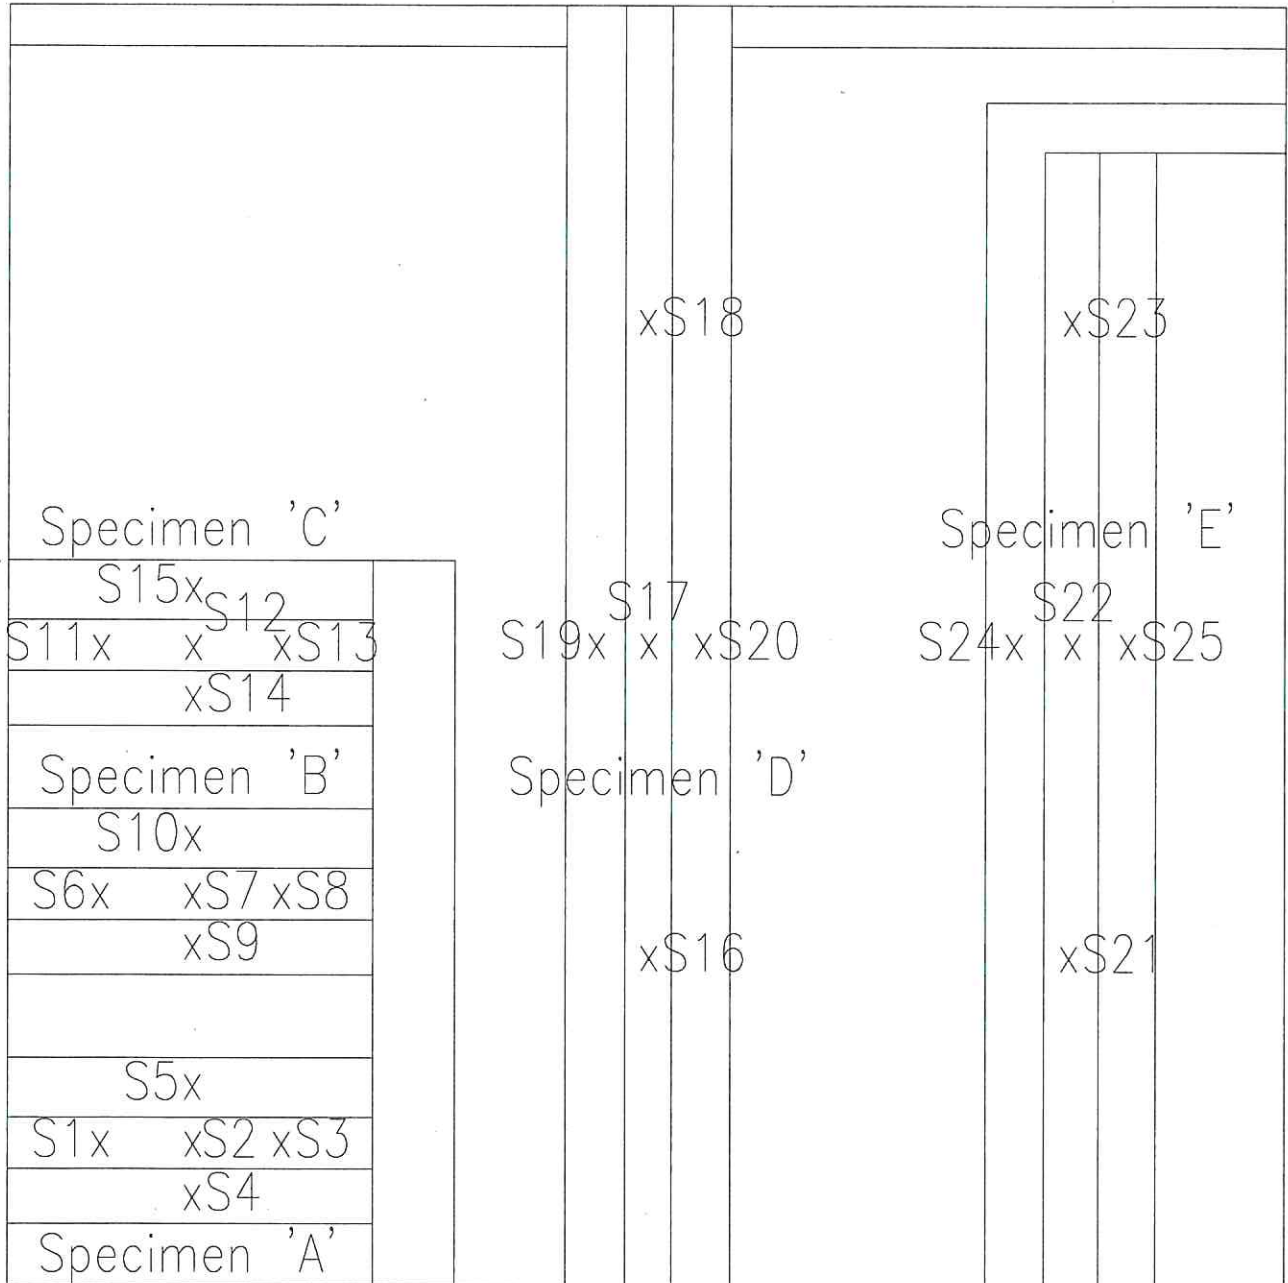
Figure 2 – Locations and reference numbers of thermocouples to monitor the temperature of unexposed surface of the specimens.

(This figure is not to scale.)

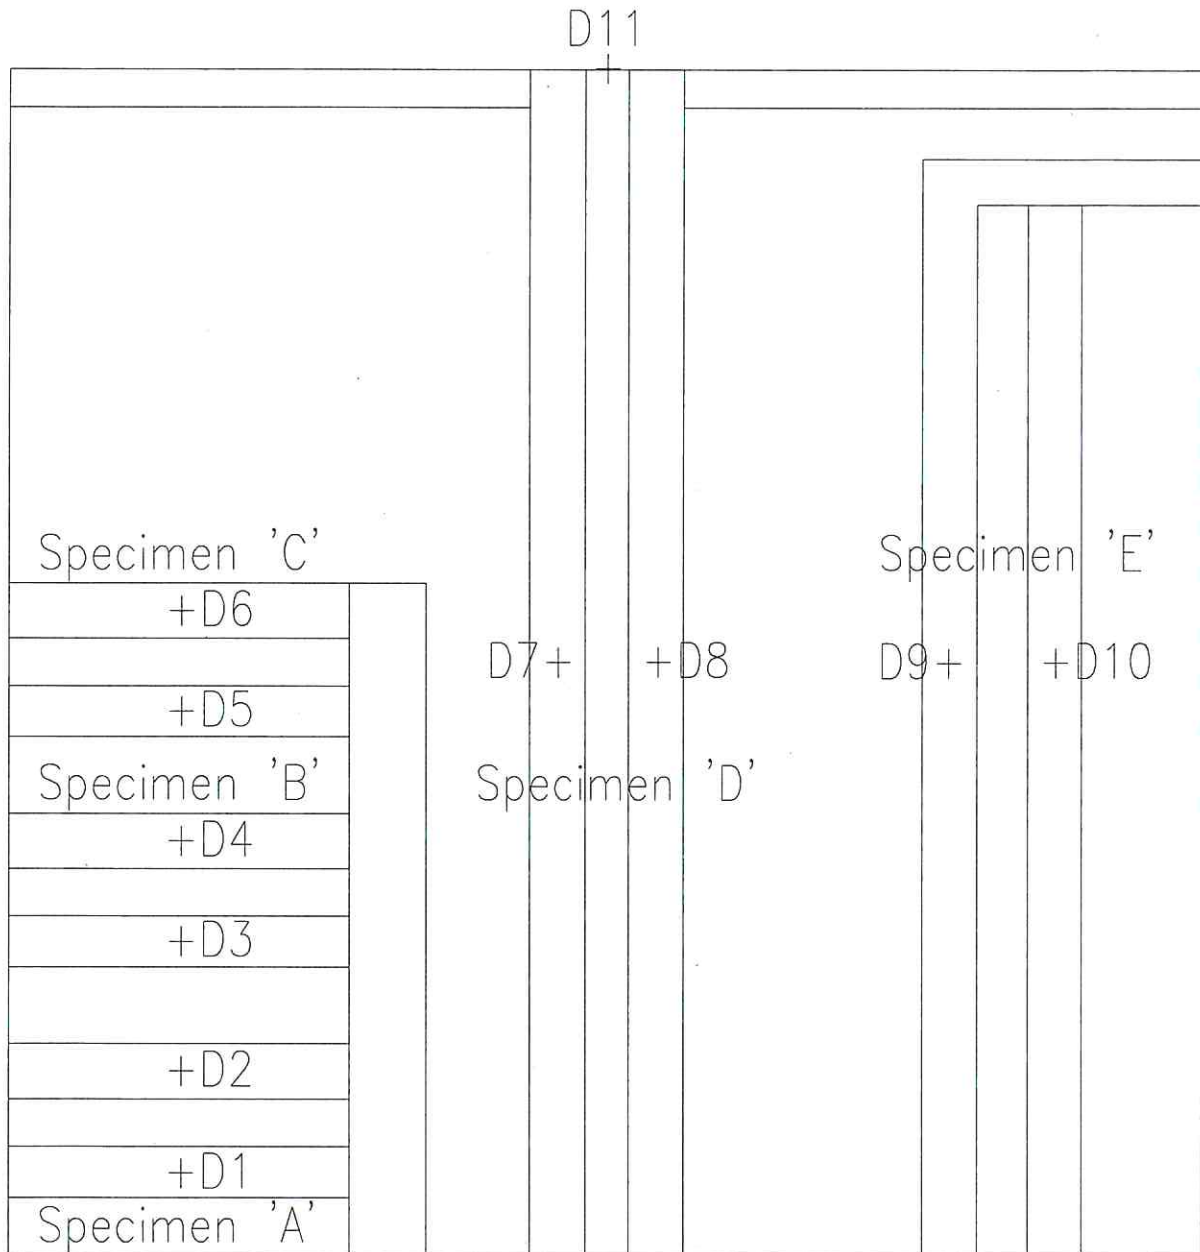
Figure 3 – Locations and reference numbers of displacement measurements.

(This figure is not to scale.)

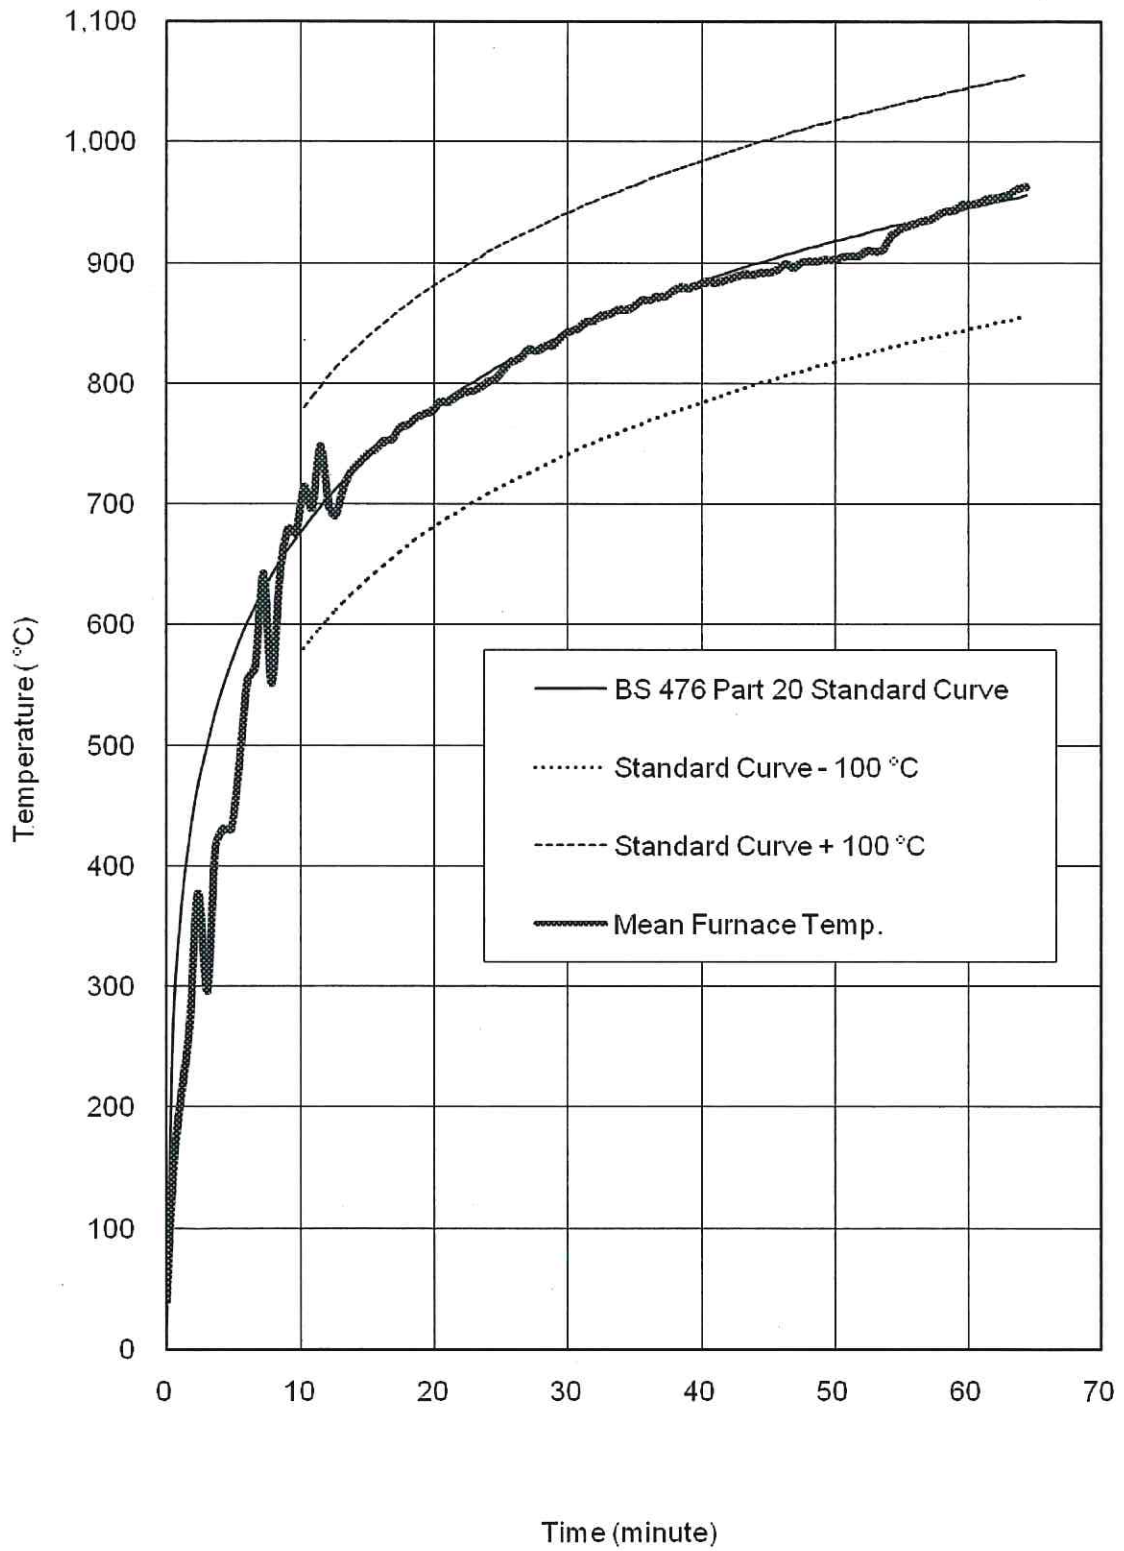
Figure 4 – Mean furnace temperature.

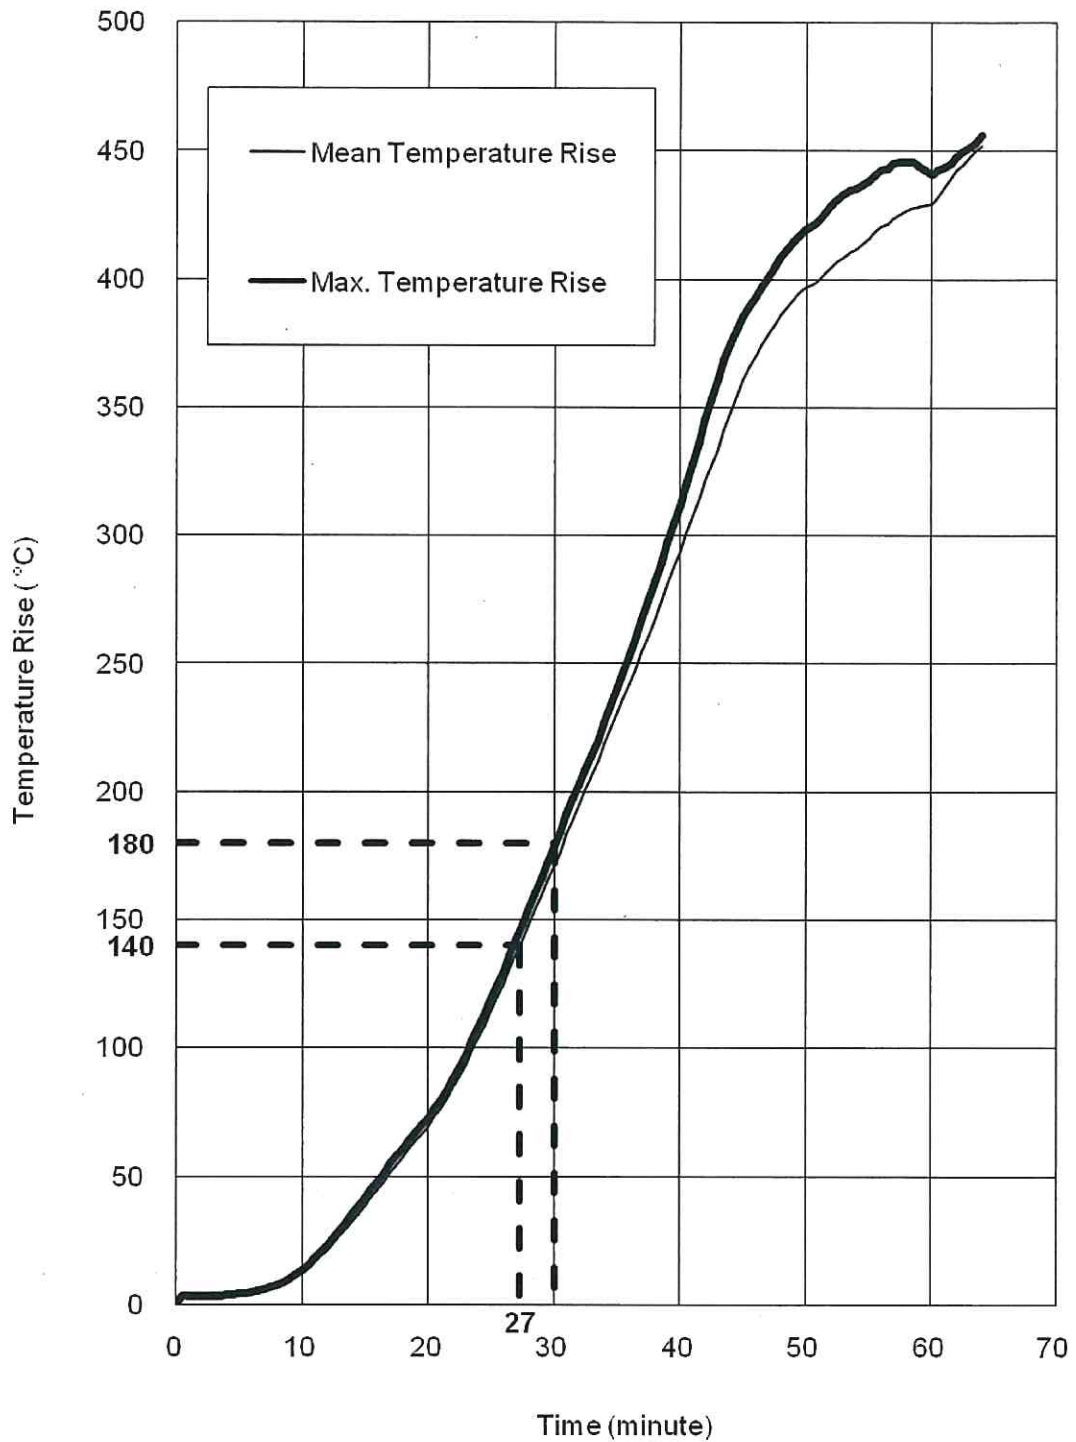
Figure 5 – Temperature rises of unexposed surface of Rockwool of specimen 'A'.

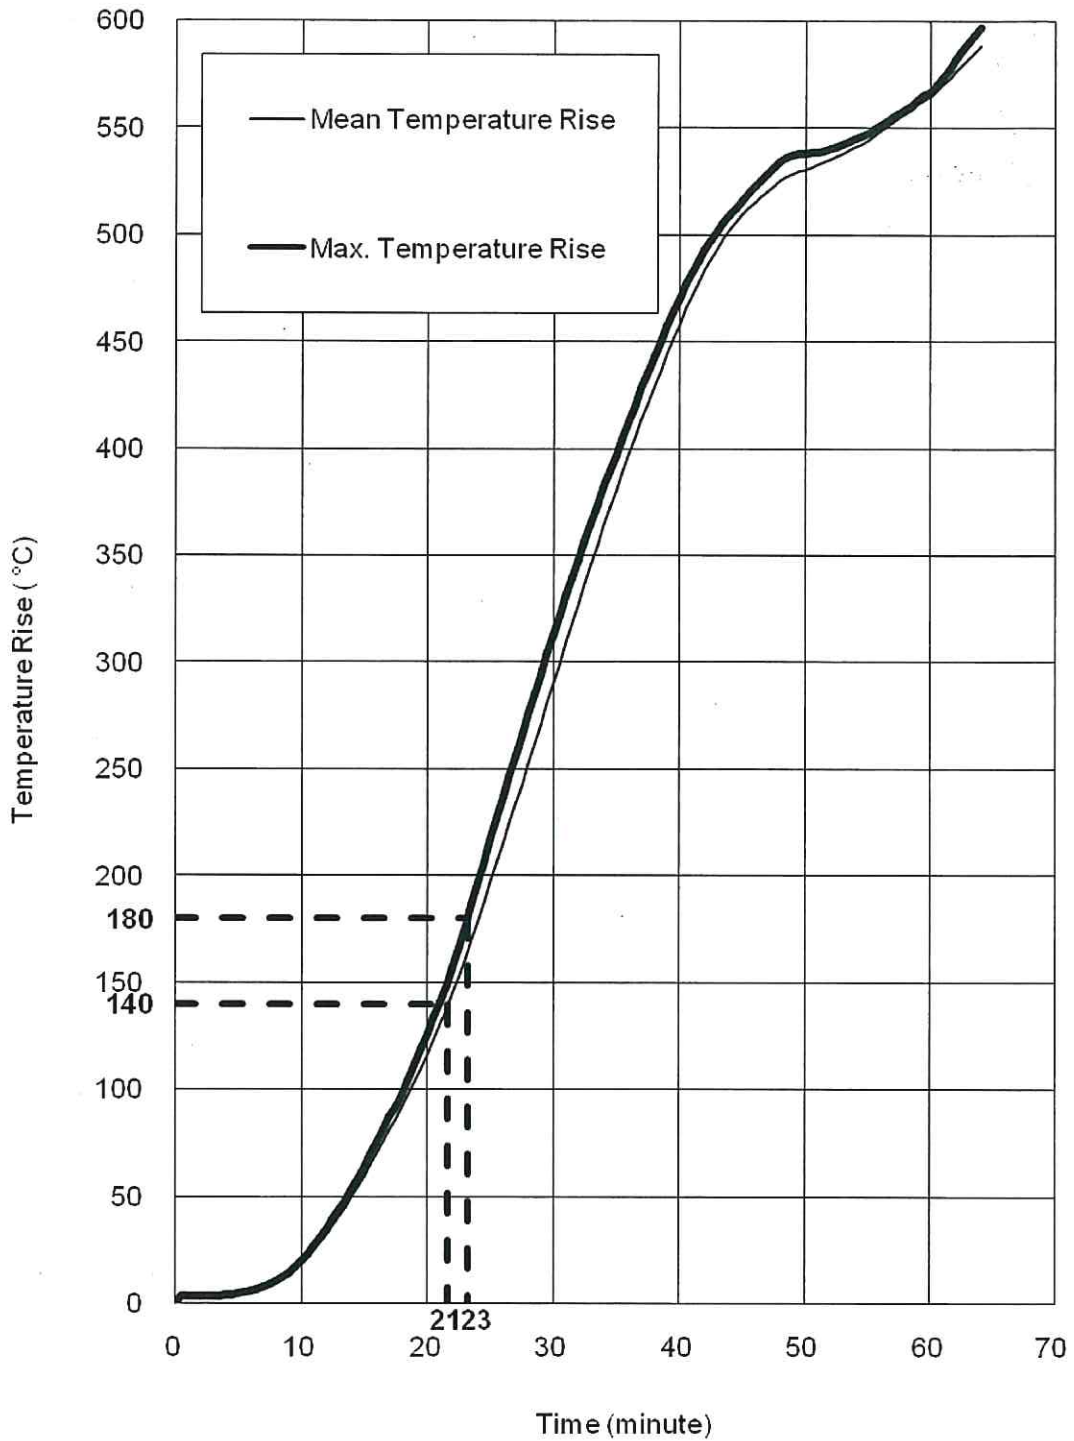
Figure 6 – Temperature rises of unexposed surface of steel hollows of specimen 'A'.

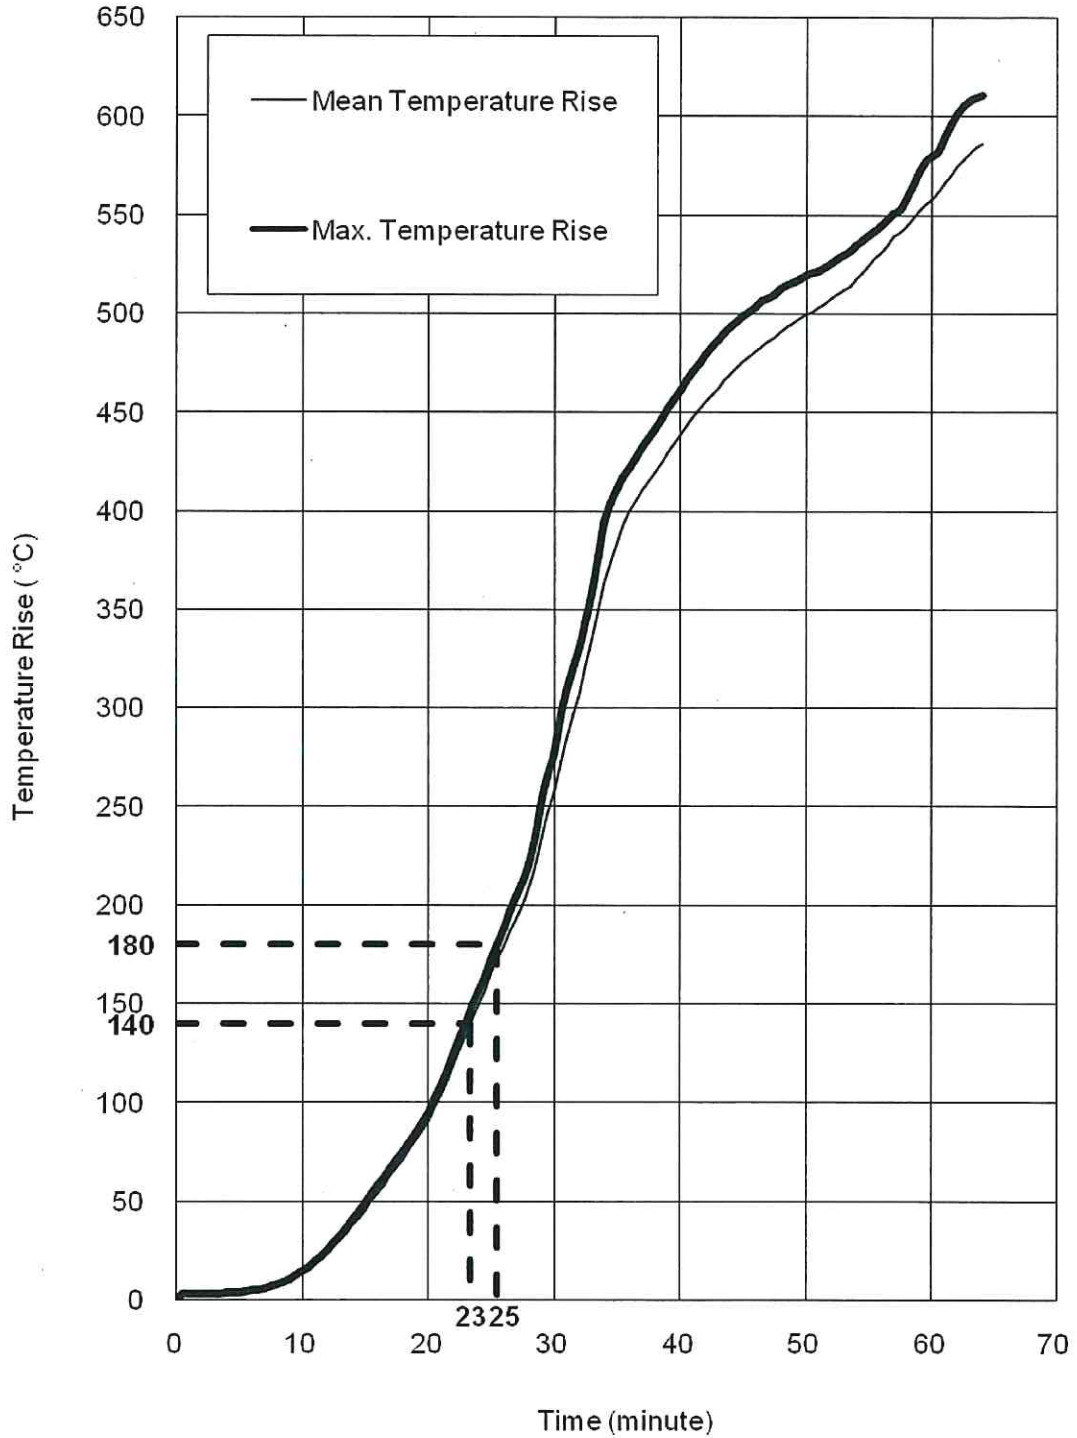
Figure 7 – Temperature rises of unexposed surface of Hilti CFS-HFF of specimen 'B'.

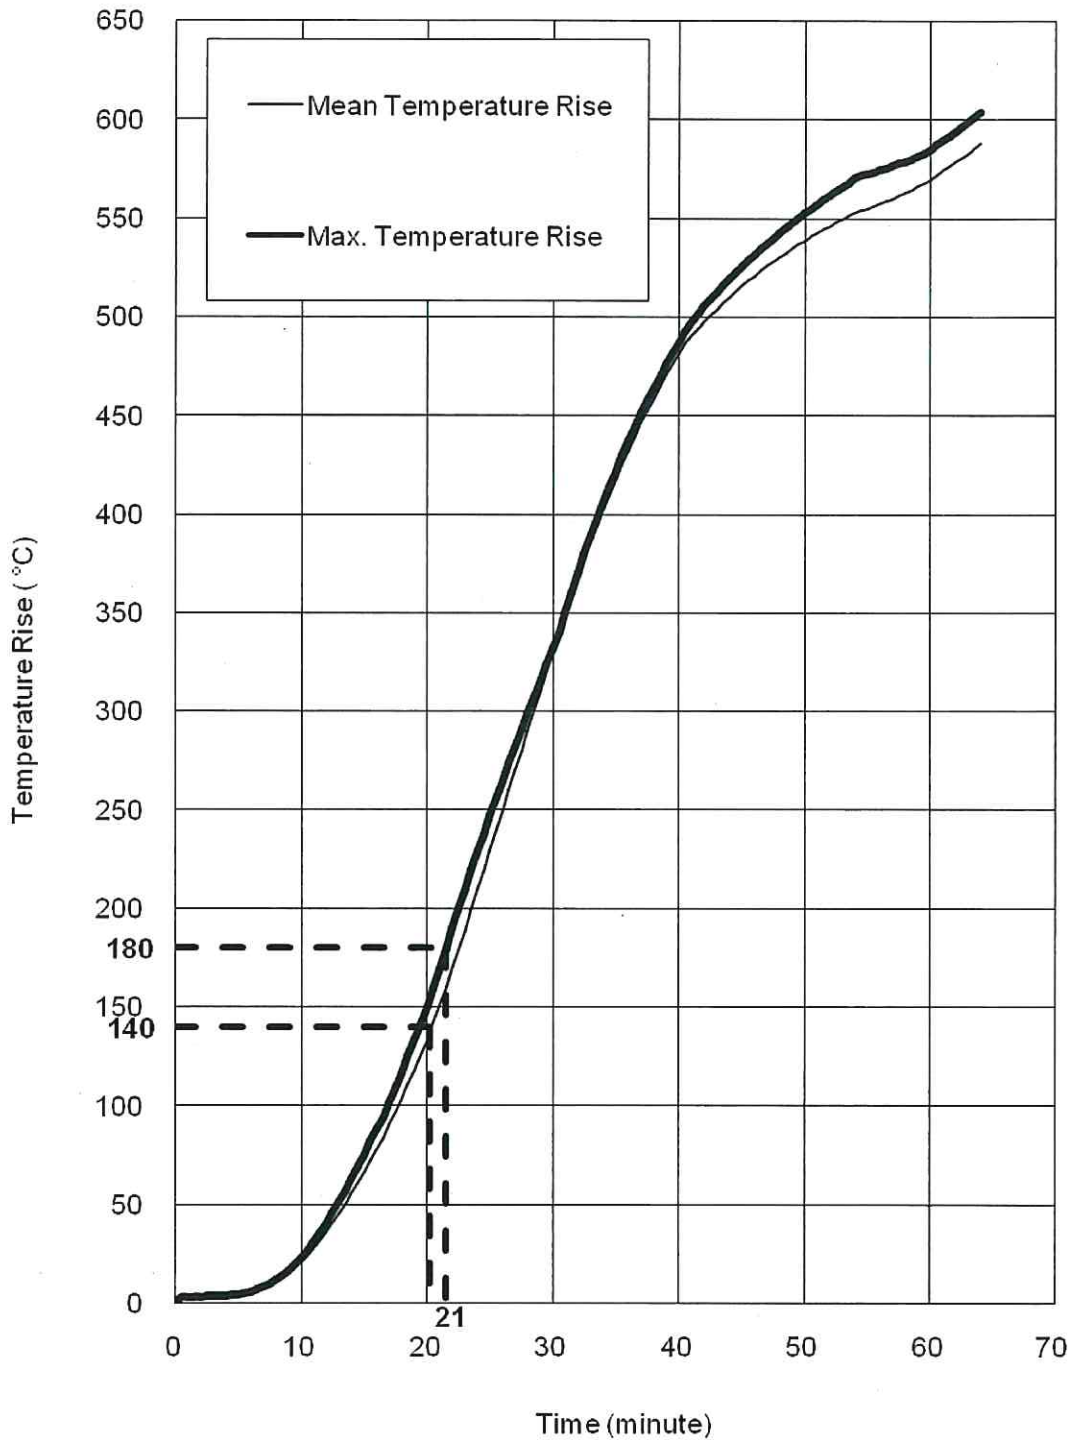
Figure 8 – Temperature rises of unexposed surface of steel hollows of specimen 'B'.

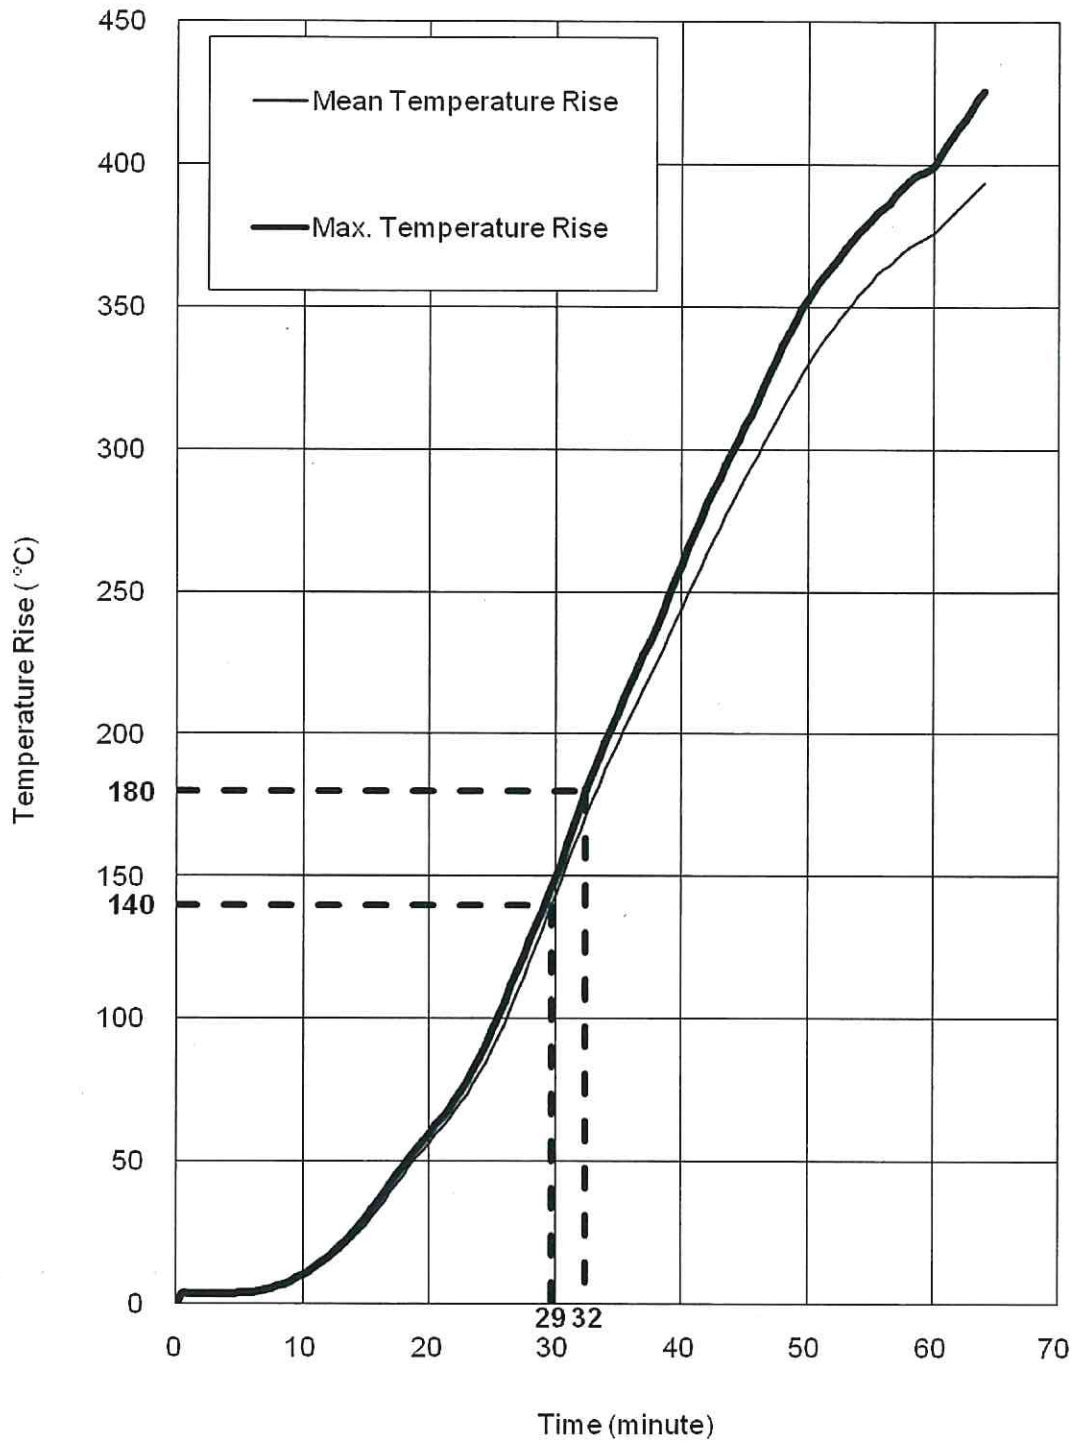
Figure 9 – Temperature rises of unexposed surface of Rockwool of specimen 'C'.

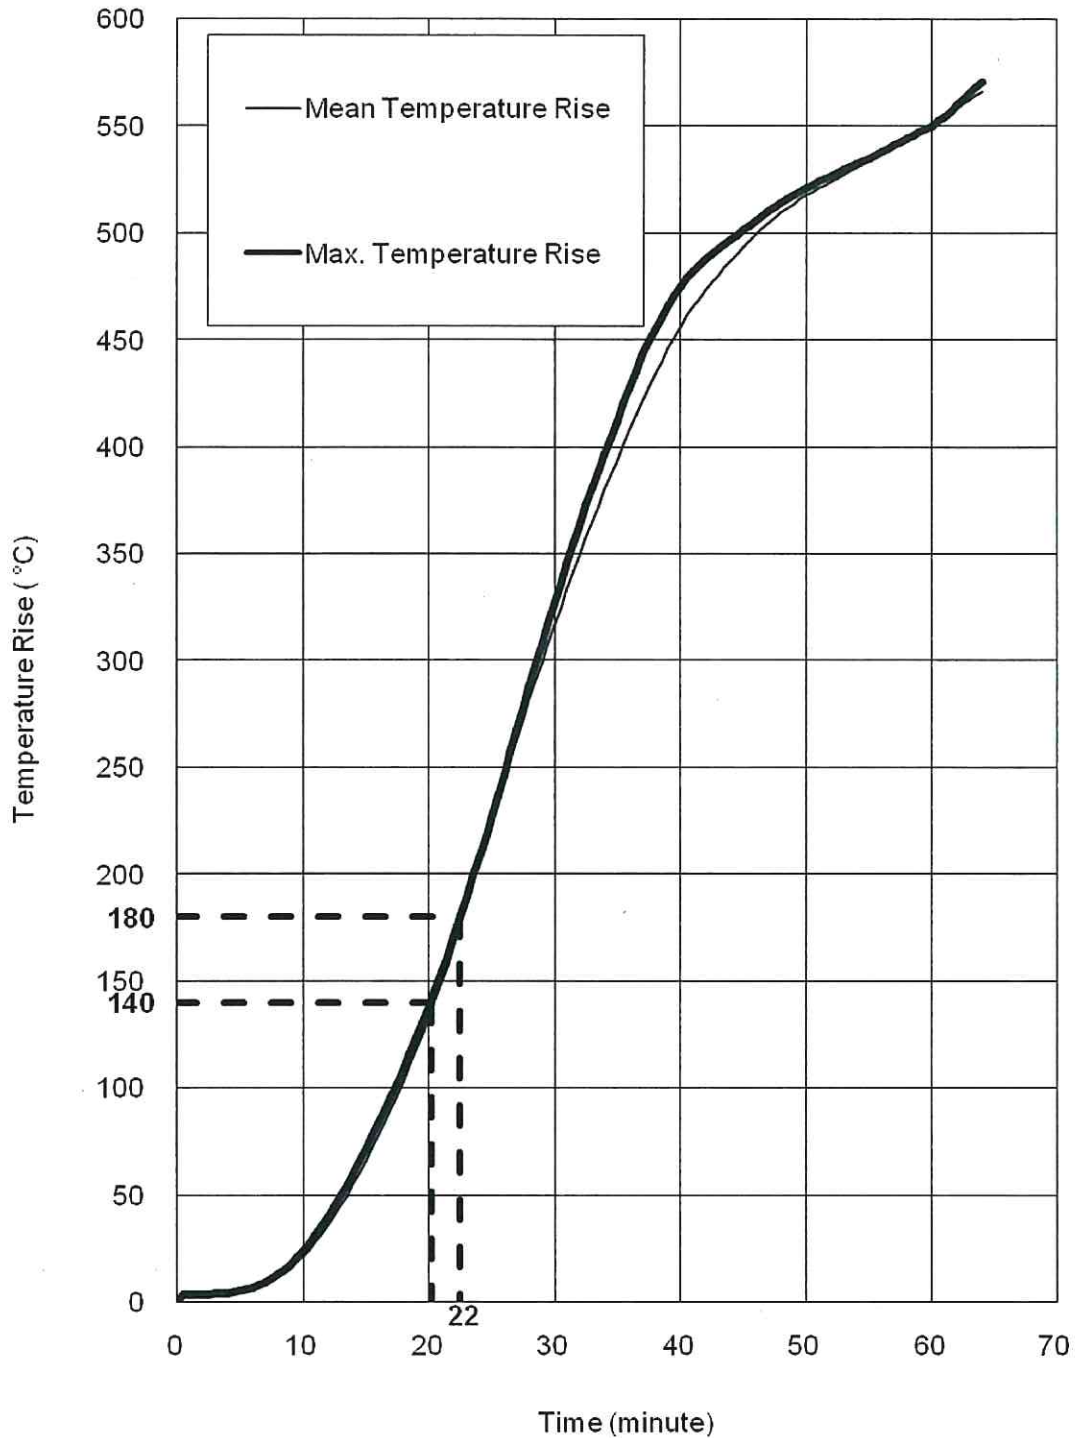
Figure 10 – Temperature rises of unexposed surface of steel hollows of specimen 'C'.

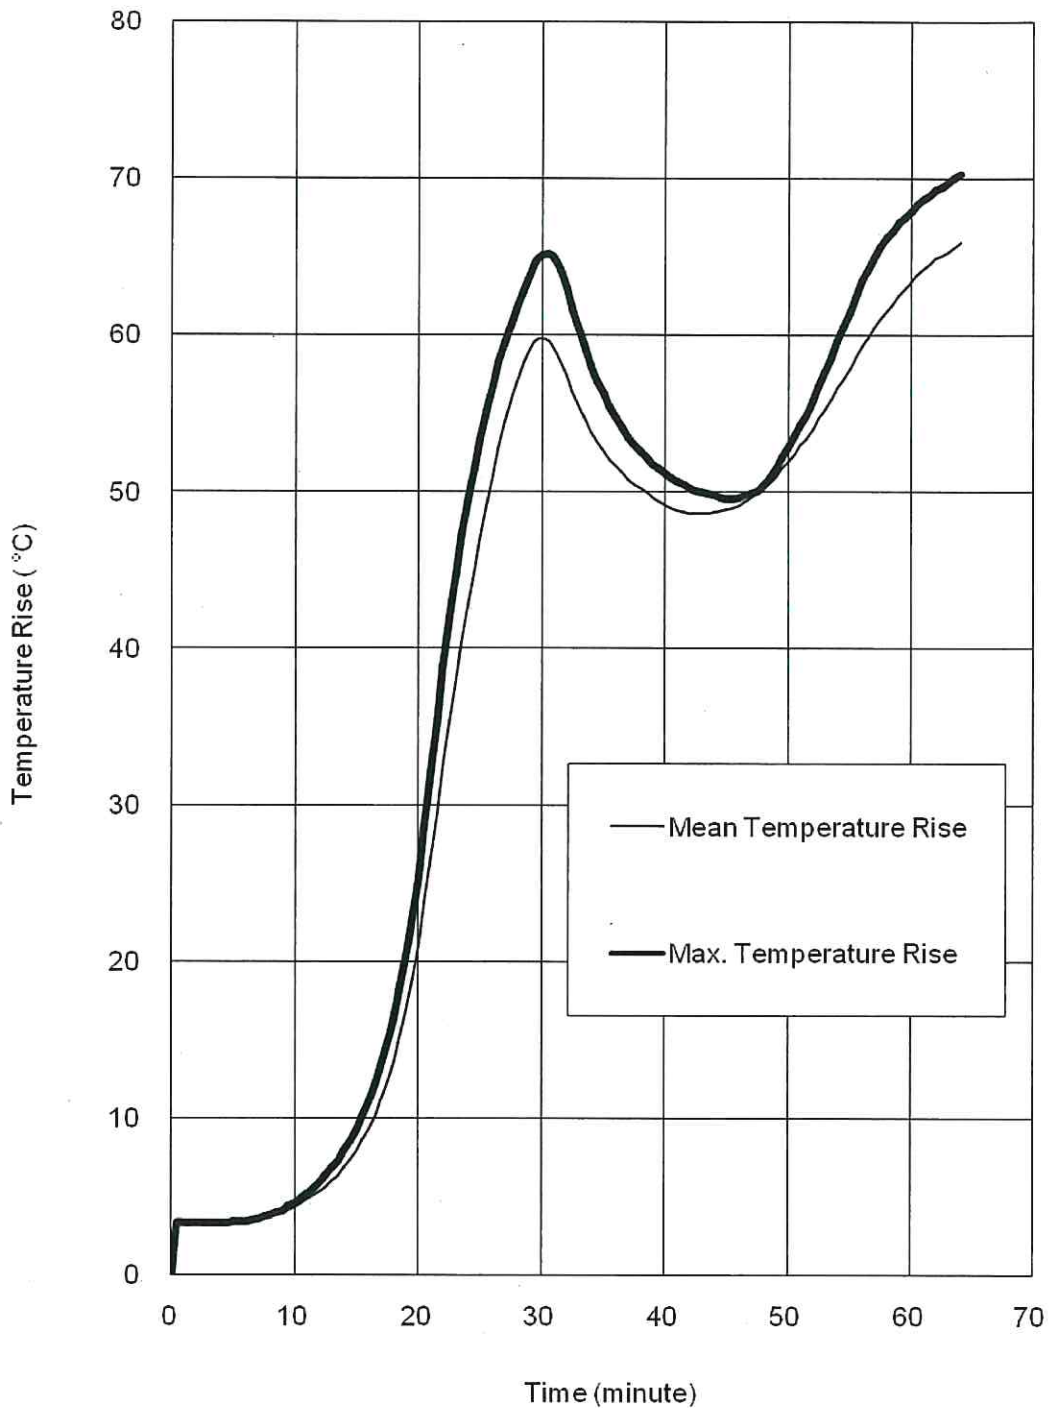
Figure 11 – Temperature rises of unexposed surface of Rockwool of specimen 'D'.

*Note: The test load was released as requested by test sponsor after a heating period of 36 minutes.*
