# Hilti CFS-HFF Firestop Flute Filler

## FIRE RESISTANCE TEST IN ACCORDANCE WITH BS 476: PART 20: 1987

On 3 nos. of Cavity Barriers

**Test Report No.:** R19L23-1A

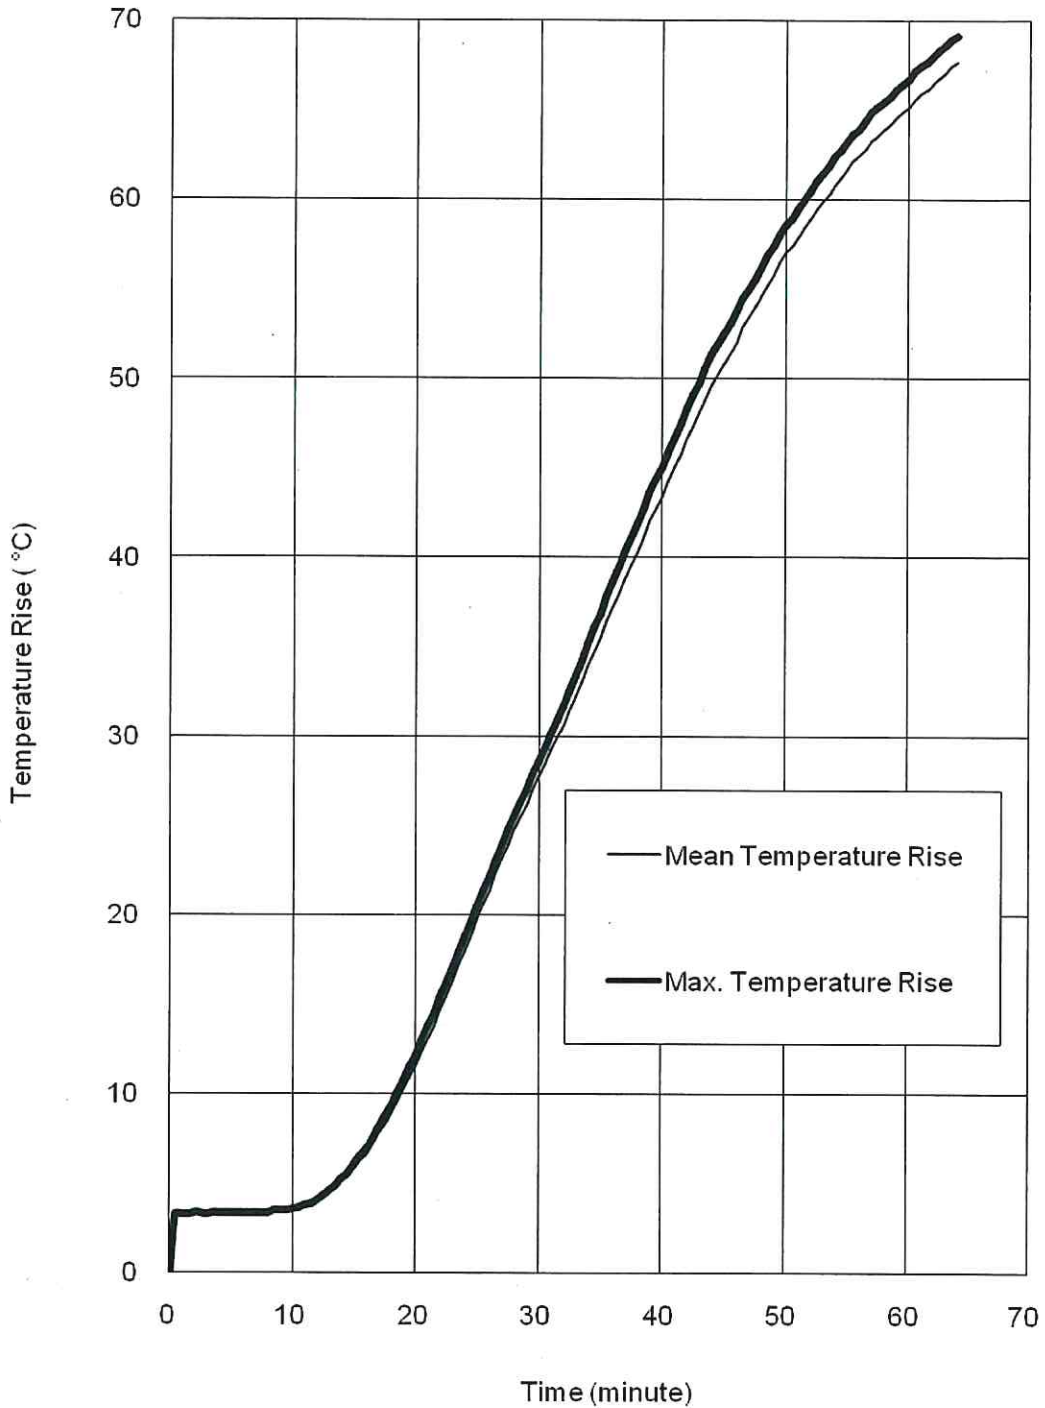
Figure 12 – Temperature rises of unexposed surface of steel hollows with fire rated boards of specimen 'D'.

*Note: The test load was released as requested by test sponsor after a heating period of 36 minutes.*

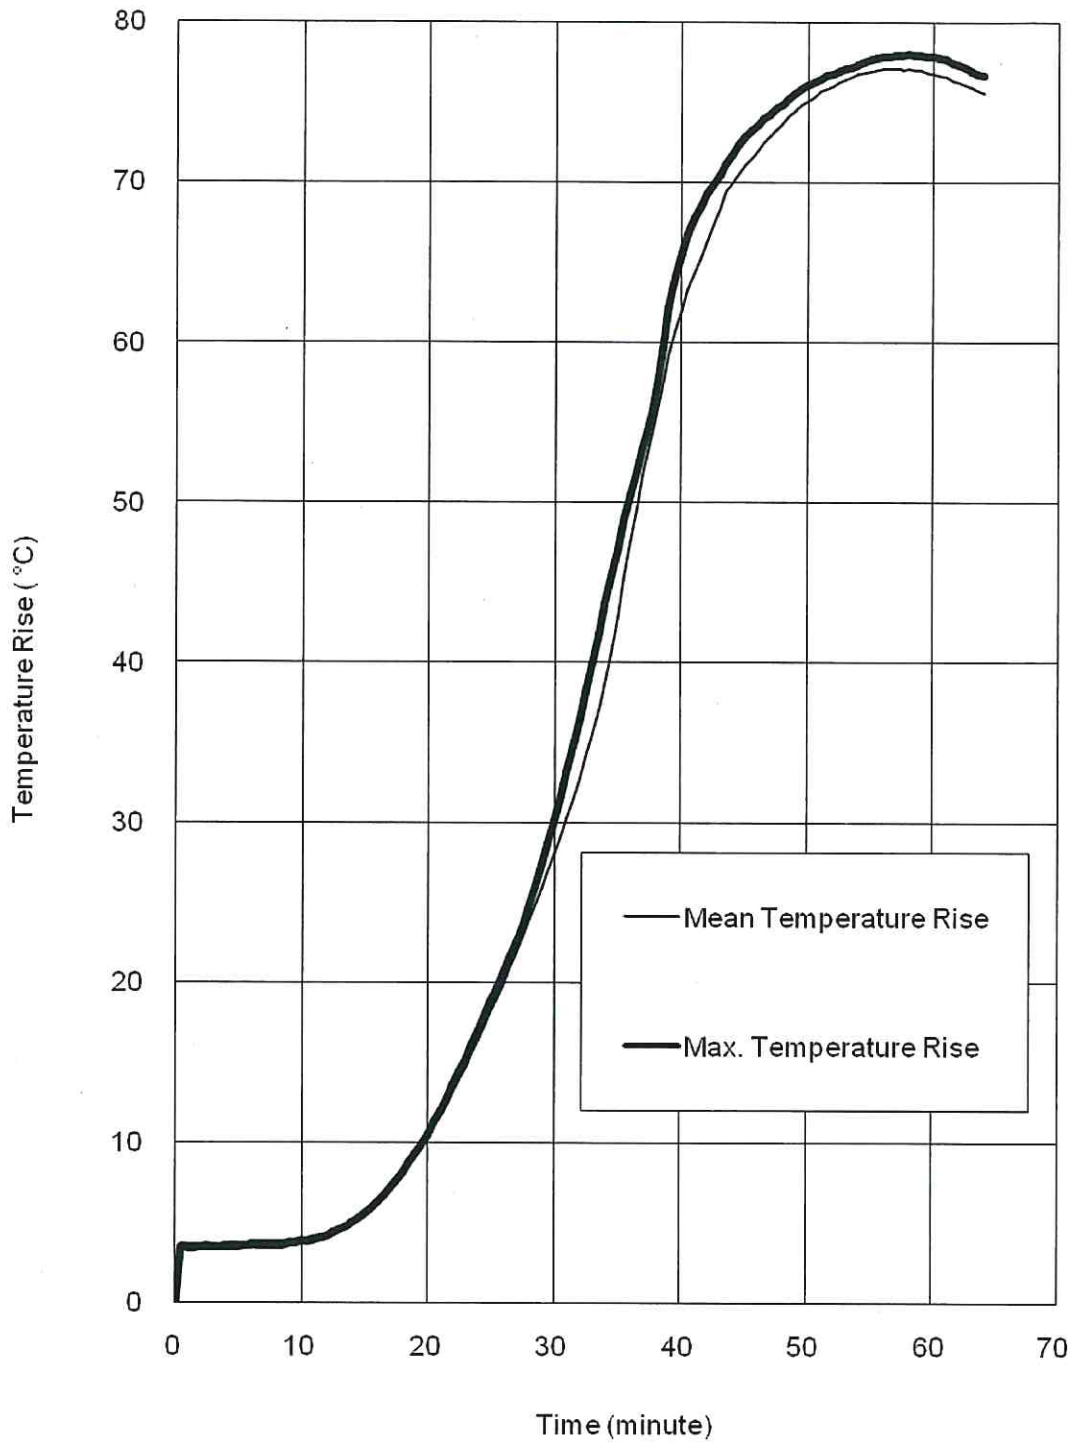
Figure 13 – Temperature rises of unexposed surface of Hilti CFS-HFF of specimen 'E'.

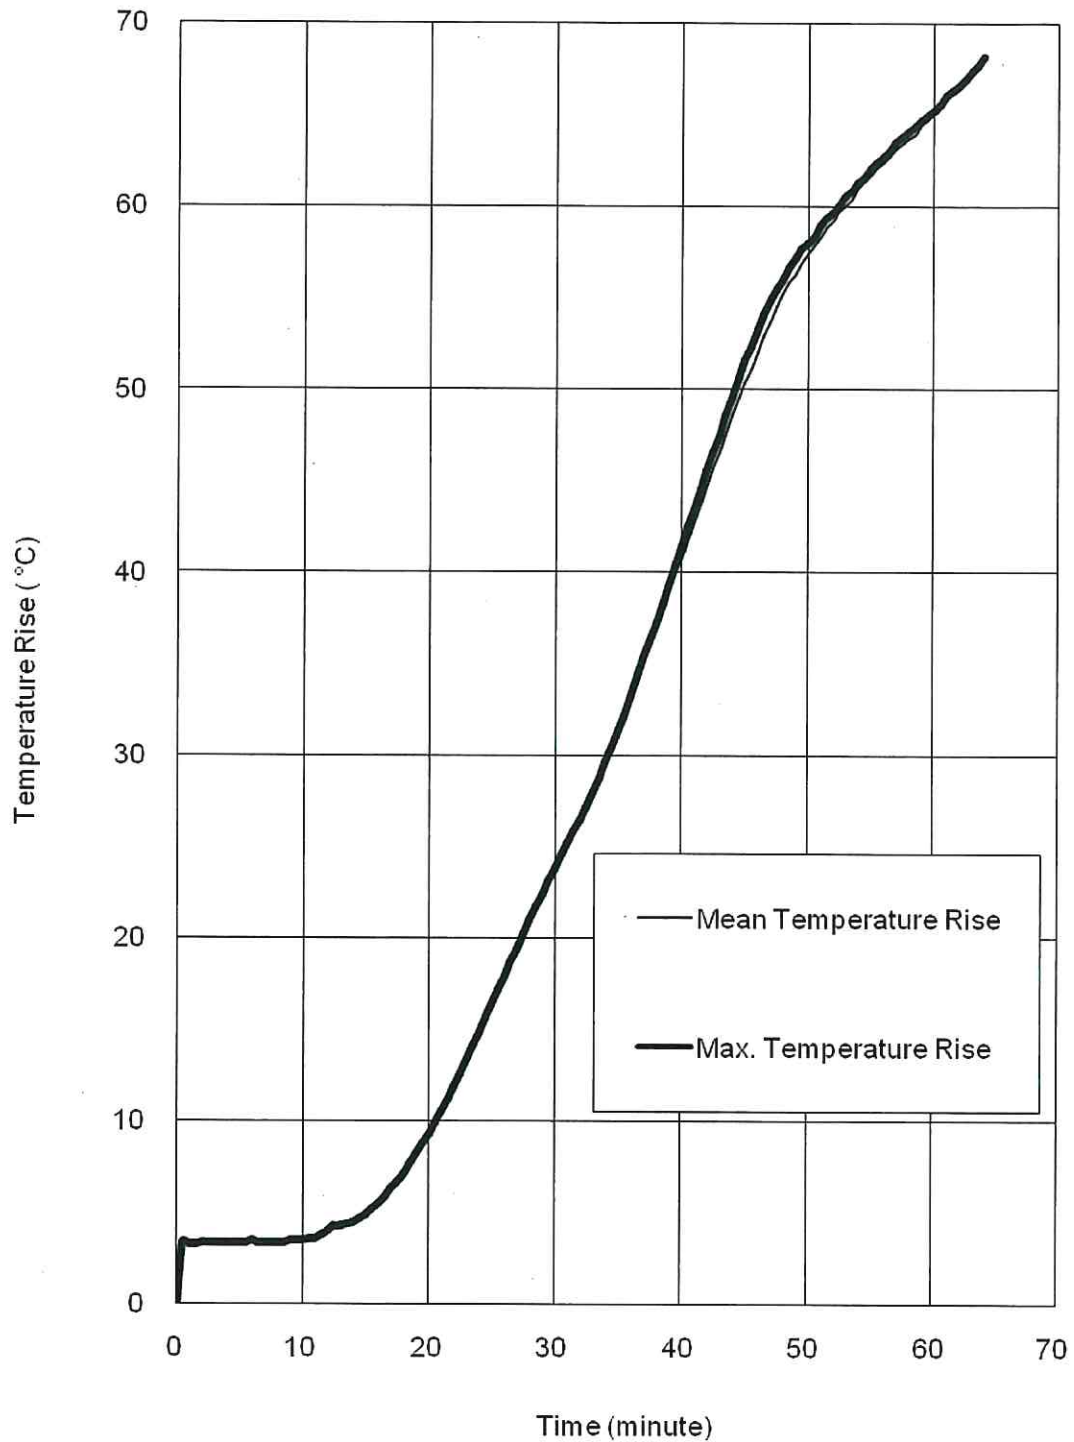
Figure 14 – Temperature rises of unexposed surface of steel hollows with fire rated boards of specimen 'E'.

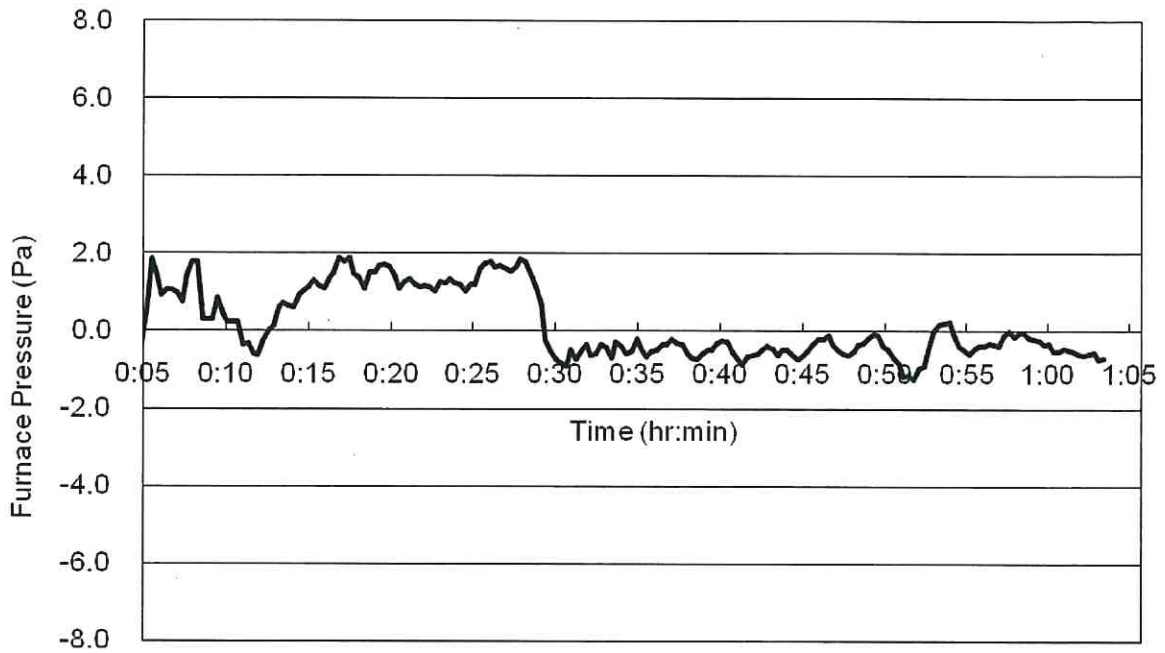
After the first 5 minutes of the test, the furnace pressure was maintained at  $0 \pm 2$  Pa relative to atmosphere, at 1,000 mm from the notional floor level.

Figure 15 – Furnace pressure.

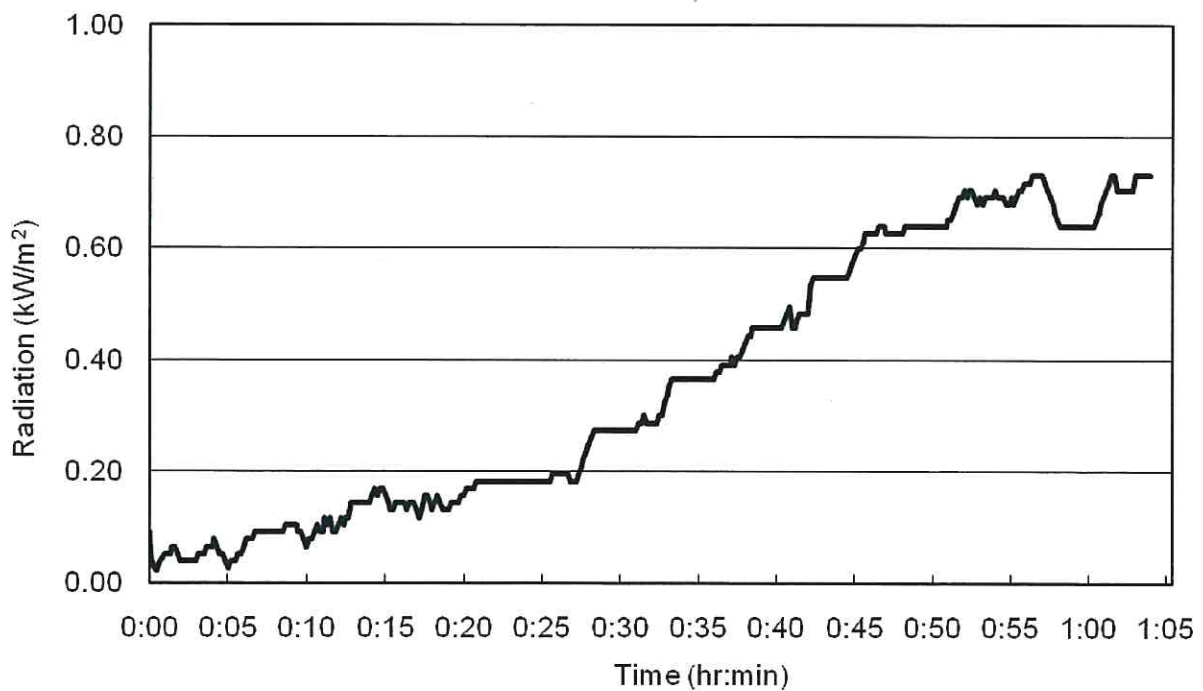
A radiometer placed at 3,000 mm away from the unexposed surface to measure the radiation of unexposed surface of the specimen.

Figure 16 – Radiation.

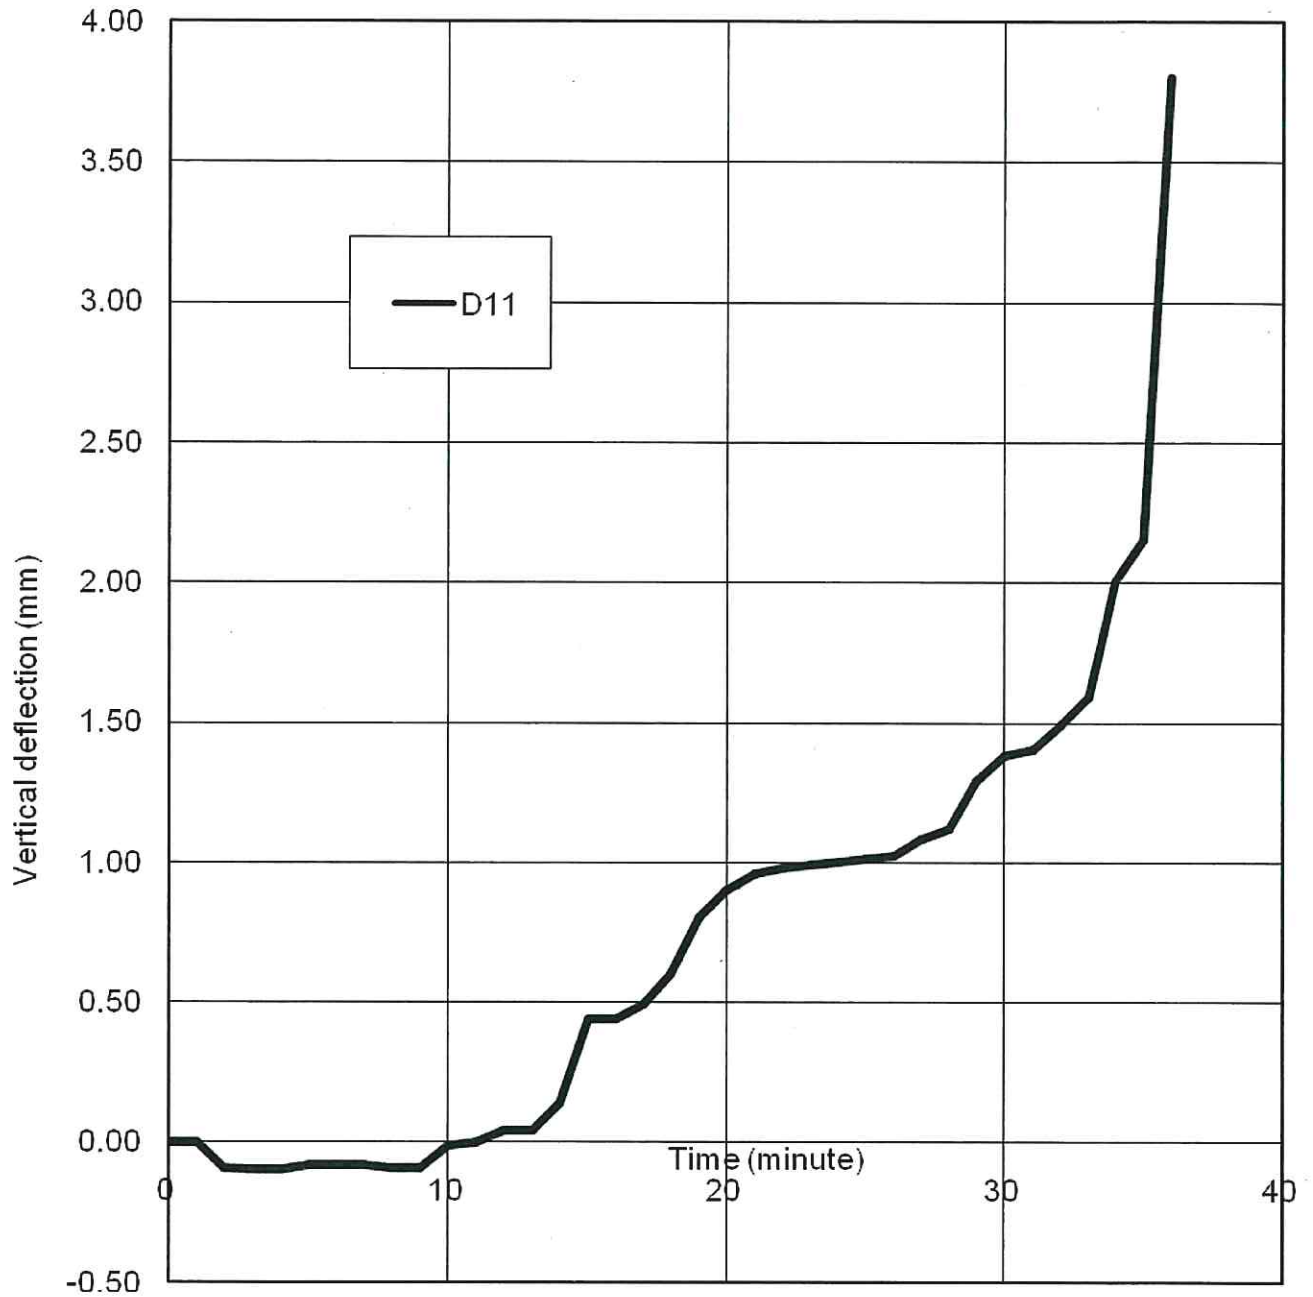
Figure 17 - Vertical deflection of specimen 'D'.

*Notes: Negative vertical deflection indicates downward movement.*

*Positive vertical deflection indicates upward movement.*

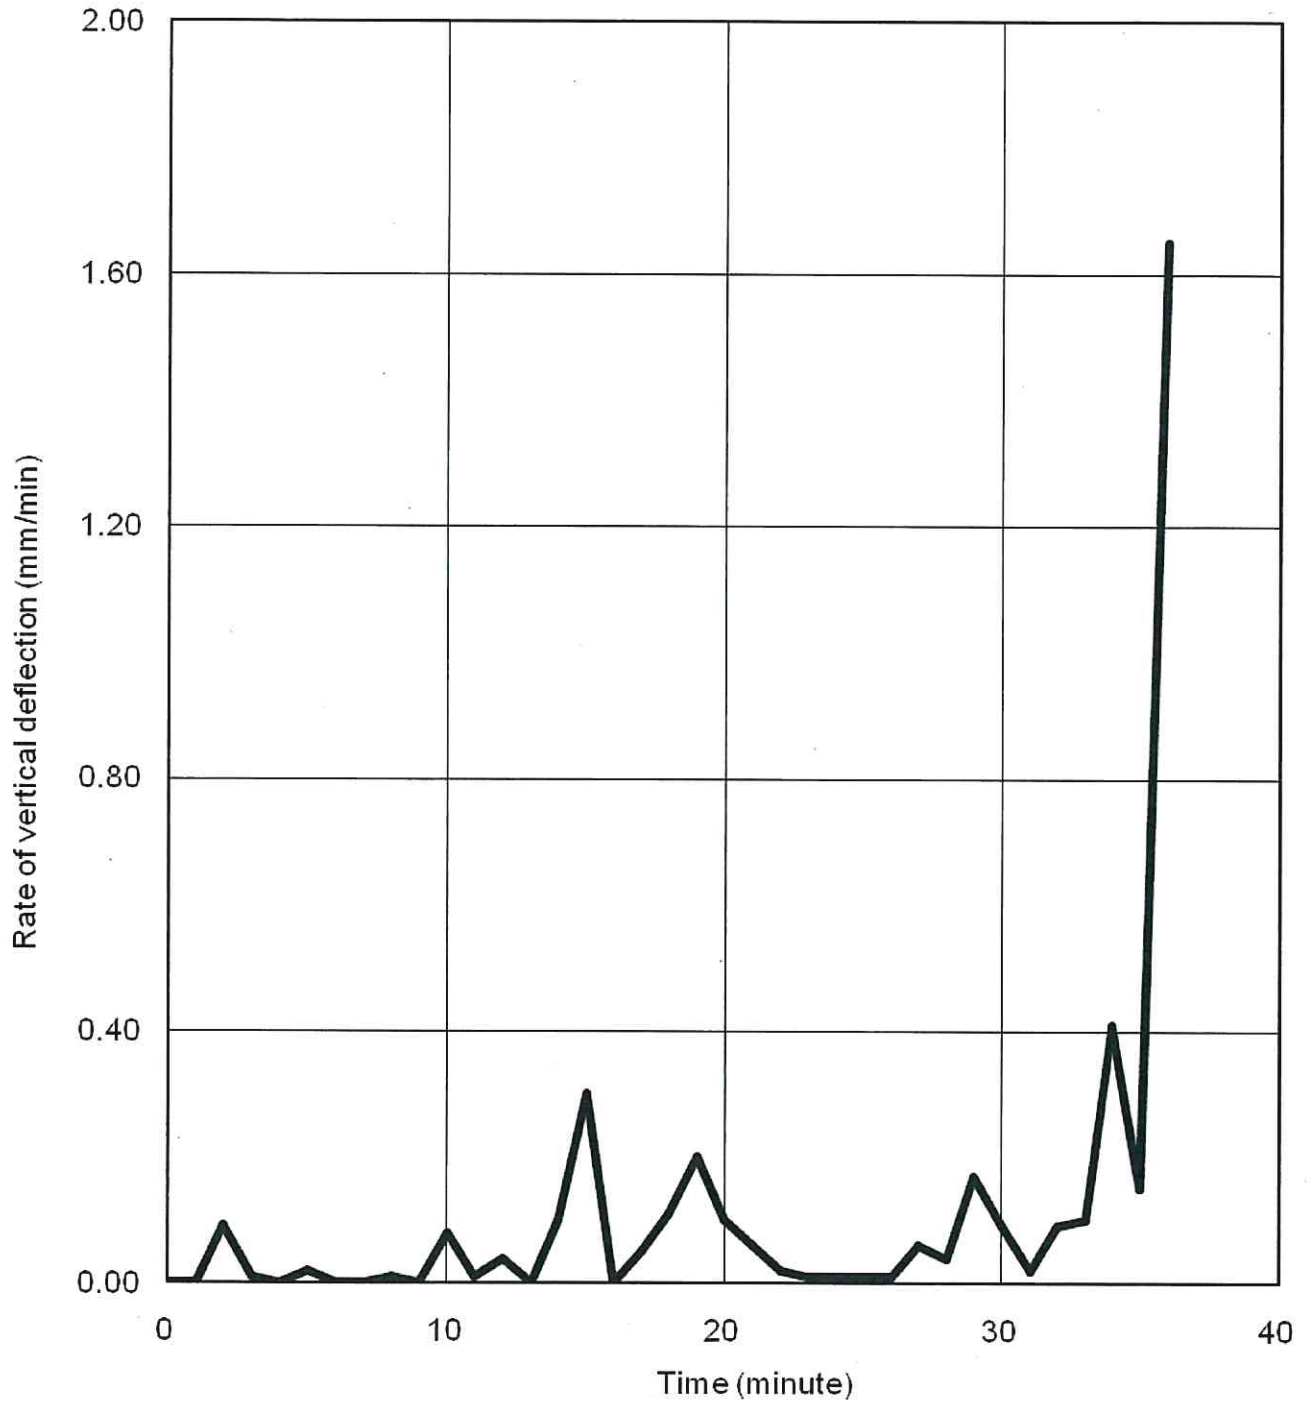
Figure 18 - Rate of vertical deflection of specimen 'D'.

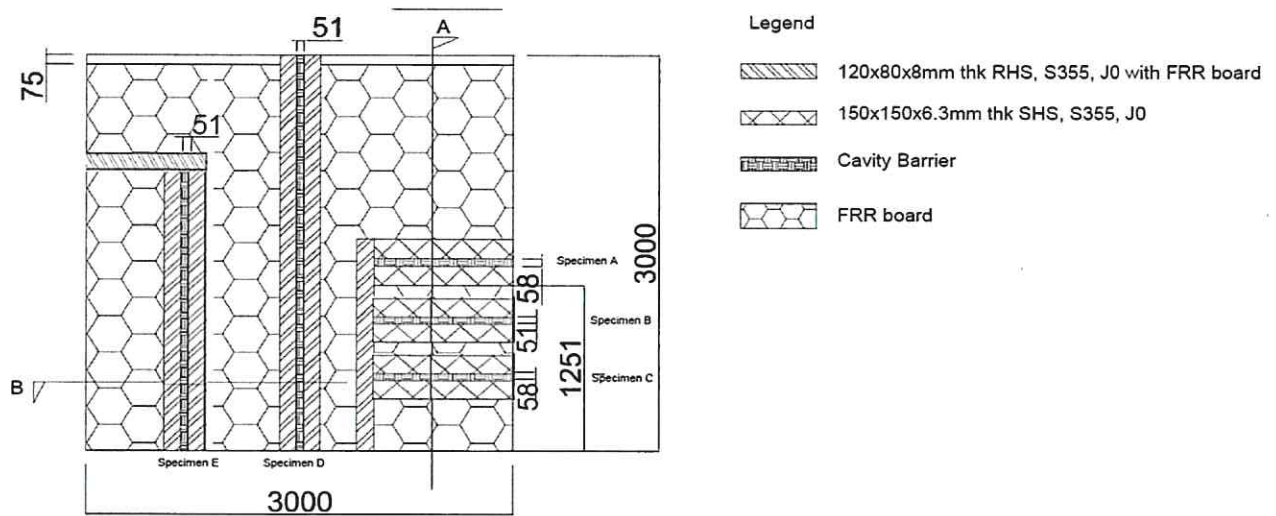
/ 1

**HILTI** Elevation

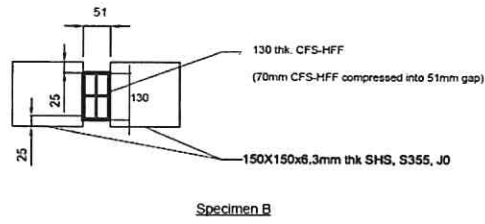
/ 3

Section A\_Specimen B

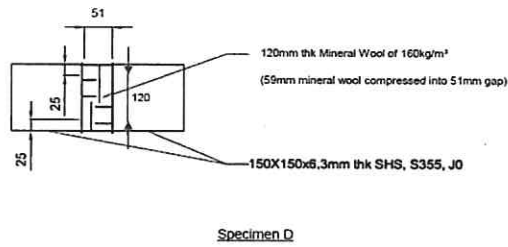
/ 4

Section B\_Specimen D

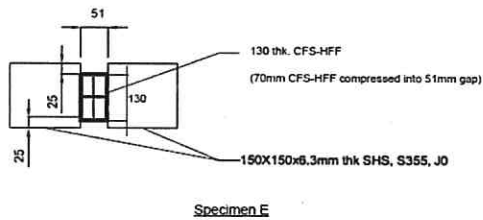
/ 5

Section B\_Specimen E
