Hilti CP 606 Firestop Acrylic

Sealant Submission Folder

Product Information and Method Statement	2
Test Reports	
Top of Wall Joint	
- RED No. R22D26-1A	7
Pipe Penetration	
- RED No. R23A14-1A	31
- IA23-036	51
Door Frame	
RED No. R22D25-1A Issue 1	64
General	
- VOC Content	76
Letters	
Government Letters	77
Country of Origin	80
LEED Letter	81
BEAM Plus Information	82
Material Safety Data Sheet	83
Job Reference	90

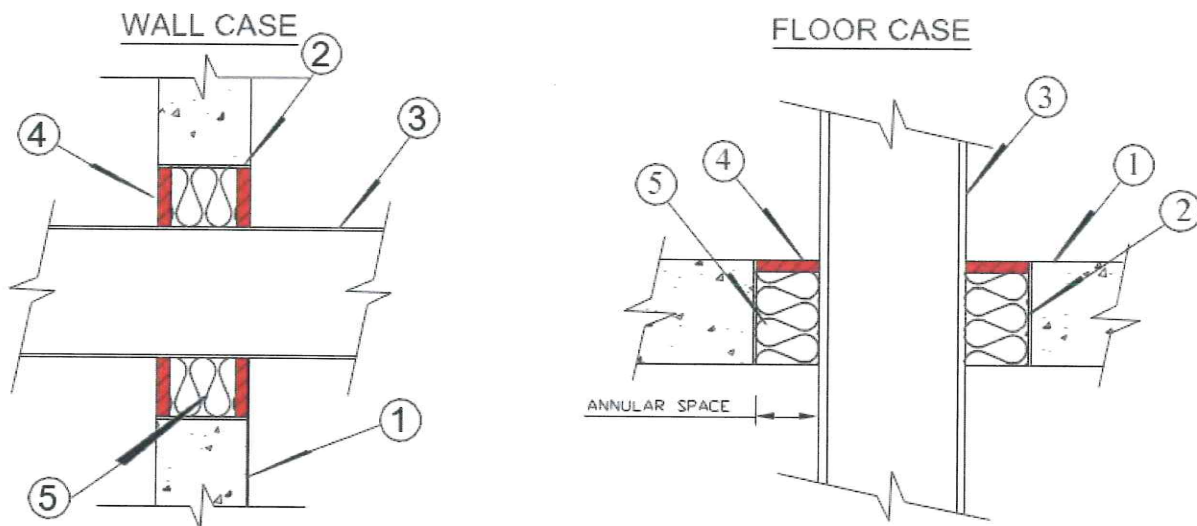
Drawing refers to Table 4.2.1 & 4.2.2 on metal pipe penetration application by using CP606 or CP601S

1. FLOOR ASSEMBLY: CONCRETE FLOOR
WALL ASSEMBLY: CONCRETE WALL OR FIRE-RATED BLOCK WALL
2. OPTIONAL: METAL SLEEVE
3. REPENETRATING ITEM: STEEL/CAST/D.I./COPPER PIPE
4. CP606 / CP601S
5. MINIMUM 100 KG/M³ DENSITY MINERAL WOOL AS BACKING MATERIAL

- (b) The annual gaps at the pipe penetration may be maximum 42 mm wide or narrower;
- (c) The condition of penetration sealing using either CP606 or CP601S for various type of pipe, pipe diameter, pipe wall thickness, depth of sealant to be applied, the conditions of backing mineral wool and the expected fire resistance performance are as given in the tables below;

- (d) The condition of penetration sealing using the CP 606 backed with Hilti CF-F 750 filling foam may be used, but the pipe diameter may be up to 50 mm for copper pipe and up to 140 mm for steel pipe. Also the width of annular gap need to reduce to 10 mm.
