Hilti CP 601S Firestop Silicone Sealant

Submission Folder

Product Information and Method Statement	2
Test Reports	
General	
- VOC Content	7
- RED R23A14-1A	8
Top of Wall Joint	
- RED R22D26-1A	28
Precast Façade Joint	
- RED R15C39-1A	52
- RED R15F37	72
Piping Penetration	
- RED R23A14-1A	81
- IA23-036	101
Letters	
Government Letters	114
Country of Origin	117
LEED Letter	118
Non-CFC and Ozone Confirmation	119
Material Safety Data Sheet	120
Job Reference	128

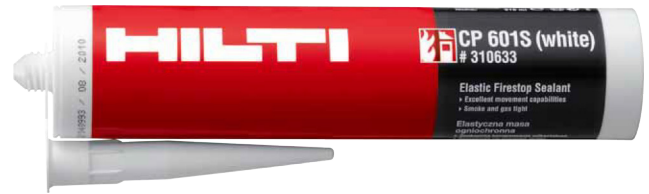
Consumption Guide

Cartridge volume = 310 ml (CP 601S)
 a = Joint width in mm
 b = Sealant depth in mm
 Linear metre per cartridge = $\frac{\text{Cartridge volume in ml}}{a \times b}$
 e.g. a floor 50mm wide with product depth of 10mm; with 310ml cartridge
 Therefore linear metres per cartridge = $310 / (50 \times 15) = 0.41$ metre per cartridge for one side of the floor

Joint width (mm)	0-15	16-100
Sealant depth (mm)	6	15

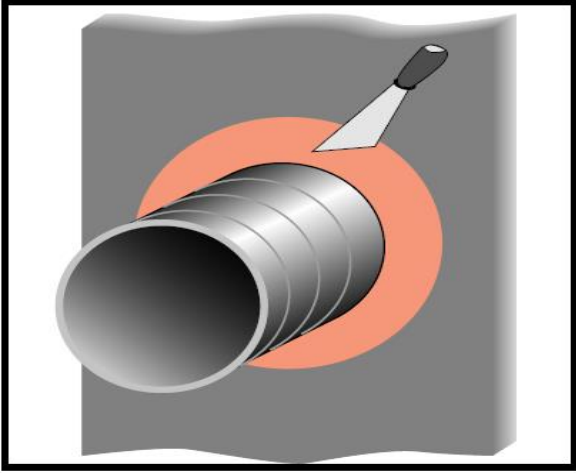
4	<p>Smooth the firestop sealant with a trowel before the skin forms. Once cured, CP 601S can only be removed mechanically.</p>

An illustration showing a grey metal pipe protruding from a grey wall. A red circular sealant is applied around the pipe. A trowel with a black handle is shown smoothing the sealant. The background is a light grey gradient.
5	<p>For maintenance reasons, a penetration seal could be permanently marked with an identification plate. In such a case, mark the Identification plate and fasten it in a visible position next to the seal.</p>

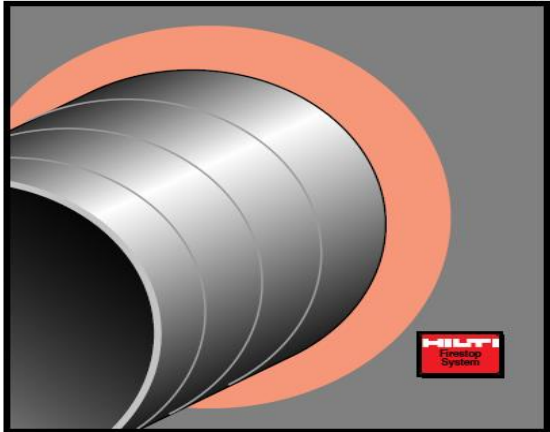
An illustration showing a grey metal pipe protruding from a grey wall. A red circular sealant is applied around the pipe. A small red identification plate with the HILTI logo and the text 'Firestop Systems' is attached to the wall next to the sealant. The background is a light grey gradient.

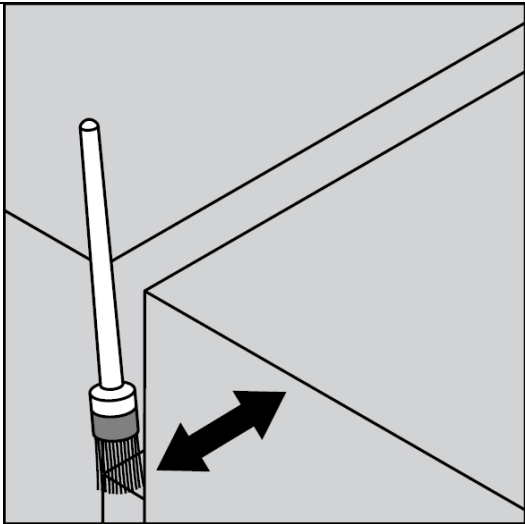
Setting Operation							
1	<p>Clean the opening. Surfaces to which CP 601S will be applied should be cleaned of loose debris, dirt, oil, wax and grease. The surface should be moisture and frost free.</p>

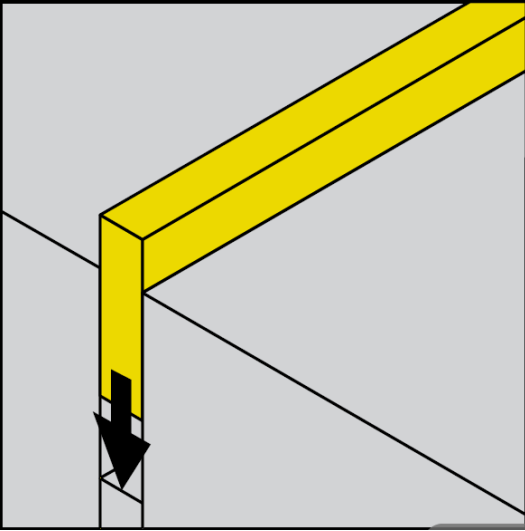
2	<p>Insert fill of mineral wool or backing material (if required)</p>

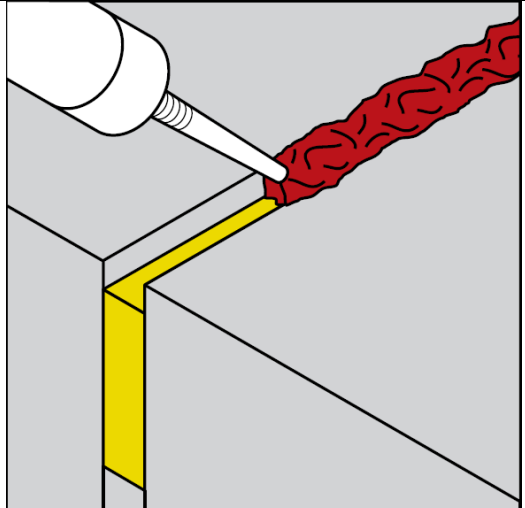
3	<p>Apply CP 601S over the backing material .</p> <table border="1" style="margin-left: 20px;"> <tr> <td>Joint width (mm)</td> <td>0-15</td> <td>16-100</td> </tr> <tr> <td>Sealant thickness (mm)</td> <td>6</td> <td>15</td> </tr> </table>

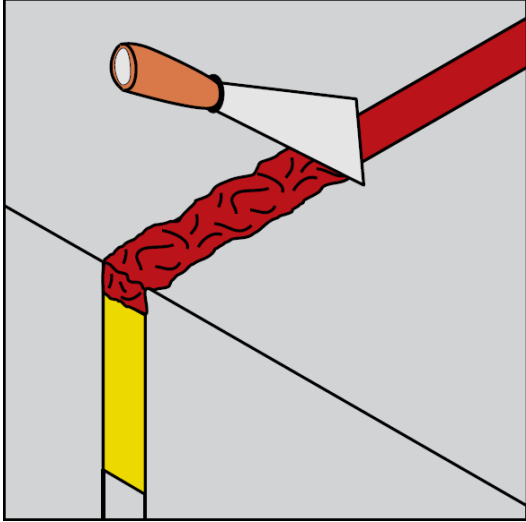
4	Smooth CP 601S using a trowel before the skin forms. It can only be removed mechanically once it is cured.

A cross-sectional diagram of a corner joint between two concrete surfaces. A red silicone sealant bead is being applied to the joint. A trowel with a wooden handle and a metal blade is shown smoothing the surface of the sealant. The sealant is shown with a textured, skin-like appearance. A yellow vertical strip is visible on the left side of the joint.
5	For maintenance reasons, a penetration seal would be permanently marked with an identification plate. In such a case mark the identification plate and fasten it in a visible position next to the seal

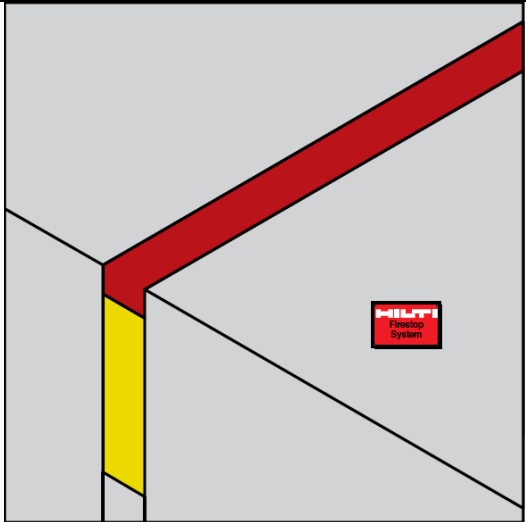
A cross-sectional diagram of a corner joint between two concrete surfaces. A red silicone sealant bead is applied to the joint. A small red identification plate with the HILTI logo and the text 'Firestop System' is fastened to the concrete surface next to the sealant. A yellow vertical strip is visible on the left side of the joint.

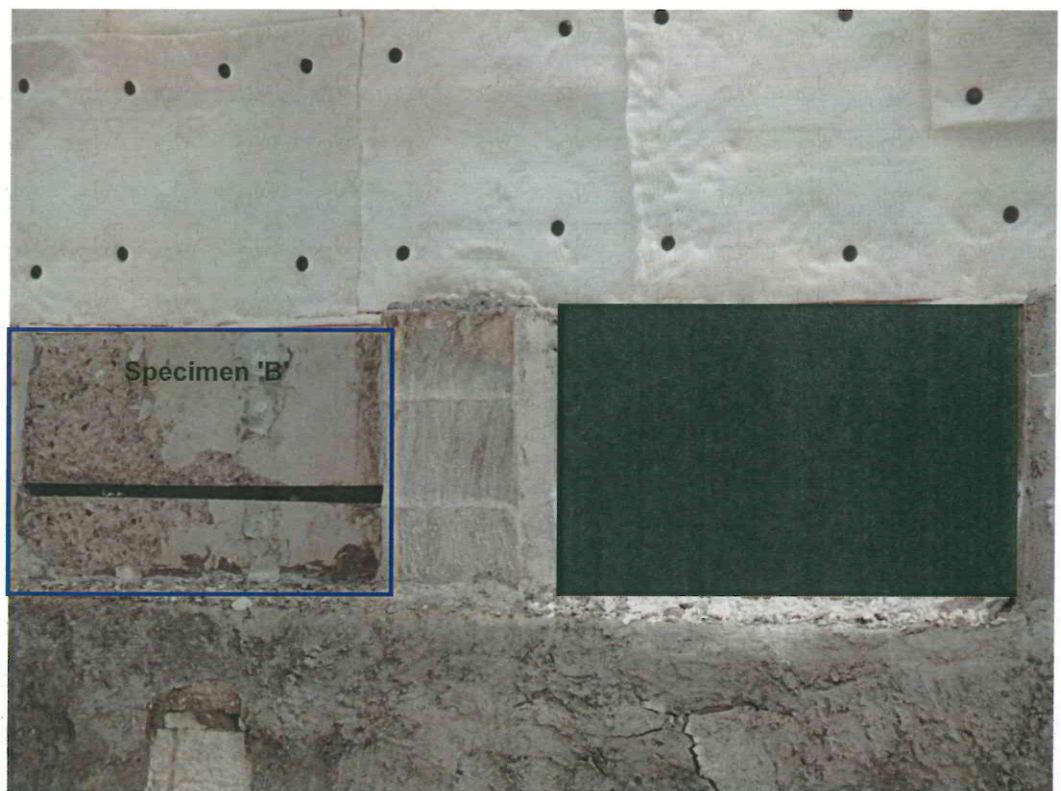
Photo 6: The exposed face of the specimens after the test.

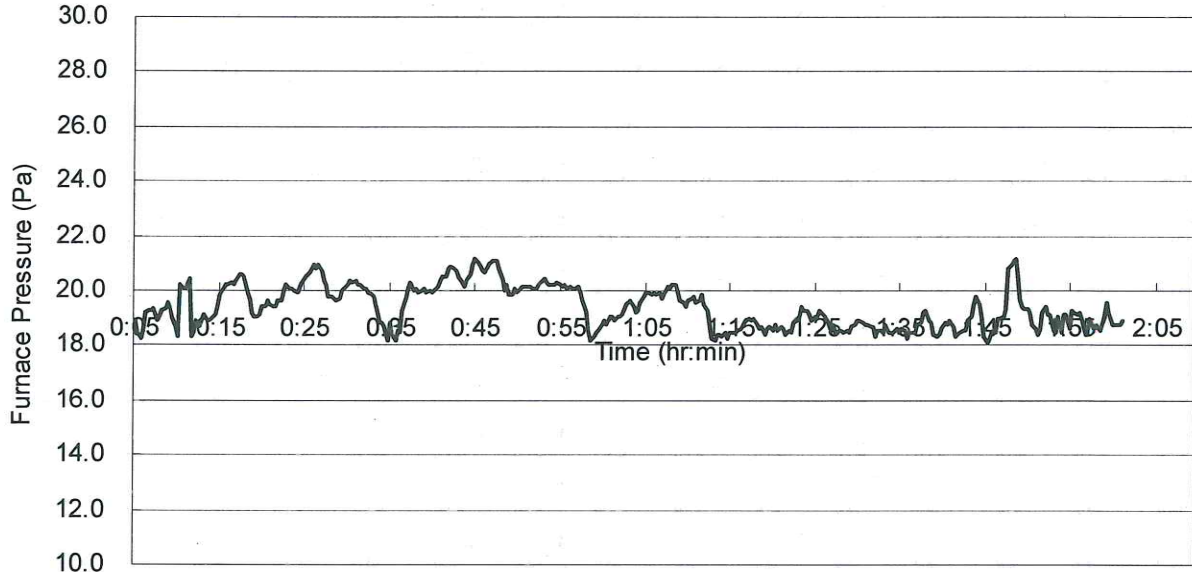
After the first 5 minutes of the test, the furnace pressure was maintained at 20 ± 2 Pa relative to atmosphere, at the same level as the specimens.

Figure 5 – Furnace pressure.

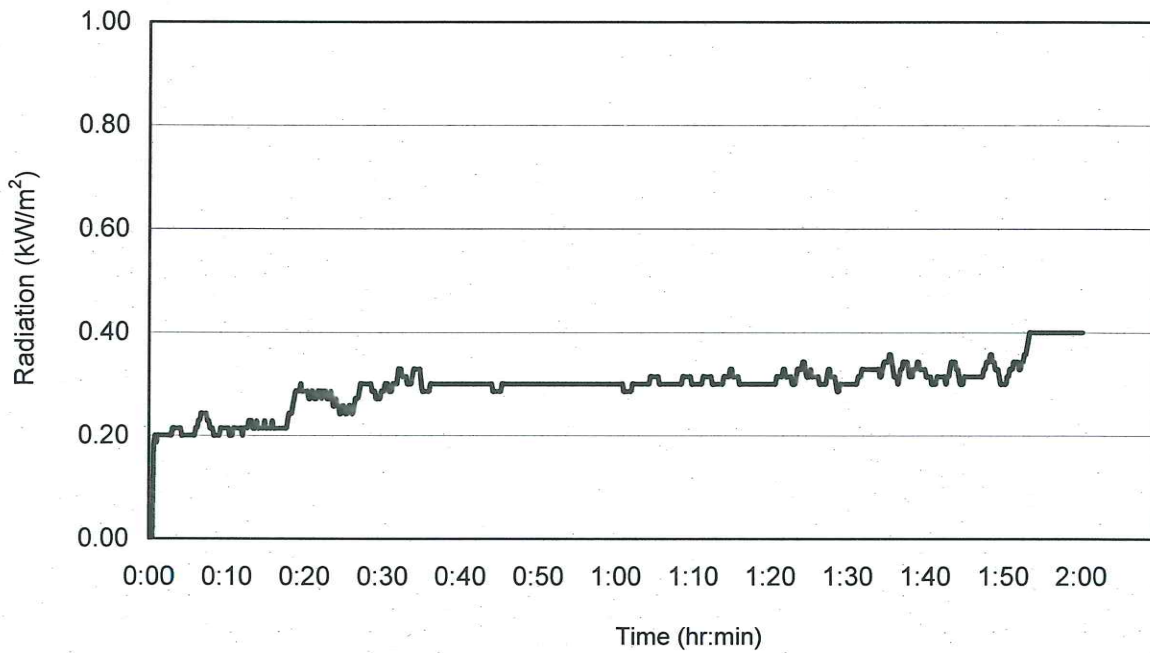
A radiometer placed at 1,000 mm away from the unexposed surface to measure the radiation of unexposed surface of the specimens.

Figure 6 – Radiation.

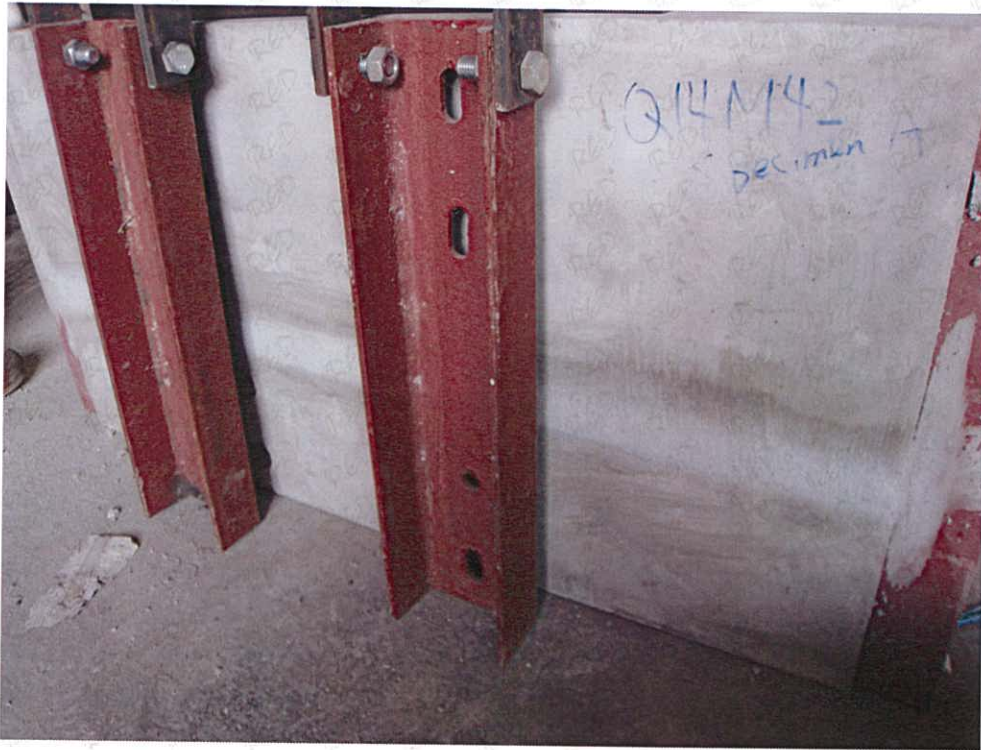
Photo 2: Specimen A before the test

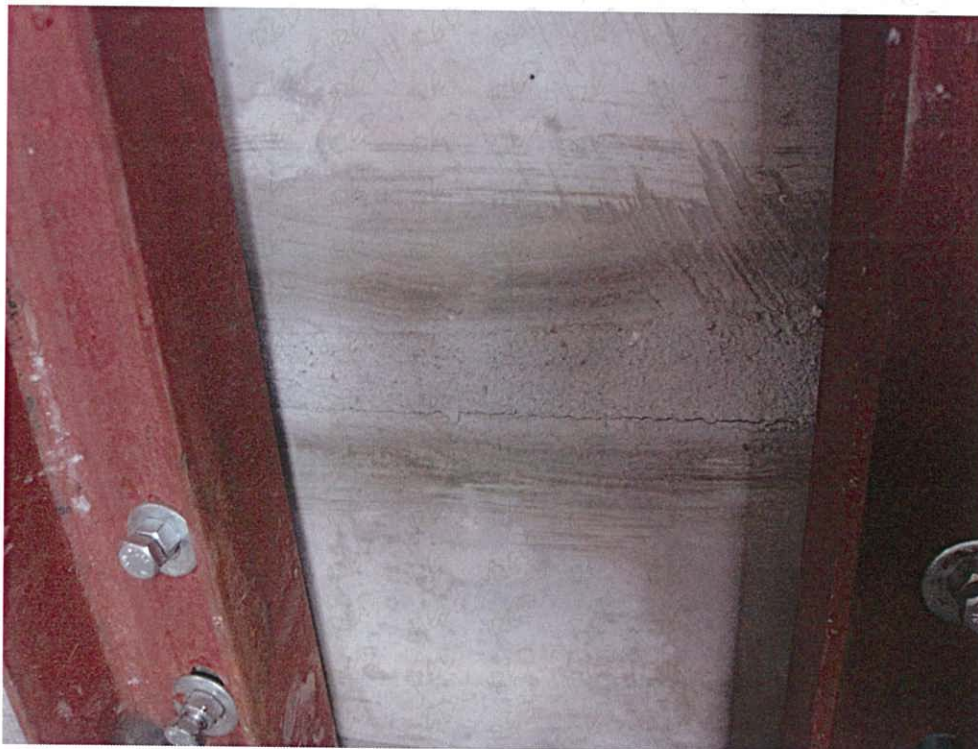
Photo 3: Specimen A after the test, the upper interface detached from the concrete substrate

The cement grout sealant detached from the upper pre-cast concrete at the beginning of the test. While the Hilti 'CP 601S' sealant complete the cycling test without visible damage.

Specimen A failed to satisfy the cyclic test.
