# Hilti CP644 Firestop Collar

## Submission Folder

### The Fire Resistance Performance of Hilti Pipe Penetration Sealing Systems

**Report No.:** R23A14-2A Issue 1

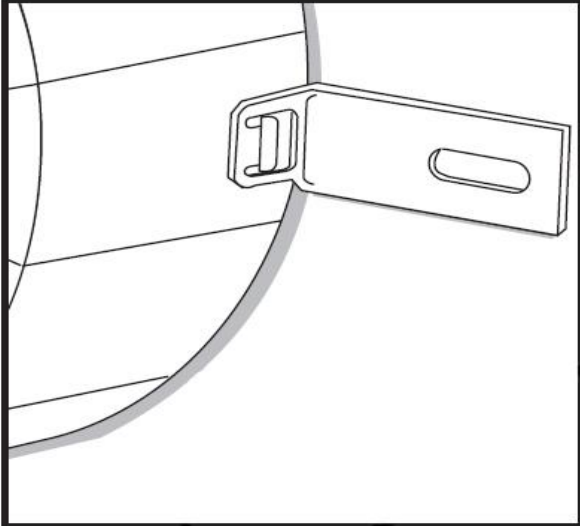
4	Attach fastening hooks. The fastening hooks can be attached to various points on the metal housing.

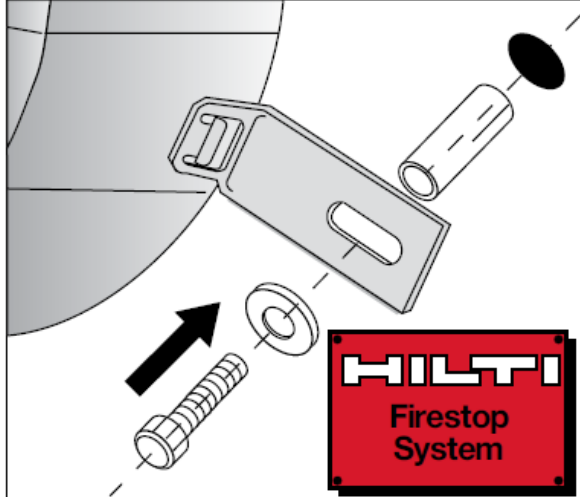
5	<p>Fasten the CP 643N Firestop Collar. Only when fastened properly can CP 643N offer protection against fire.</p> <ol style="list-style-type: none"><li>Mark the fastening points.</li><li>Drill holes with a Hilti rotary hammer drill (i.e. TE 4-A18) or, depending on the base material, fasten using Hilti powder-actuated tool.</li><li>To secure the CP 643N Firestop Collar, use Hilti anchors/fasteners.</li><li>For maintenance reasons, a penetration can be permanently marked with an identification plate</li></ol>

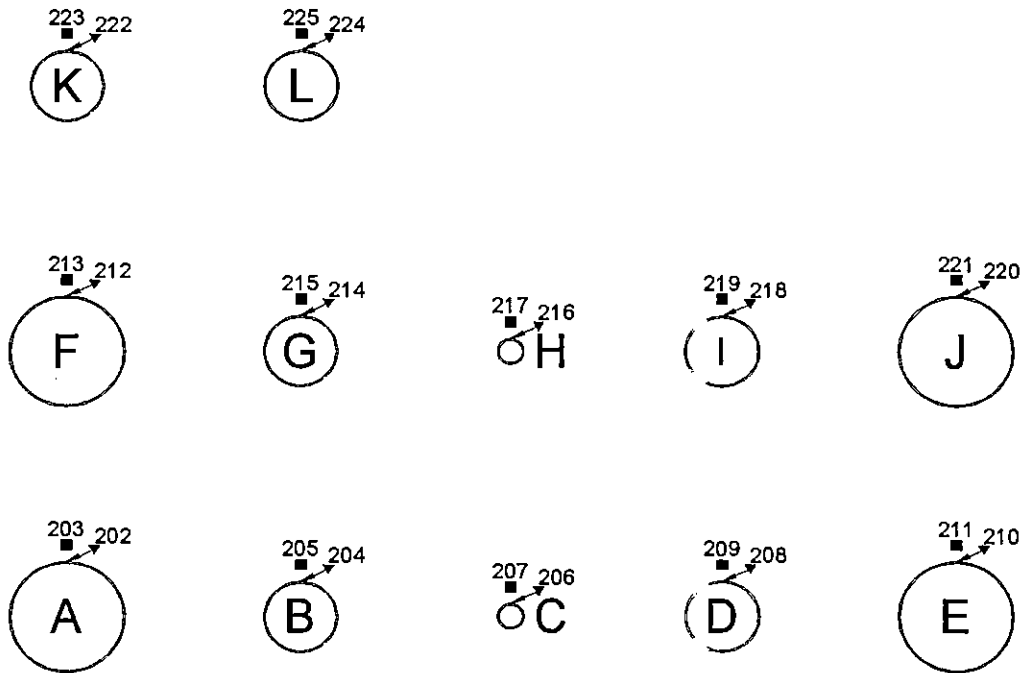
FIGURE 2

◆ Positions of thermocouples, also refer to Figures 3 & 4

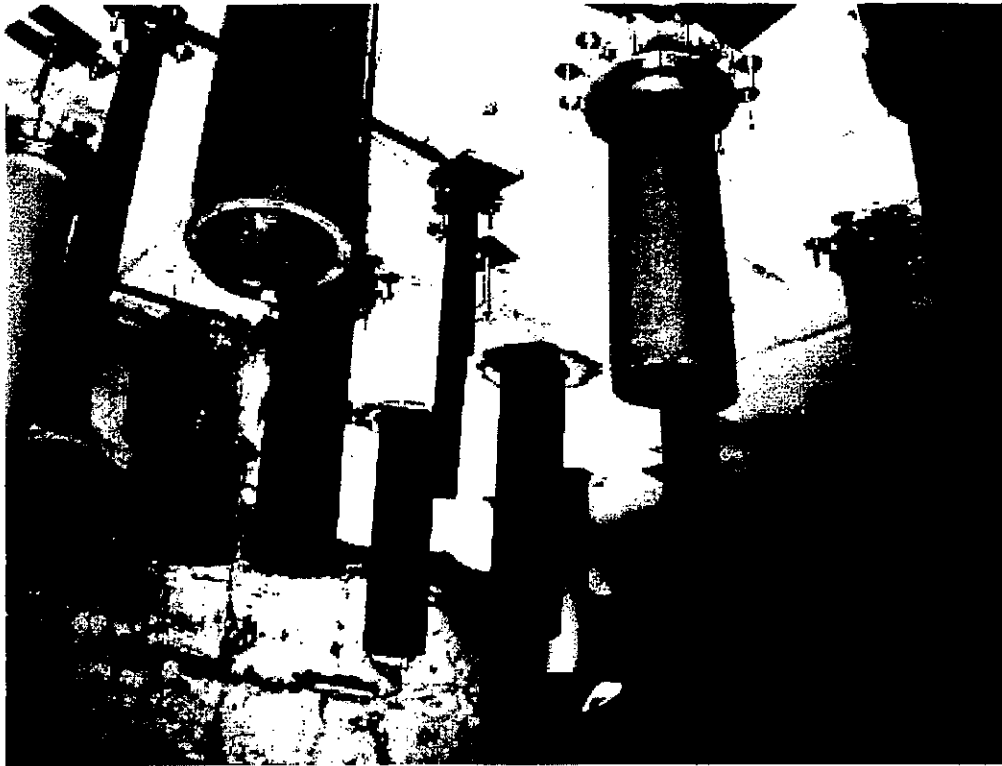
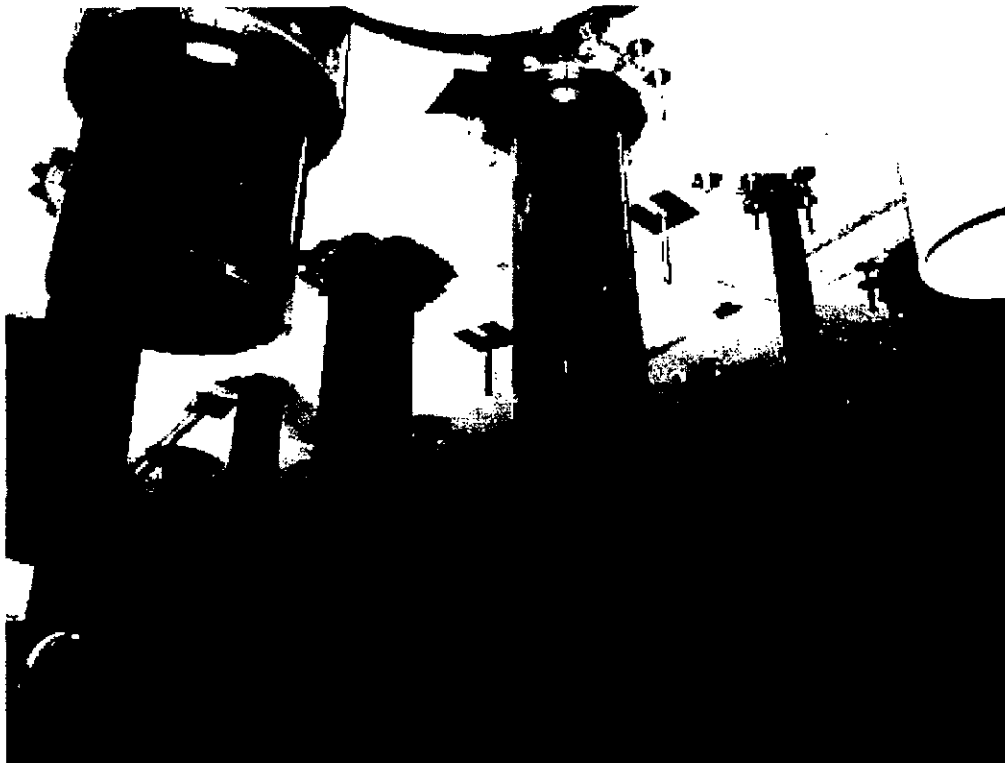
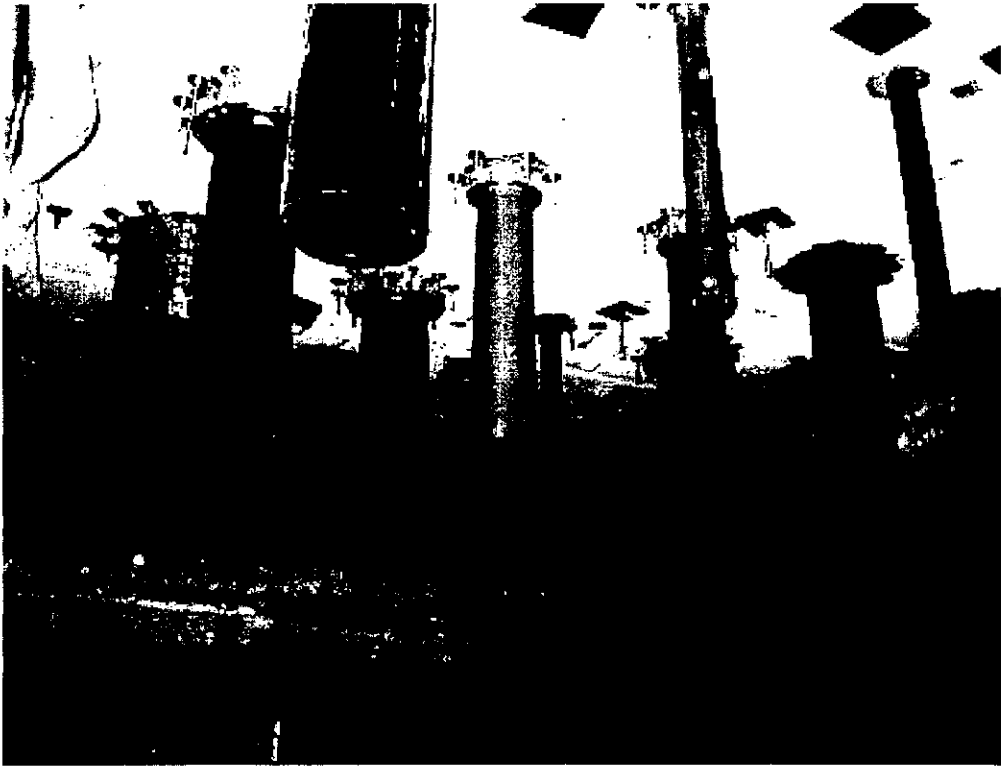
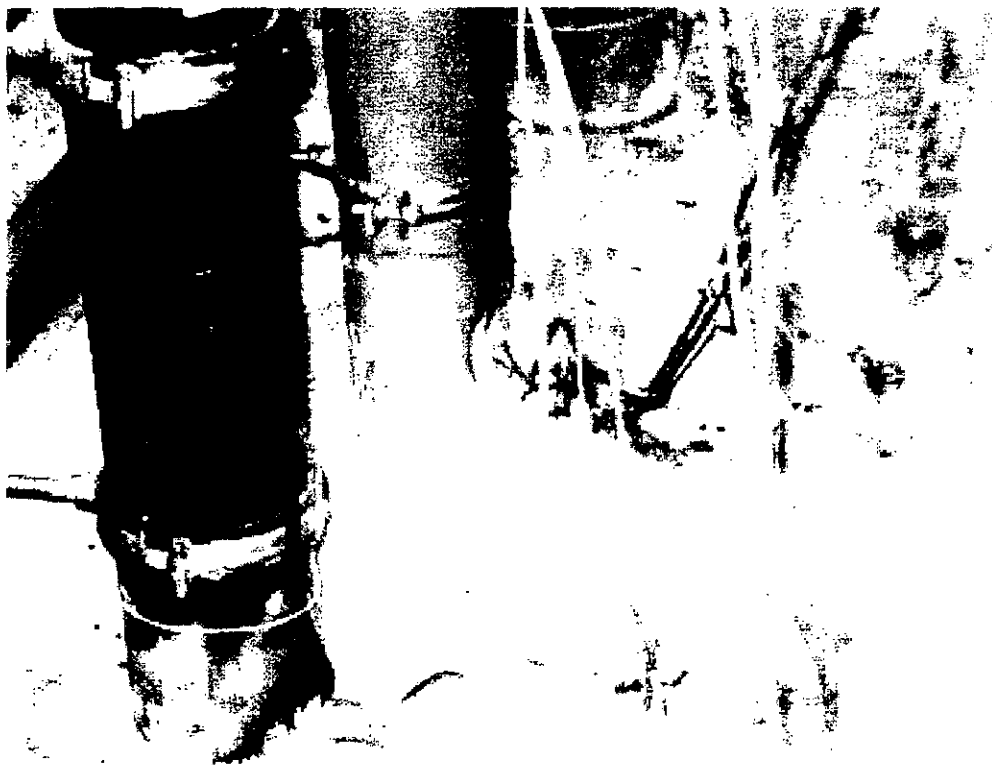
- Plate 1 : Showing the exposed face of the specimens prior to the test
- Plate 2 : Showing the exposed face of the specimens prior to the test
- Plate 3 : Showing the exposed face of the specimens prior to the test
- Plate 4 : Showing the unexposed face of the specimens during the test
- Plate 5 : Showing the unexposed face of the specimens during the test
- Plate 6 : Showing the unexposed face of the specimens during the test
- Plate 7 : Showing the unexposed face of the specimens during the test
- Plate 8 : Showing the unexposed face of the specimens during the test
- Plate 9 : Showing the unexposed face of the specimens during the test
- Plate 10: Showing the unexposed face of the specimens directly after the test

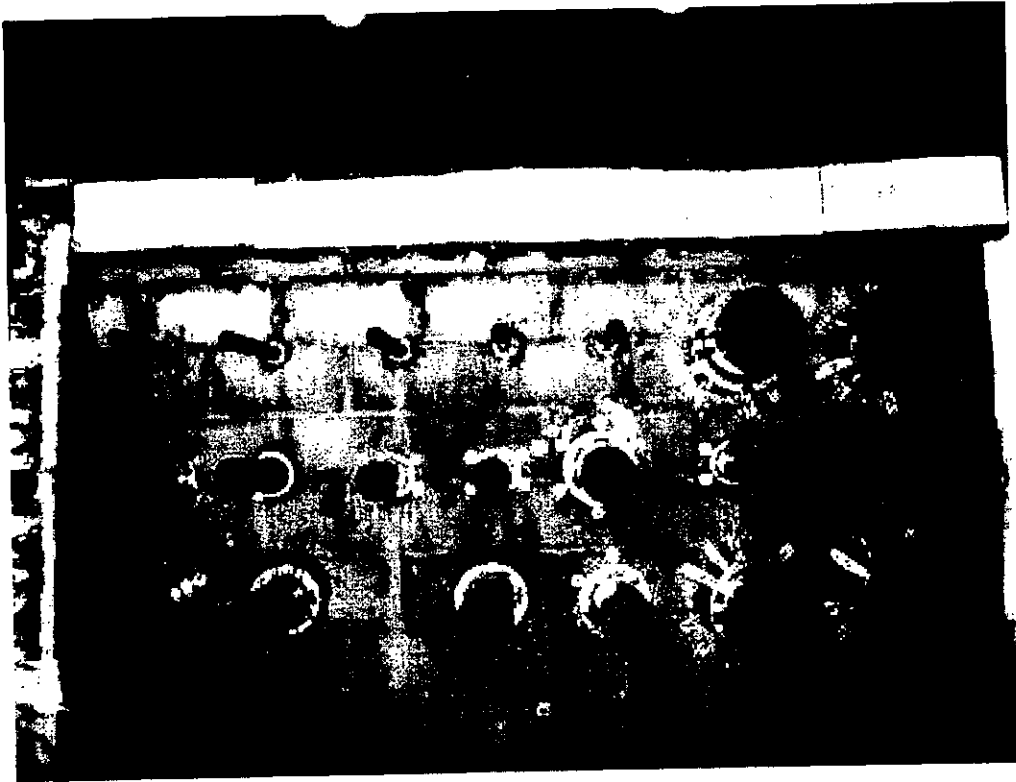
- Plate 1 : The exposed face of the assembly prior to the test
- Plate 2 : The unexposed face of the assembly prior to the test
- Plate 3 : Showing the unexposed face of the assembly during the test
- Plate 4 : Showing the unexposed face of the assembly during the test
- Plate 5 : Showing the unexposed face of the assembly during the test
- Plate 6 : Showing the unexposed face of the assembly during the test
- Plate 7 : Showing the unexposed face of the assembly during the test
- Plate 8 : Showing the unexposed face of the assembly during the test
- Plate 9 : Showing the unexposed face of the assembly during the test
- Plate 10 : Showing the exposed face of the assembly directly after the test
