Hilti CFS-COS Firestop Composite Sheet

Submission Folder

FIRE RESISTANCE TEST IN ACCORDANCE WITH BS 476: PART 20: 1987
On 9 nos. of Penetration Systems

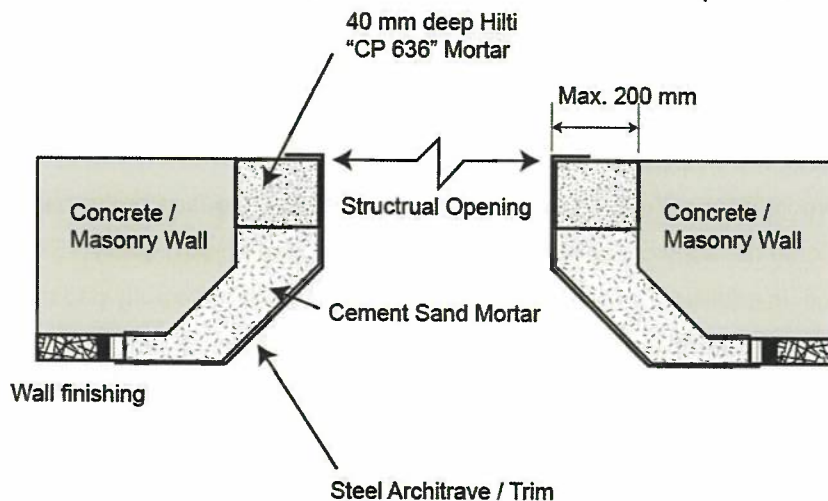
Figure 1: Illustration of the installation details of Hilti "CP636" firestop mortar for lift-landing door opening

The illustration below indicates the proposed installation details of the Hilti CP 636:

The Hilti "CP636" firestop mortar for use of lift-landing opening shall be capable to maintain the integrity performance for up to 120 minutes integrity performance when subjected to a test in accordance with BS 476: Part 20/22: 1987.

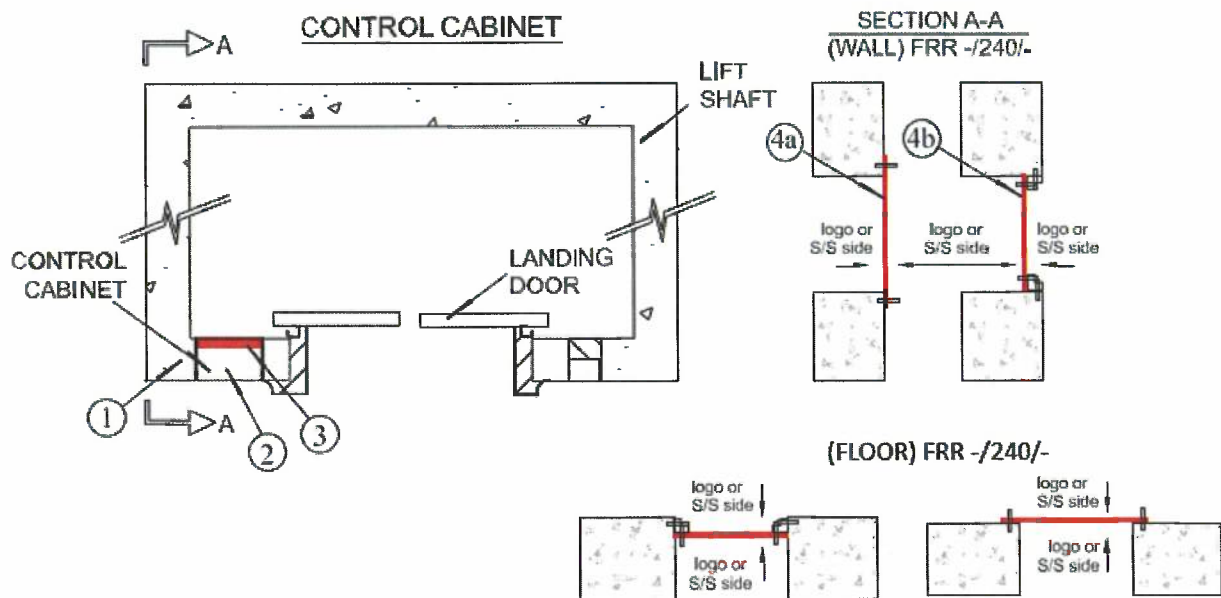
Drawing refers to Section 4.3 on lift landing doorsets application by using CFS-COS

FIRE RESISTANCE RATING: UP TO -/240/-

1. CONCRETE WALL ASSEMBLY (120/120/120 F.R.R)
- CONCRETE WALL OR FIRE-RATED BLOCKWALL
2. LIFT CONTROL CABINET
3. **CFS-COS FIRESTOP COMPOSITE SHEET** WITH EITHER LOGO OR S/S SIDE FACING THE FIRE SIDE, TO BE INSTALLED AT THE BACK OF CONTROL (SEE APPLICATION DETAILS)
4. CABINET WITH EITHER INSTALLATION METHOD AS INDICATED IN 4a AND 4b

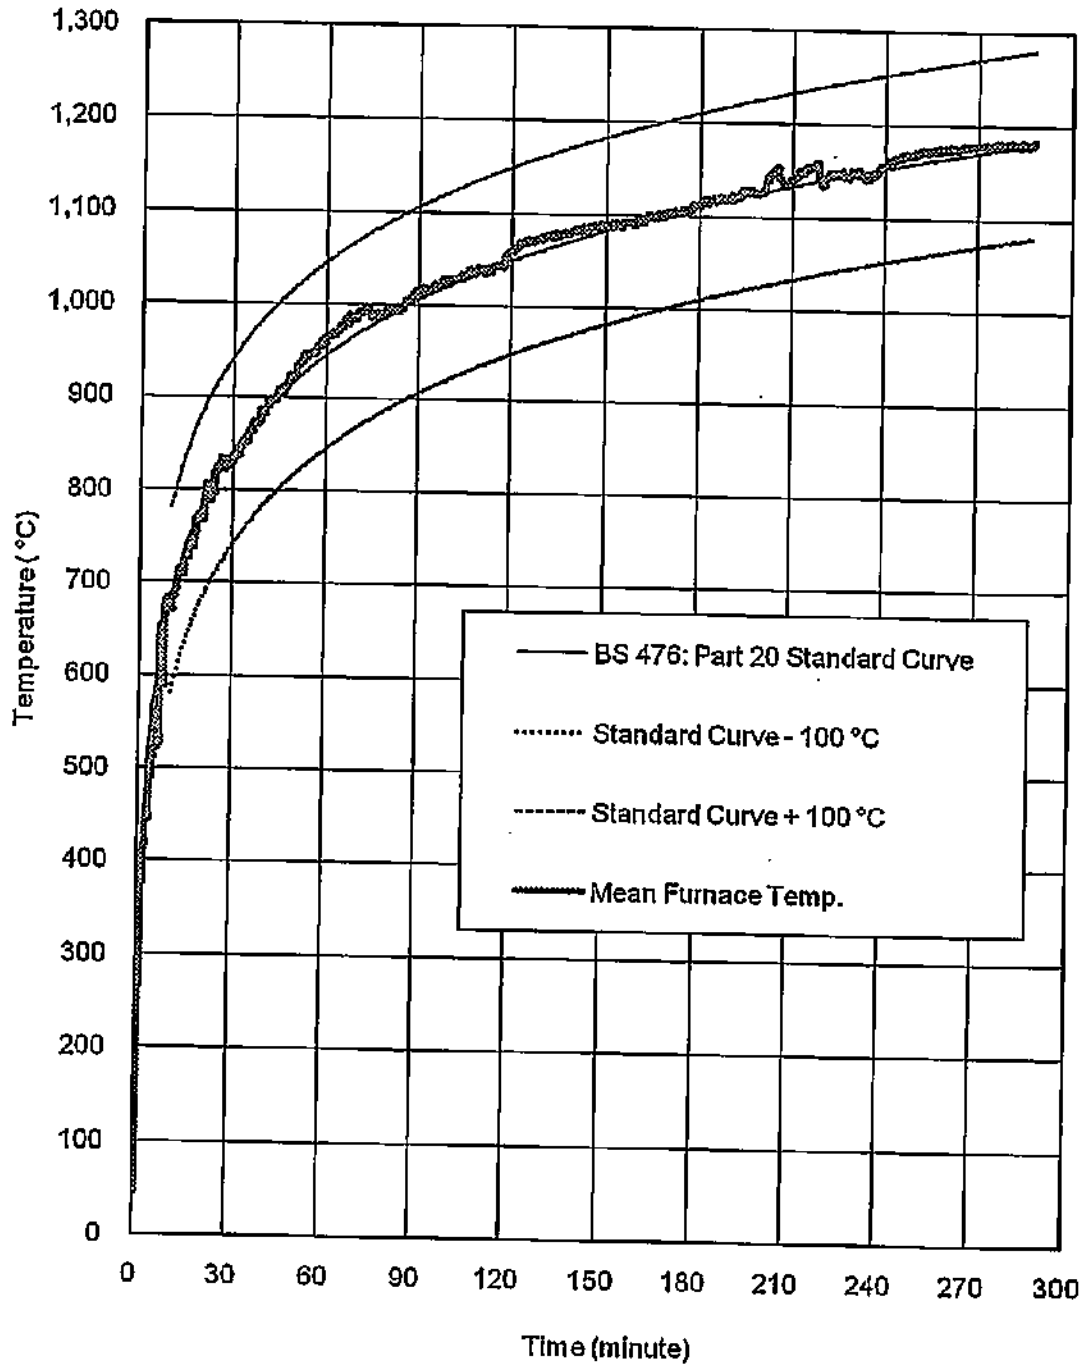
Figure 3 – Mean furnace temperature.

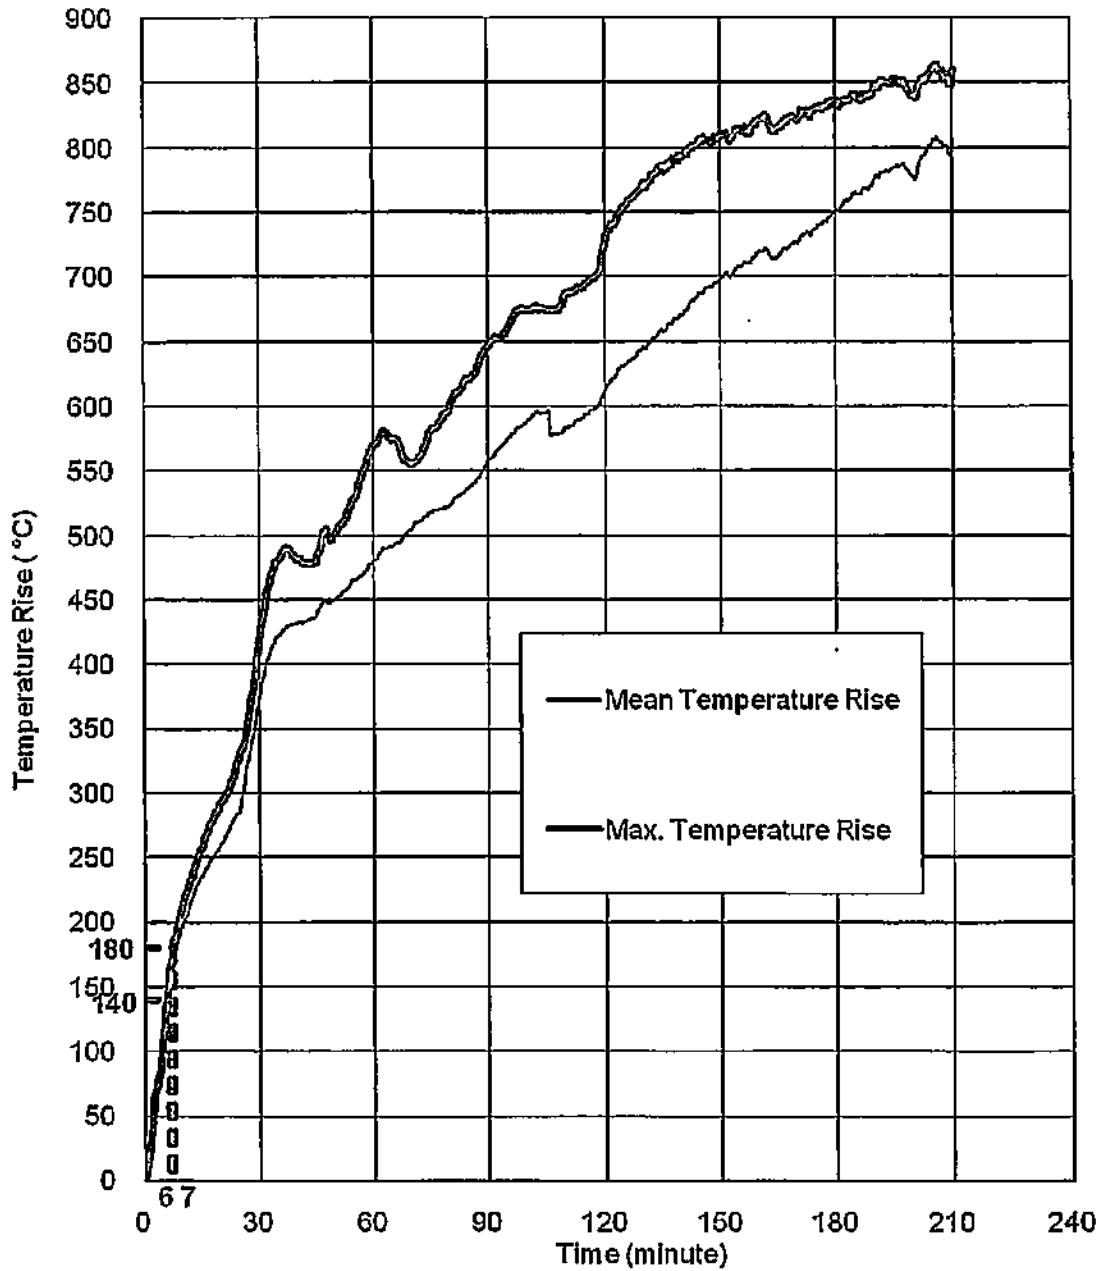
Figure 7 – Temperature rises of unexposed surface of specimen 'D'.

Notes: Thermocouple S16 malfunctioned after a heating period of 106 minutes.

Thermocouples S17 – S23 malfunctioned after a heating period of 211 minutes.

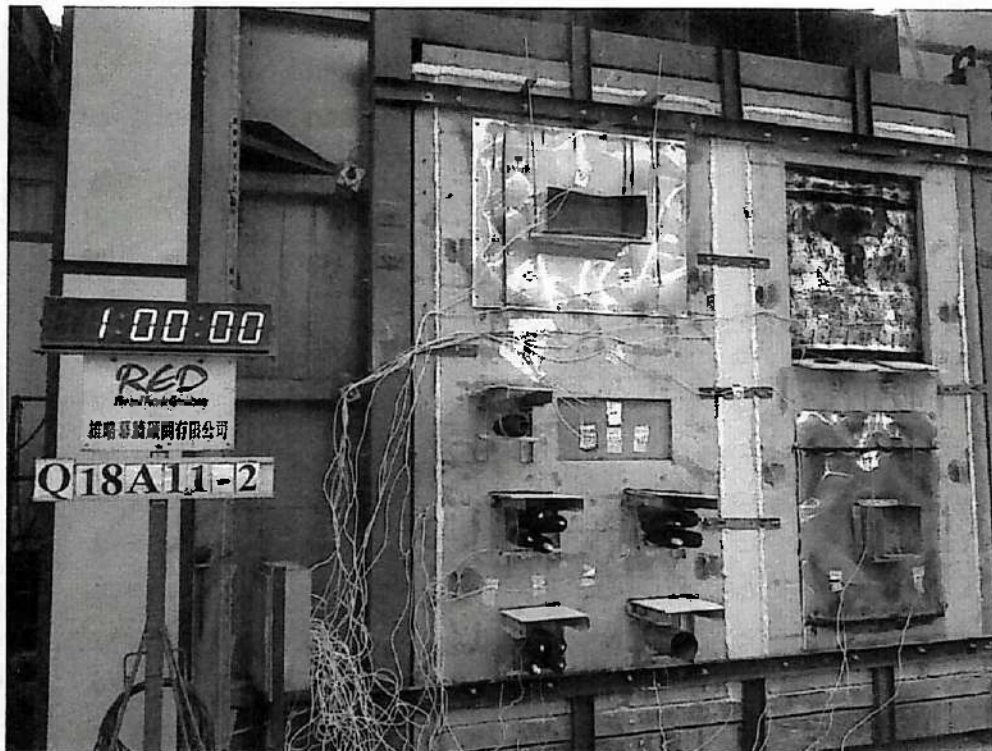
Photo 3: The unexposed face of the specimens after a heating period of 60 minutes.

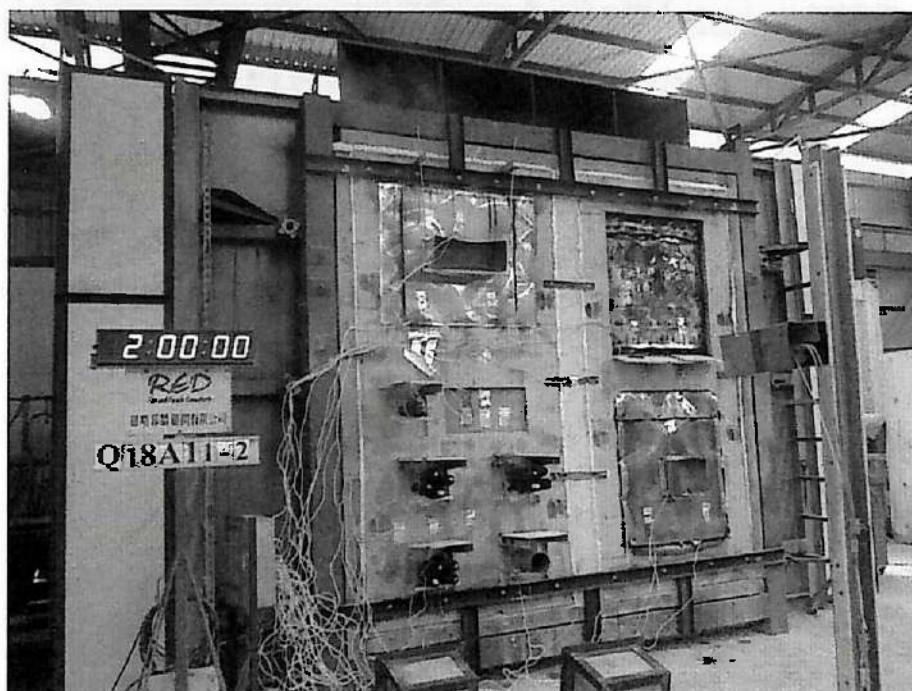
Photo 4: The unexposed face of the specimens after a heating period of 120 minutes.

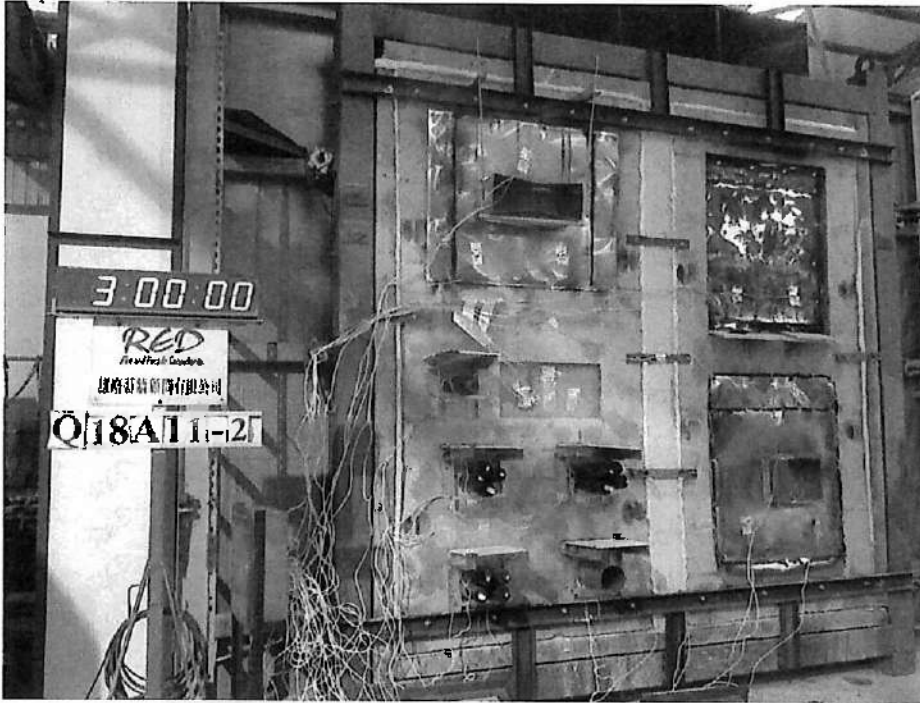
Photo 5: The unexposed face of the specimens after a heating period of 180 minutes.

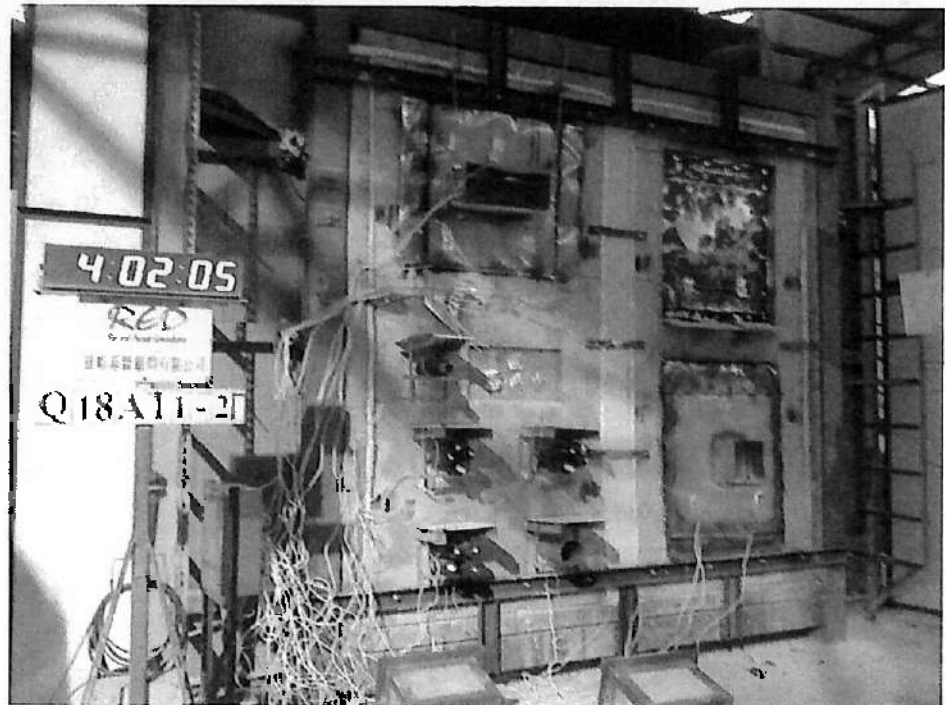
Photo 6: The unexposed face of the specimens after the test.
