# Hilti CFS-SP WB Firestop Joint Spray

## Submission Folder

Firestop joint spray CFS-SP WB

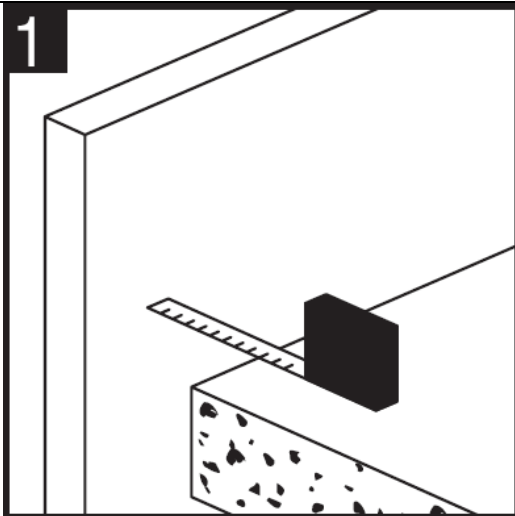
1 Clean the opening. Surfaces to which the Firestop Joint Spray will be applied should be cleaned of loose debris, dirt, oil, wax and grease. The surface should be moisture and frost free.

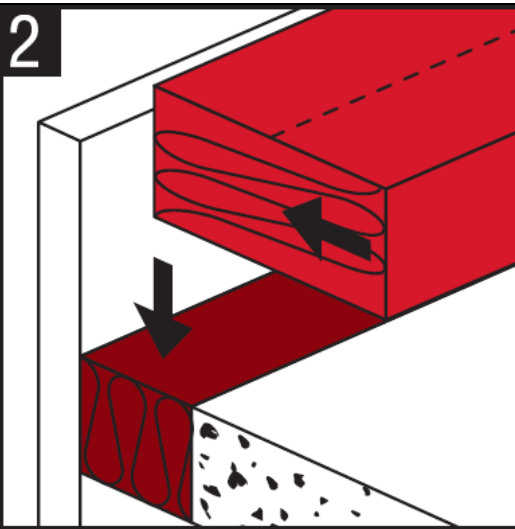
2 Install the prescribed back filling material type and depth to obtain the desired rating.

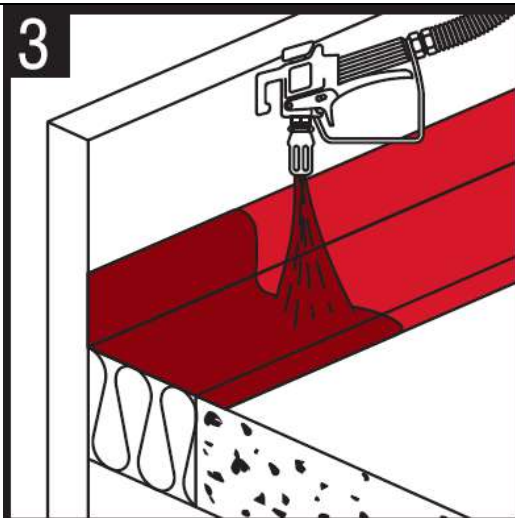
3 Apply the Firestop Joint Spray to the required thickness in order to obtain the desired rating (For wet thick: 3mm; For dry thick: 1.5mm). Make sure the Firestop Joint Spray contacts all surfaces and overlaps beyond all surrounding surfaces (Overlap length min 15mm).

For vertical joint, please apply spray on both side of the joint accordingly.

Titan Sprayers have been successful in applying Firestop Joint Spray. Hilti recommends the use of the Titan 600 (for application temperatures above 50°F / 10°C) or Firestop Joint Spray may also be brushed on with a paint brush.

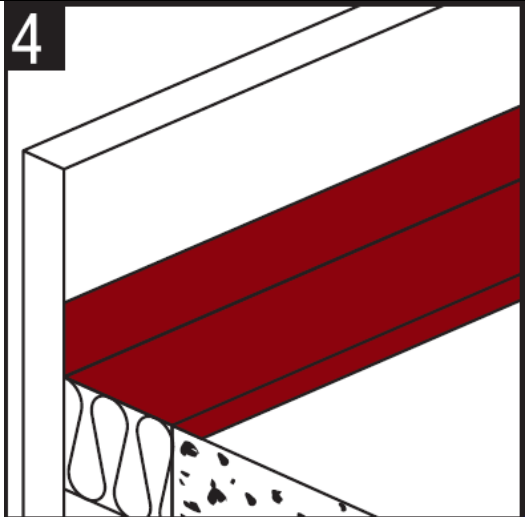
4	<p>Allow the Firestop Joint Spray to fully cure-- approx. 24 hours for typical application thickness (73°F / 23°C and 50% humidity). Users could use simple measuring tools to measure the thickness, for example: cardboard.</p>

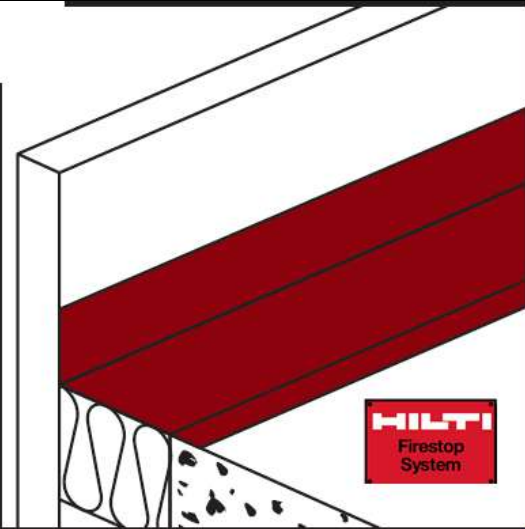
5	<p>For maintenance reasons, all Firestop Joint Spray applications shall be permanently marked with an identification plate and fastened in a visible position next to the seal.</p>

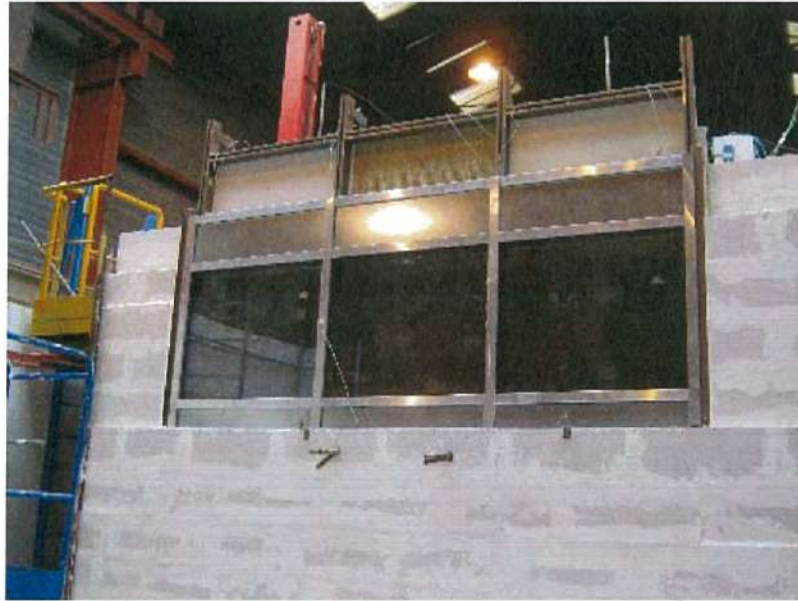
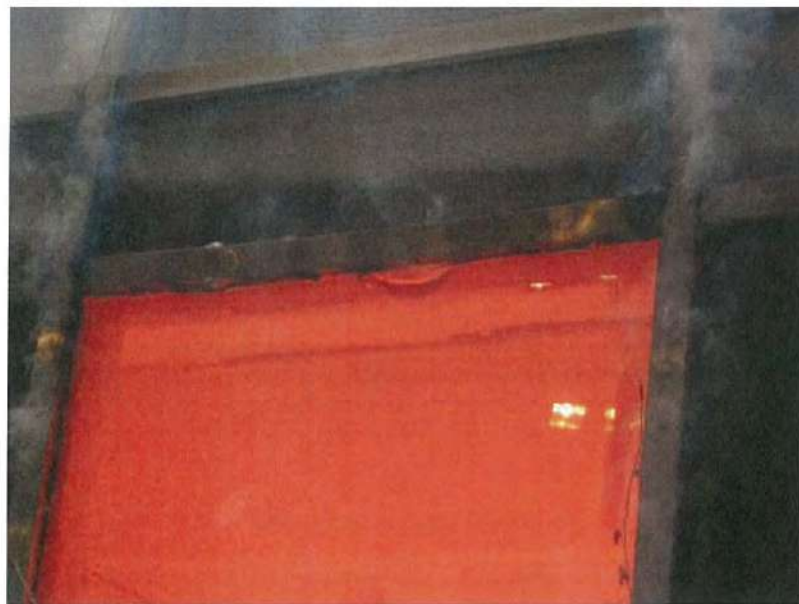
<b>Picture A</b> (Top) Commencement of test.
<b>Picture B</b> (Bottom) Smelting of the glazing in the centre of the element.

TIME [min]	OBSERVATIONS
00	Commencement of test. (Picture A)
3	Reaction of the intumescent layer of the glazing.
5	Cracking and falling down of the first tempered glass on fire side.
14	Smoke release from profiles junctions.
15	Nothing particular to report.
20	Nothing particular to report.
30	Nothing particular to report.
45	Nothing particular to report.
60	Nothing particular to report.
92	The glazing starts to fall down.
<b>103</b>	<b>Sustained lighting for a duration of more than 10 seconds on the upper rail of the glazing 2.</b>
106	Smelting of the glazing in the centre of the element. (See picture B)
110	Set up of a blind panel to replace the glazing.
120	Nothing particular to report
<b>144</b>	<b>Maximal temperature rising higher than 180°C noted by the thermocouple n° 35.</b>
<b>150</b>	<b>Maximal temperature rising higher than 180°C noted by the thermocouple n° 34.</b>
<b>155</b>	<b>Maximal rising temperature higher than 180°C noted by the mobile thermocouple (252°C) on the horizontal seal.</b>

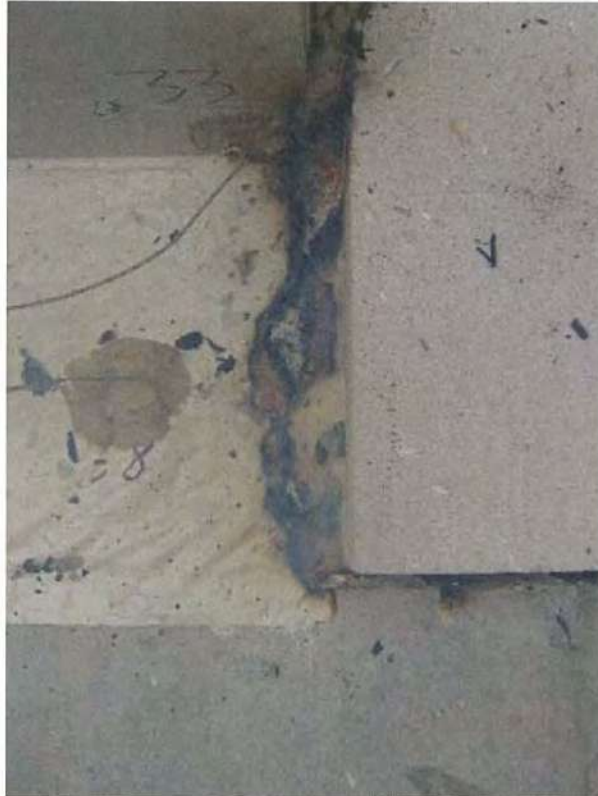
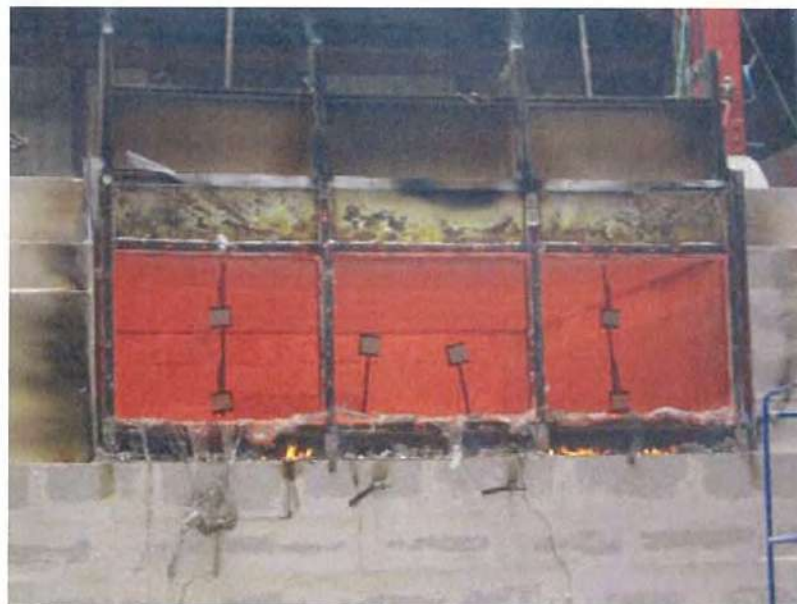
**Picture C (Top)** Cotton pad test positive on the horizontal seal

**Picture D(Bottom)** End of test.

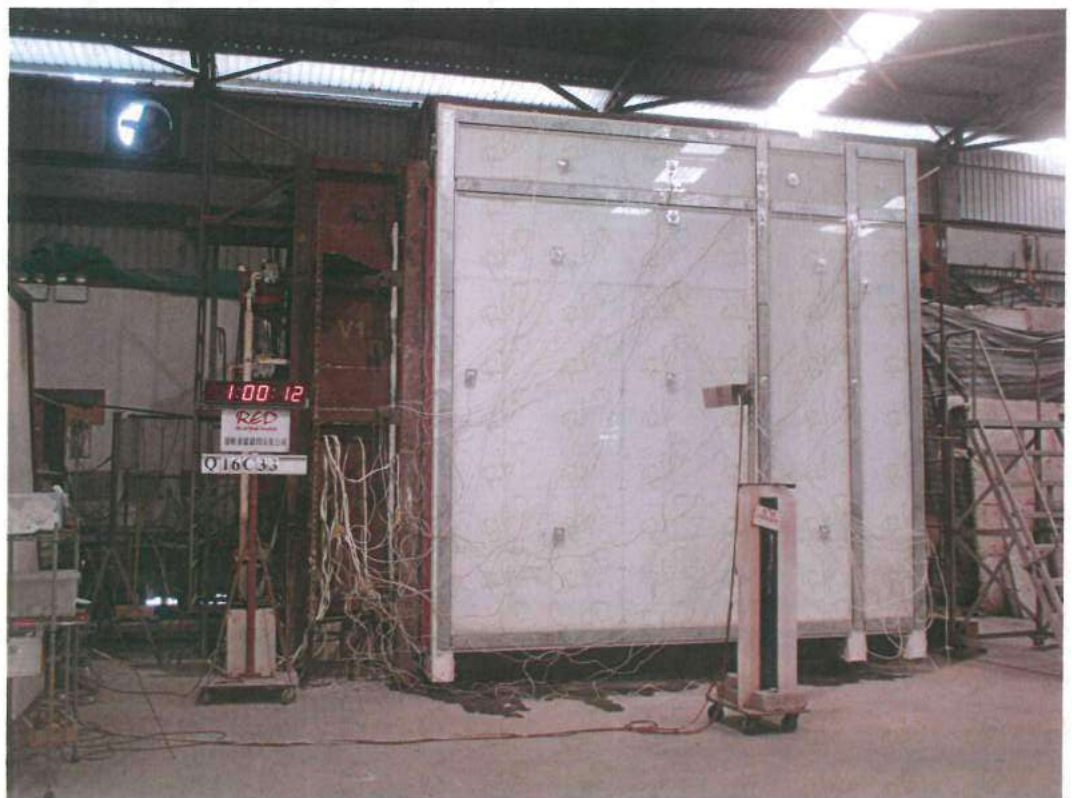
Photo 2: The unexposed face of the specimen after a heating period of 60 minutes.

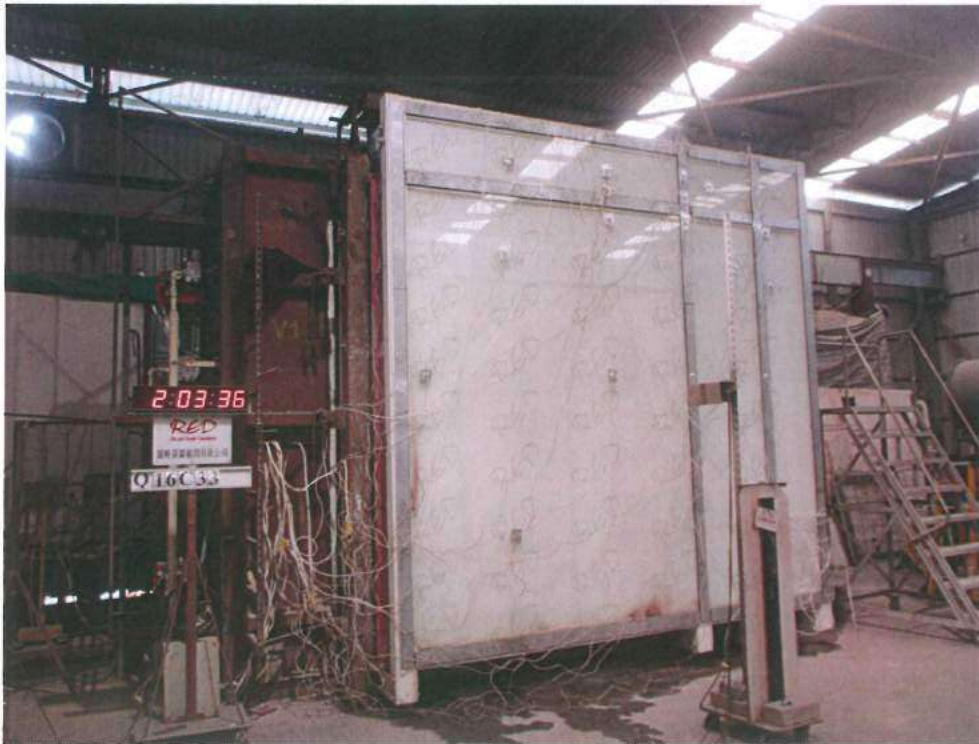
Photo 3: The unexposed face of the specimen after the test.

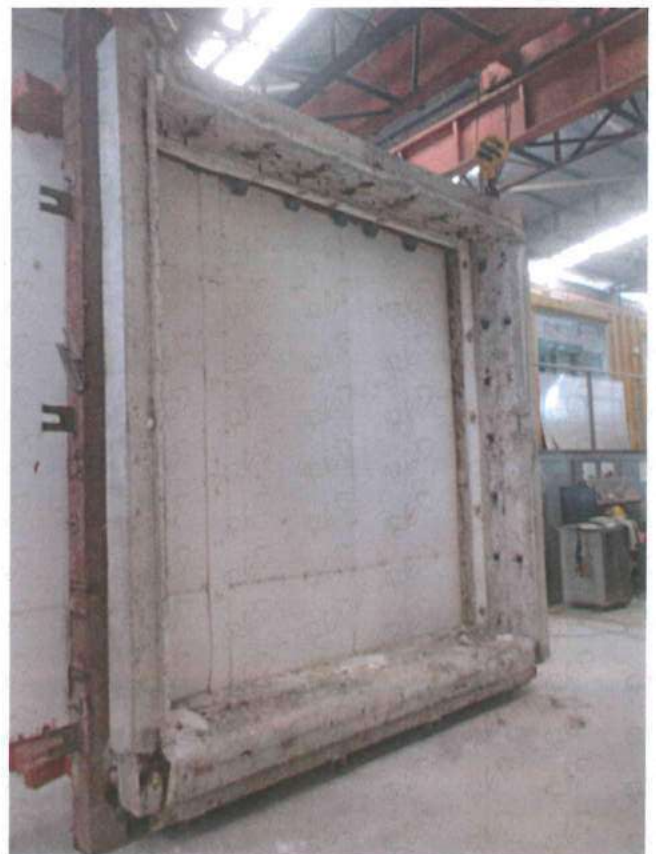
Photo 4: The exposed face of the specimen after the test.

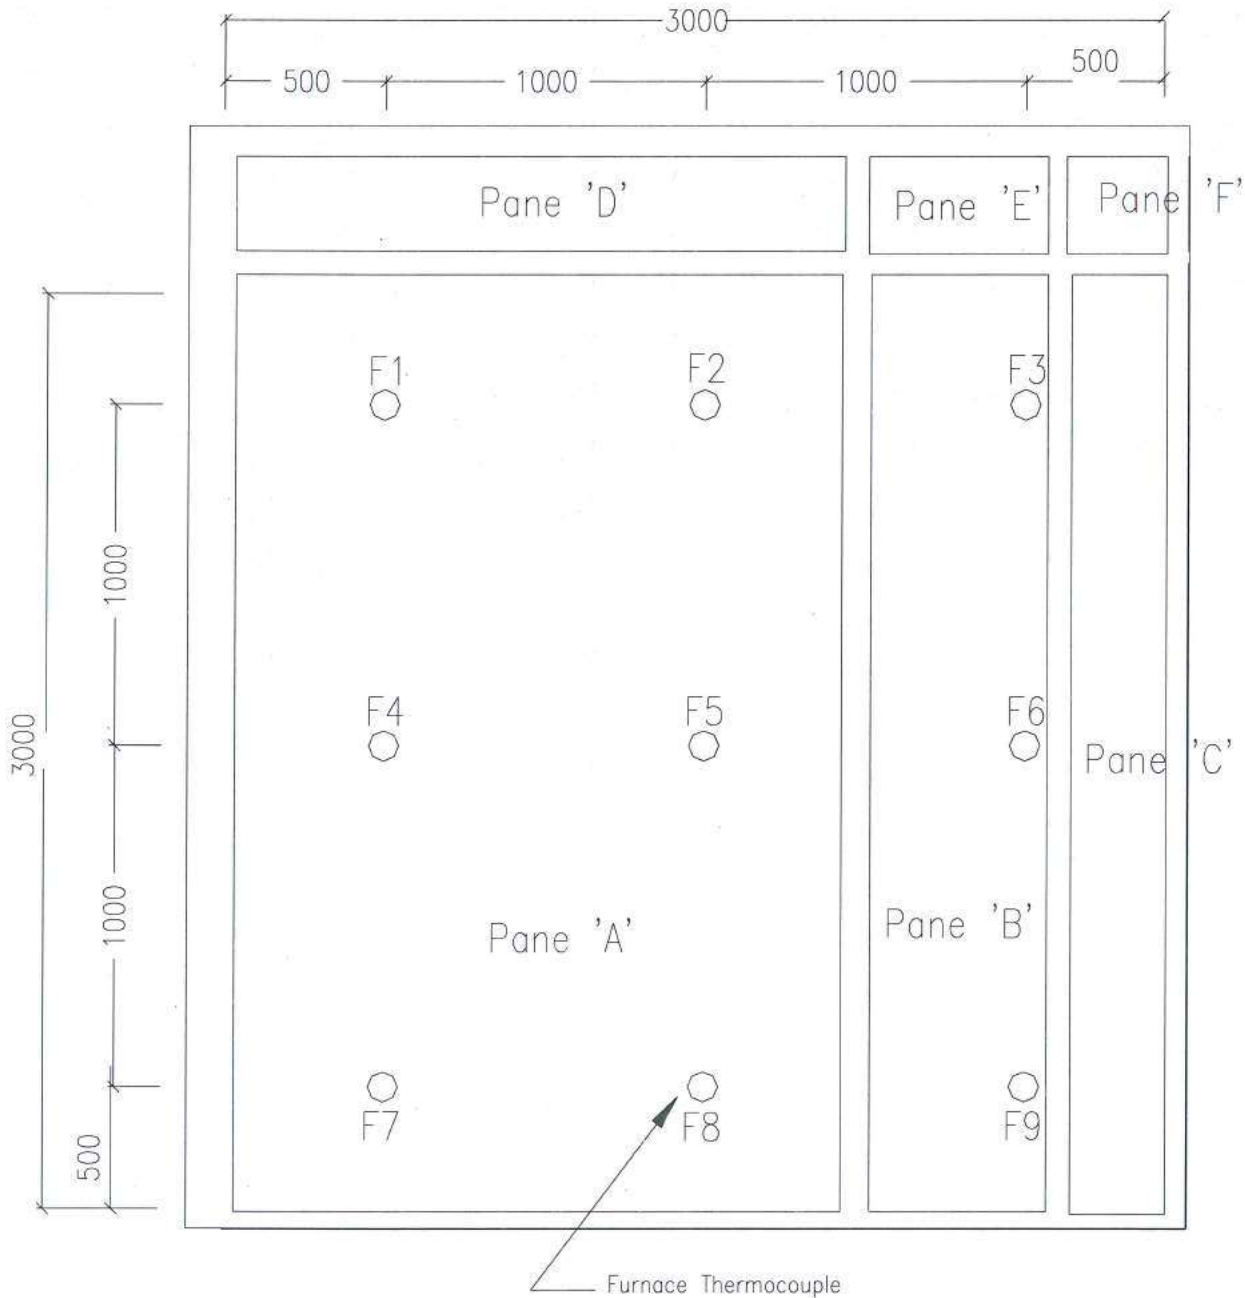
Figure 1 – Locations and reference numbers of furnace thermocouples.  
(This figure is not to scale and all dimensions are in millimetres.)

Nine (9) 'type K' thermocouples to monitor the temperature of the furnace, which were kept at 100 mm from the exposed face of the specimen (see Figure 1).

Notes: Locations of furnace thermocouples are shown in Figure 1.

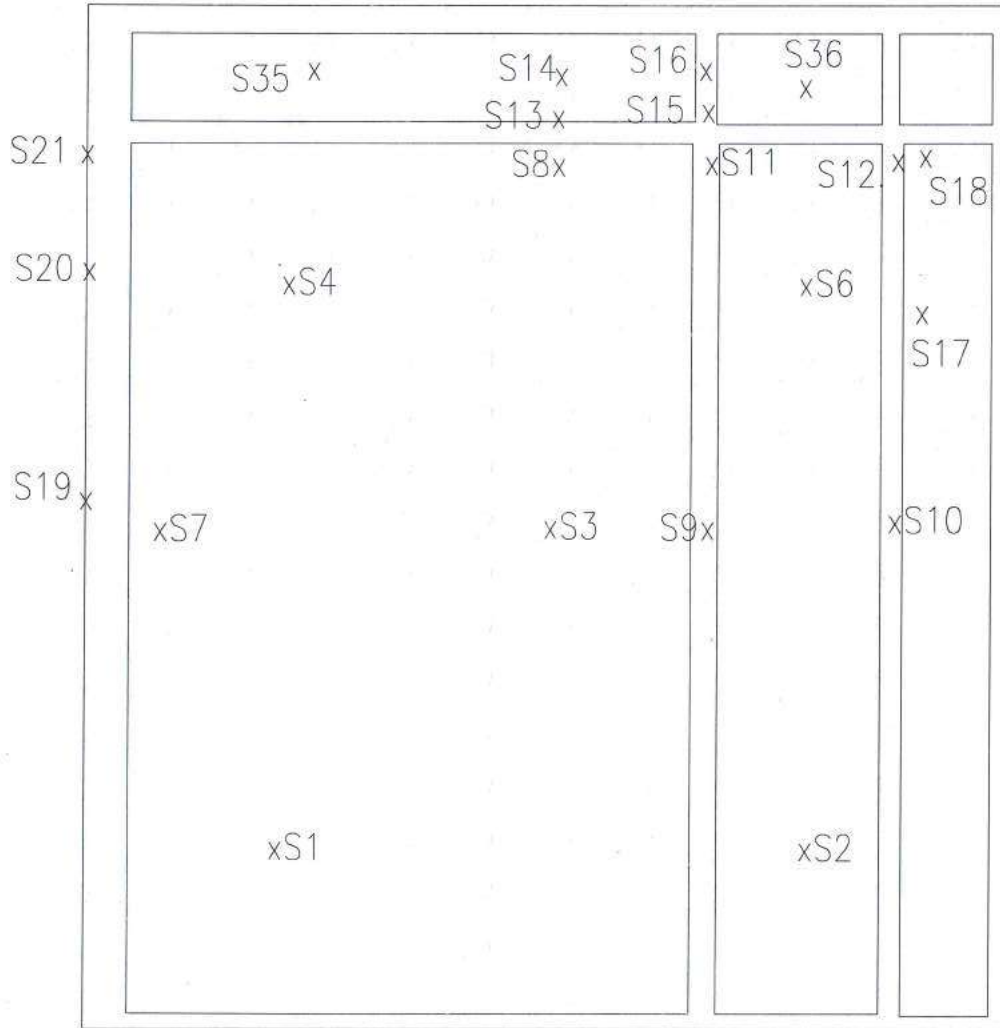
Figure 2 – Locations and reference number of thermocouples to monitor the temperature of unexposed surface (surfaces 2, 5 and 6 and left vertical linear gap seal) of the specimen.

(This figure is not to scale.)

Forty-two (42) 'type K' thermocouples to monitor the temperature of the unexposed face of the specimen (see Figure 2).

The temperature of the unexposed face was monitored by means of forty-two (42) thermocouples fixed to the unexposed surface (see Figure 2 for the locations and reference numbers of the thermocouples). Thermocouples S1 - S4, S6 were fixed on the glazing panels for mean and maximum temperatures of surface 2. Thermocouples S7 - S12 were fixed on the glazing panels and mullions for maximum temperatures of surface 2. Thermocouples S33 - S34 were fixed on the partition boards for mean and maximum temperatures of surface 3. Thermocouples S29 - S32 were fixed on the partition boards and mullions for mean and maximum temperatures of surface 3. Thermocouples S37 - S40 were fixed on the partition boards for maximum temperature rise of surface 4. Thermocouples S35 - S36 were fixed on the glazing panels for mean and maximum temperatures of surface 5. Thermocouples S13 - S16 were fixed on the mullions and glazed panels for maximum temperatures of surface 5. Thermocouples S17 - S18 were fixed on the glazed panels for maximum temperature rise of surface 6. Thermocouples S22 - S28 were fixed on horizontal linear gap seals for maximum temperatures of the unexposed surface of

Notes: Locations of thermocouples S1 – S4 & S6 - S22 are shown in Figure 2.

Notes: Locations of thermocouples S23 – S43 are shown in Figure 2.

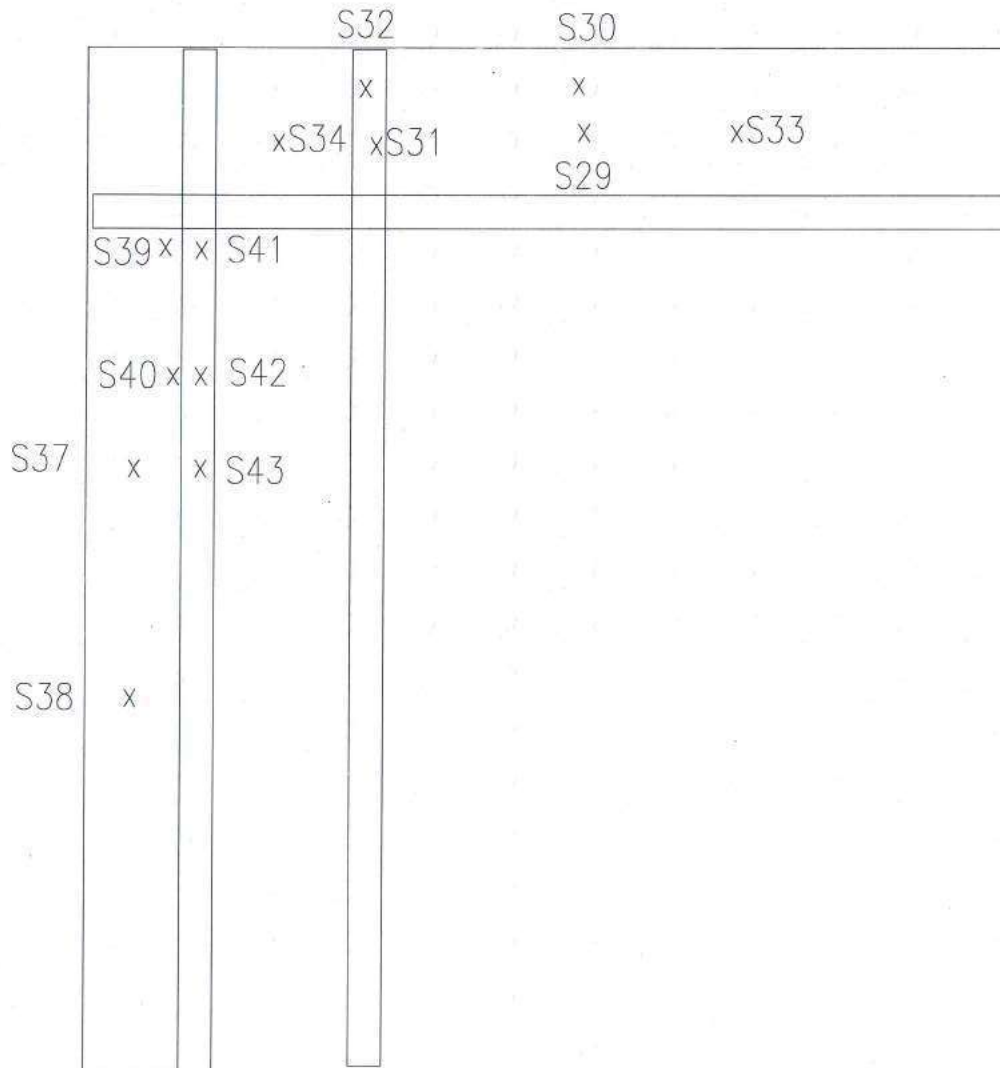
Figure 3 – Locations and reference number of thermocouples to monitor the temperature of unexposed surface (surface 3 and 4, right vertical linear gap seal and horizontal linear gap seal) of the specimen.

(This figure is not to scale.)

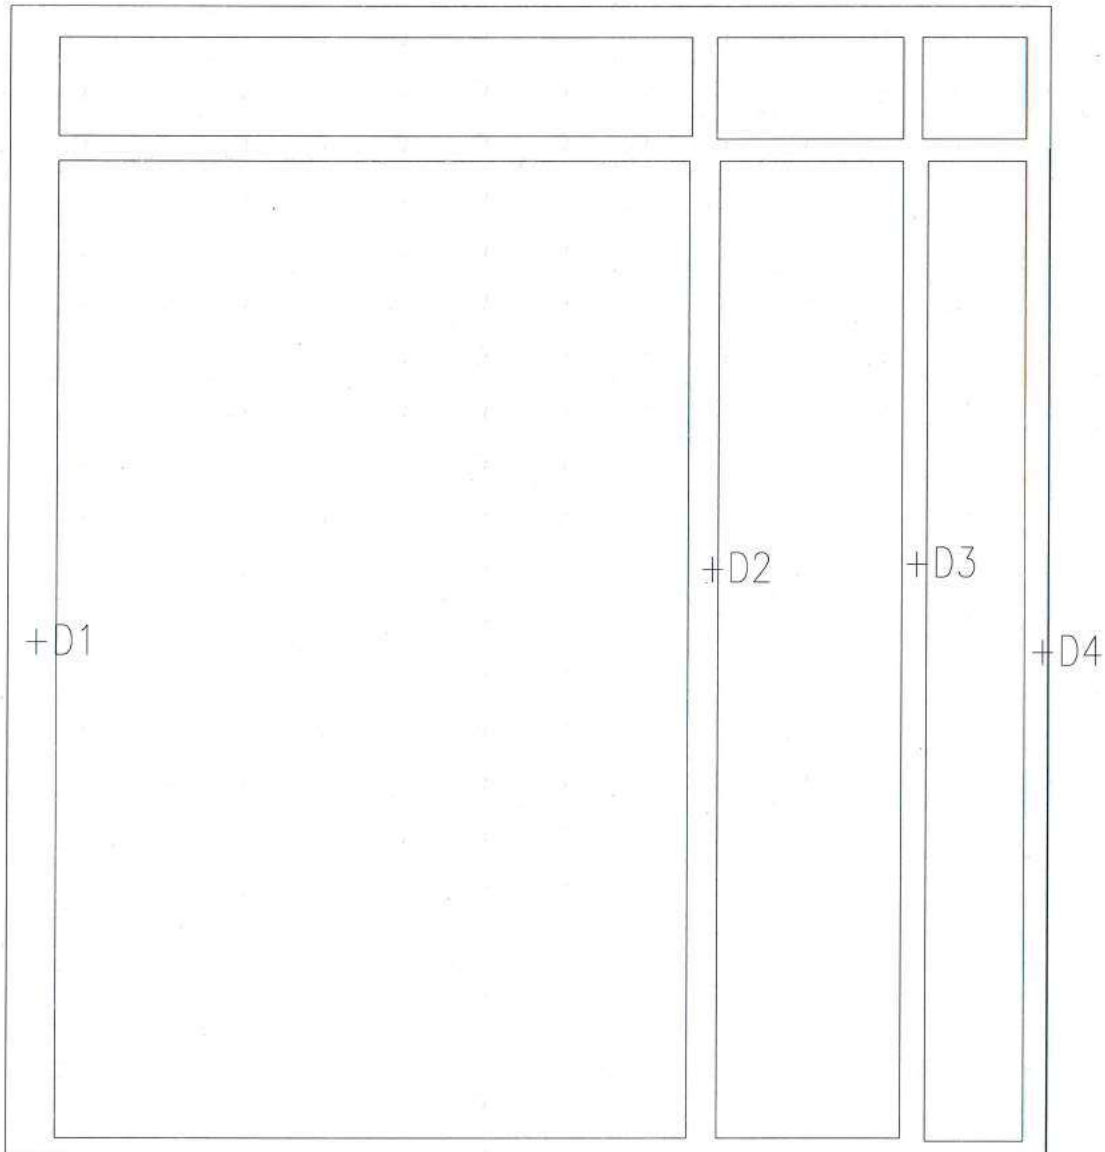
Figure 4 – Locations and reference numbers of displacement measurement.

(This figure is not to scale.)

Positive deflection indicates movement towards the furnace (see also Figure 3 for the locations).

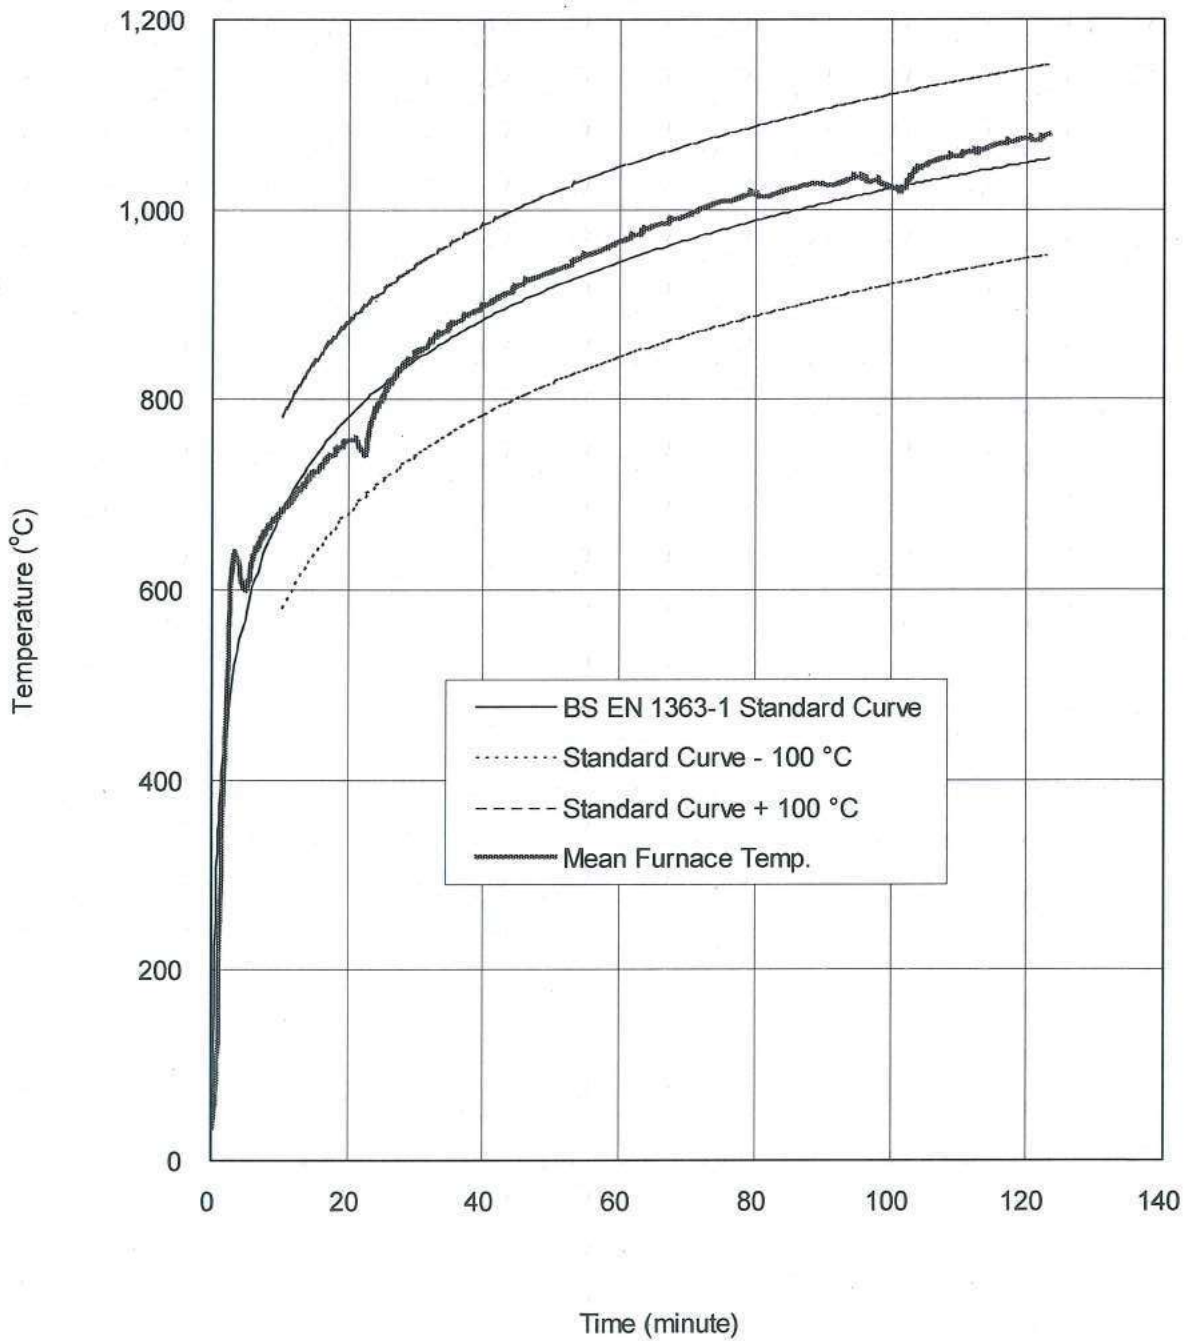
Figure 5 – Mean furnace temperature.

The furnace was controlled so that the mean furnace temperature complied with the requirements of Clause 4.5.1.1 of BS EN 1363-1: 2012. The temperature recorded is shown graphically in Figure 5.

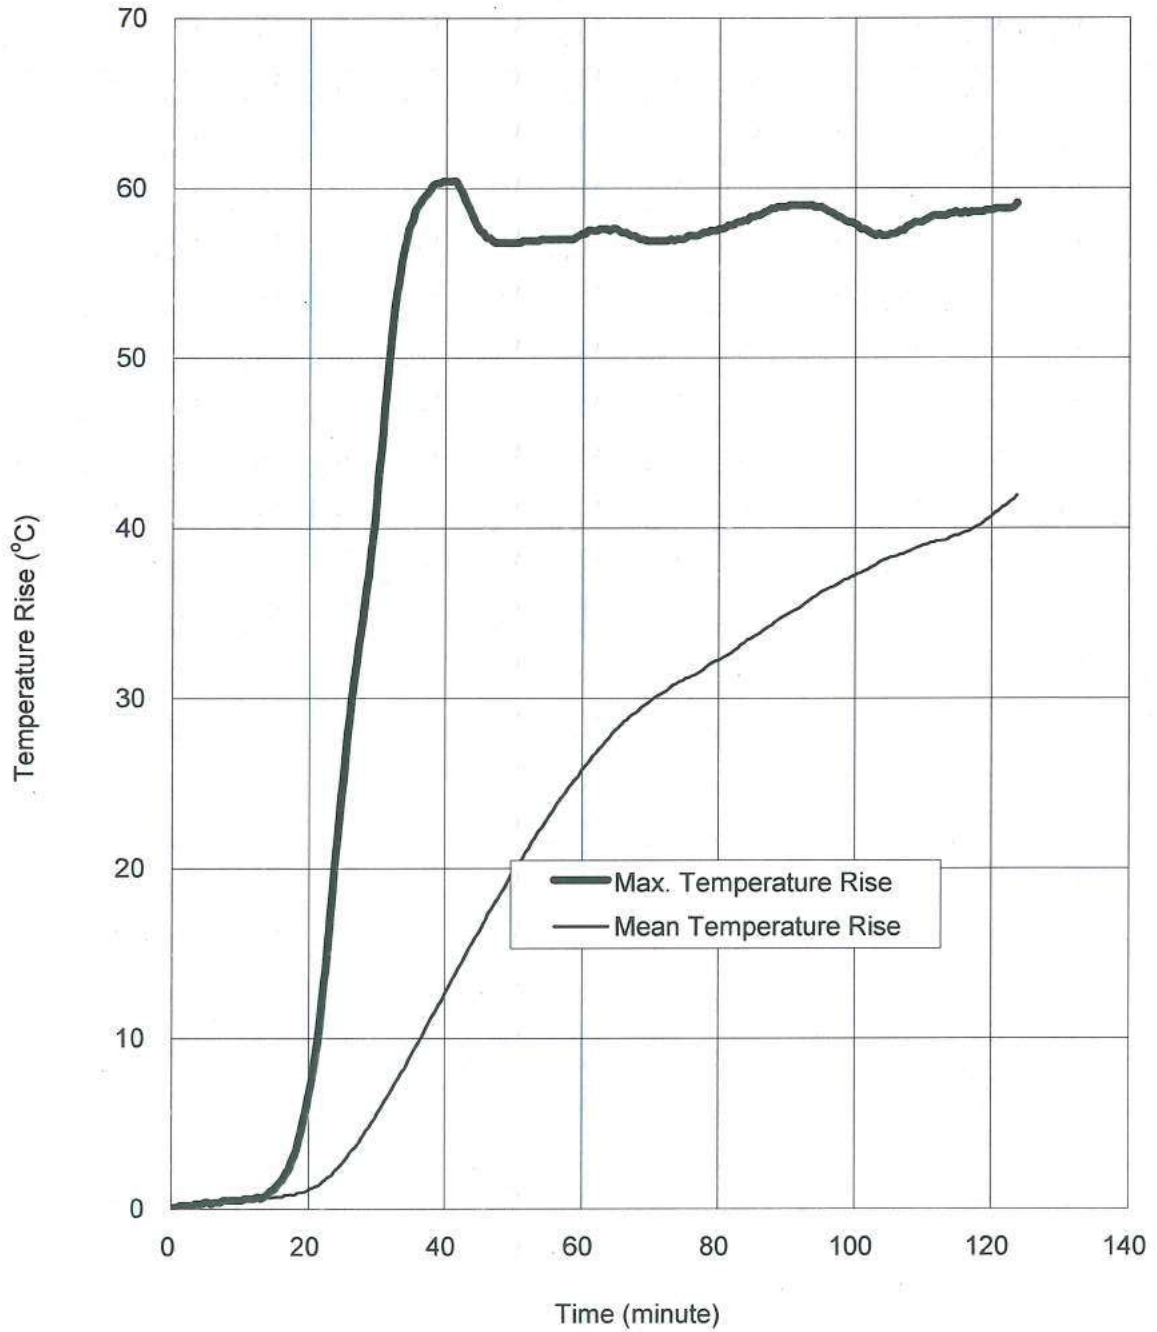
Figure 6 – Temperature rise of unexposed surface of surface 2.

The mean and maximum temperatures of the surface 2 are shown graphically in Figure 6.

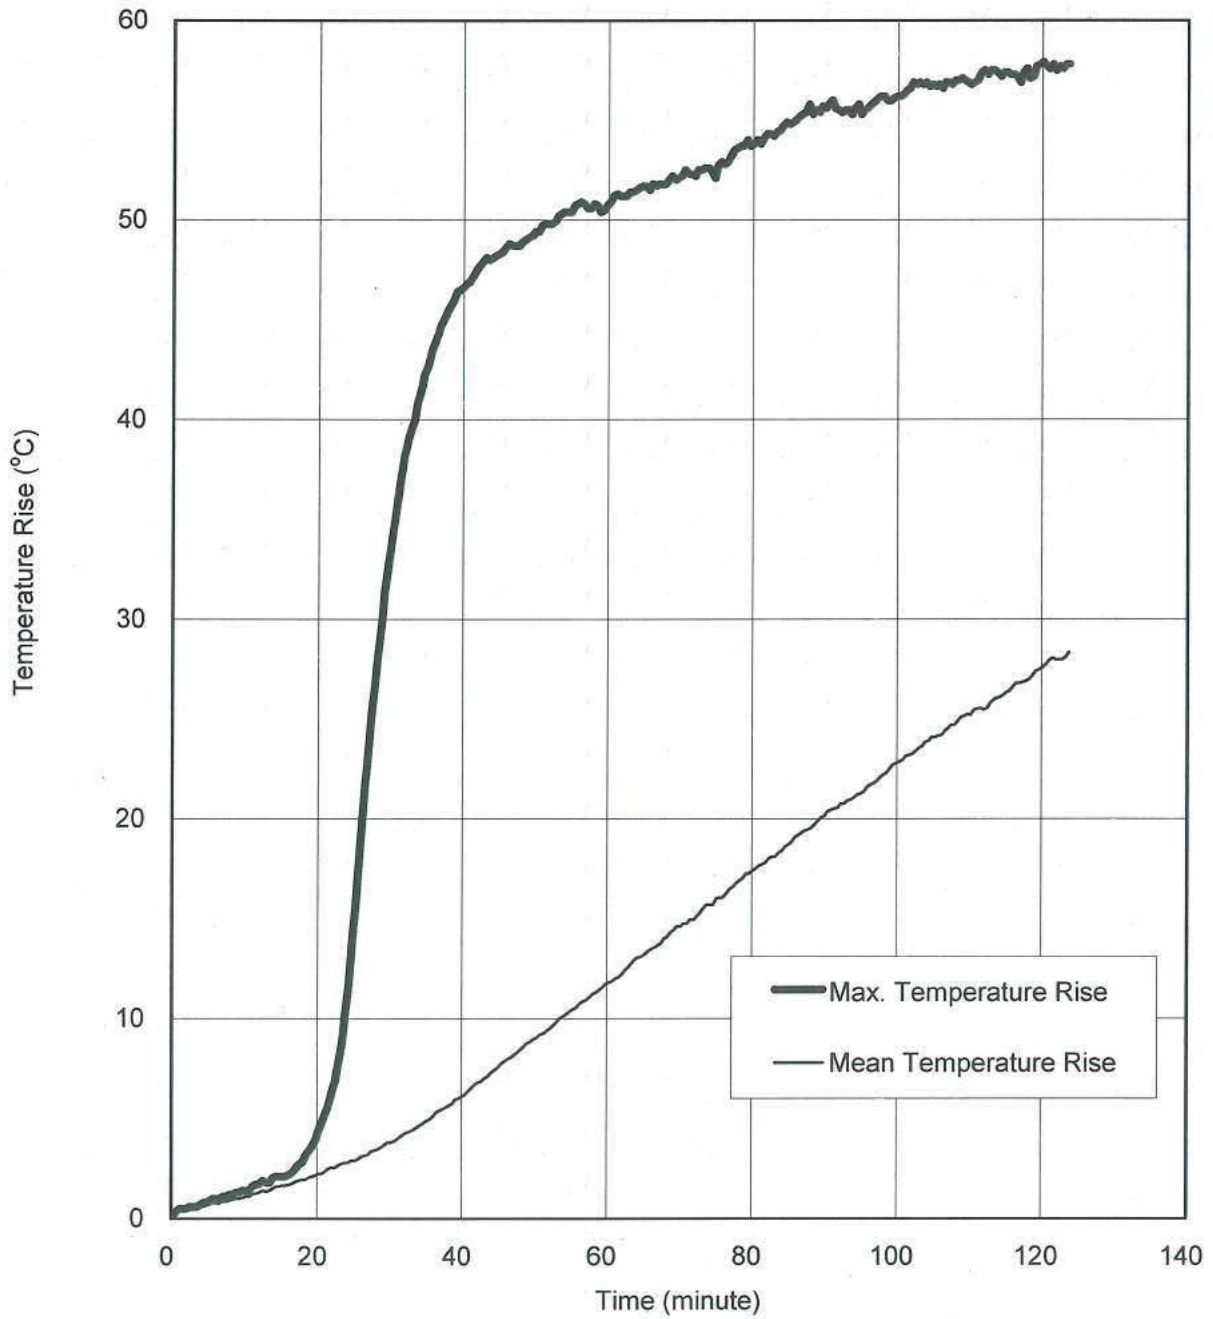
Figure 7 – Temperature rise of unexposed surface of surface 3.

The mean and maximum temperatures of the surface 3 are shown graphically in Figure 7.

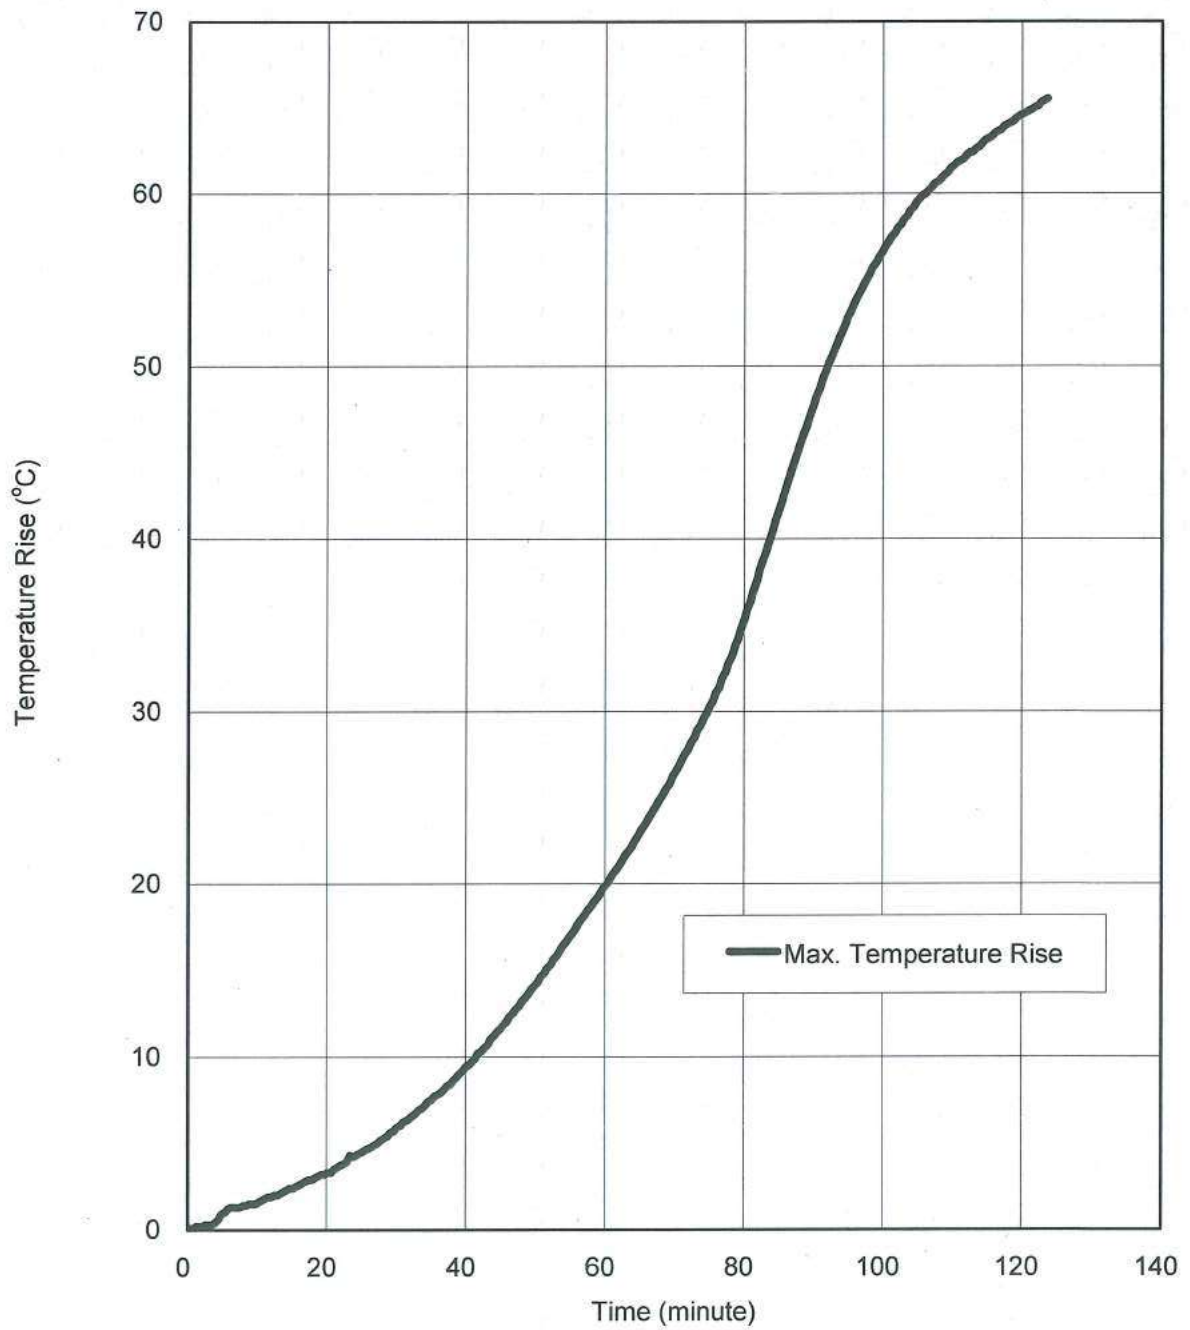
Figure 8 – Temperature rise of unexposed surface of surface 4.

The maximum temperatures of the surface 4 are shown graphically in Figure 8.

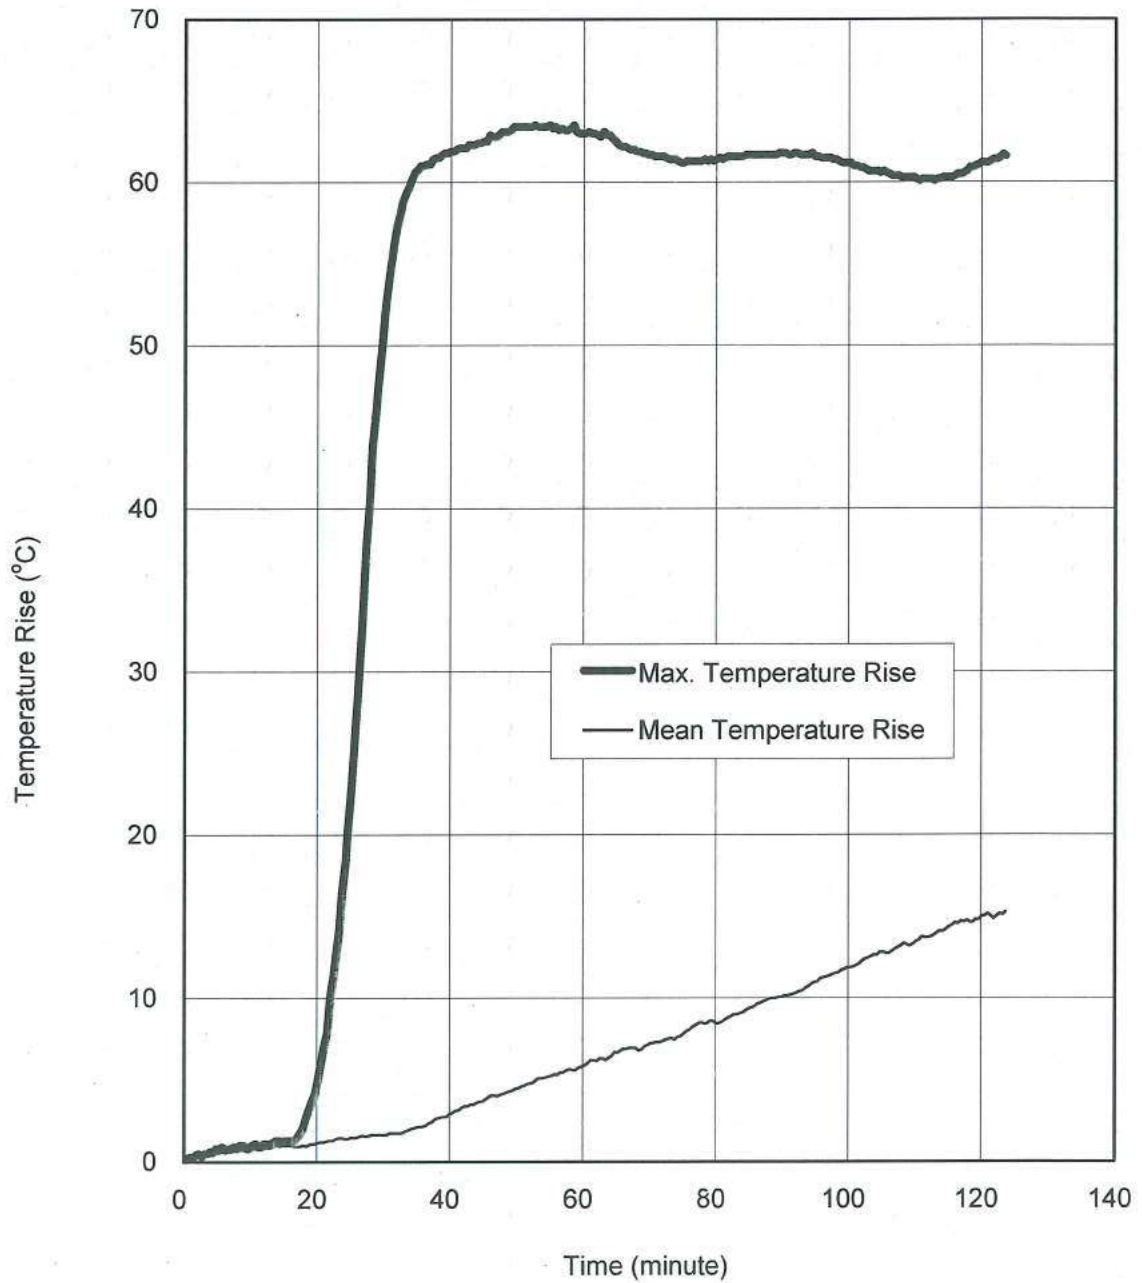
Figure 9 – Temperature rise of unexposed surface of surface 5.

The mean and maximum temperatures of the surface 5 are shown graphically in Figure 9.

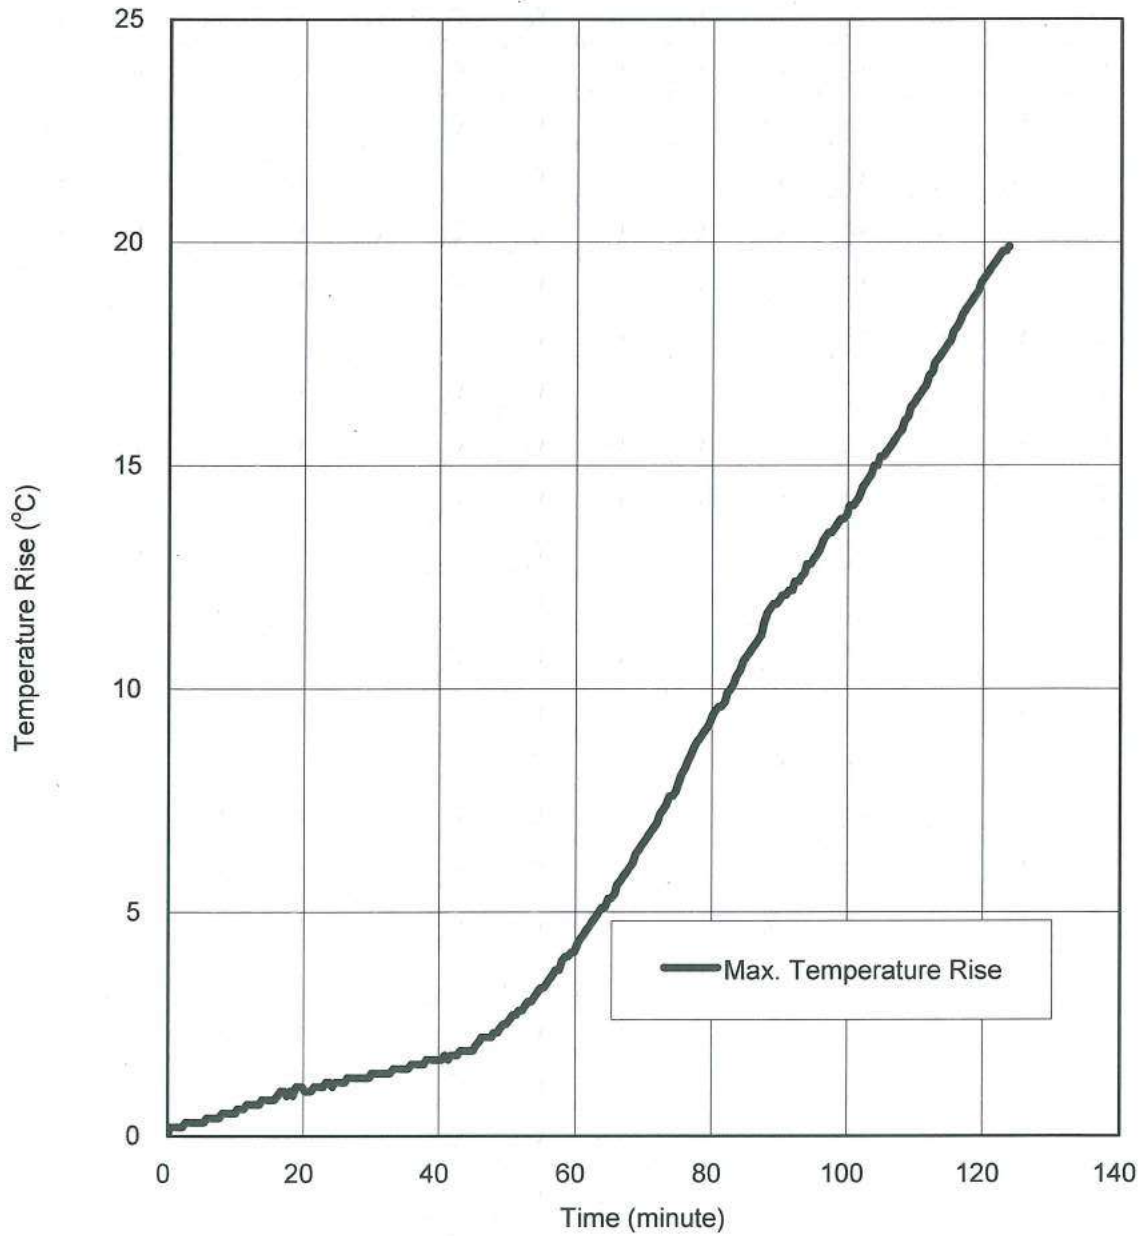
Figure 10 – Temperature rise of unexposed surface of surface 6.

The maximum temperatures of the surface 6 are shown graphically in Figure 10.

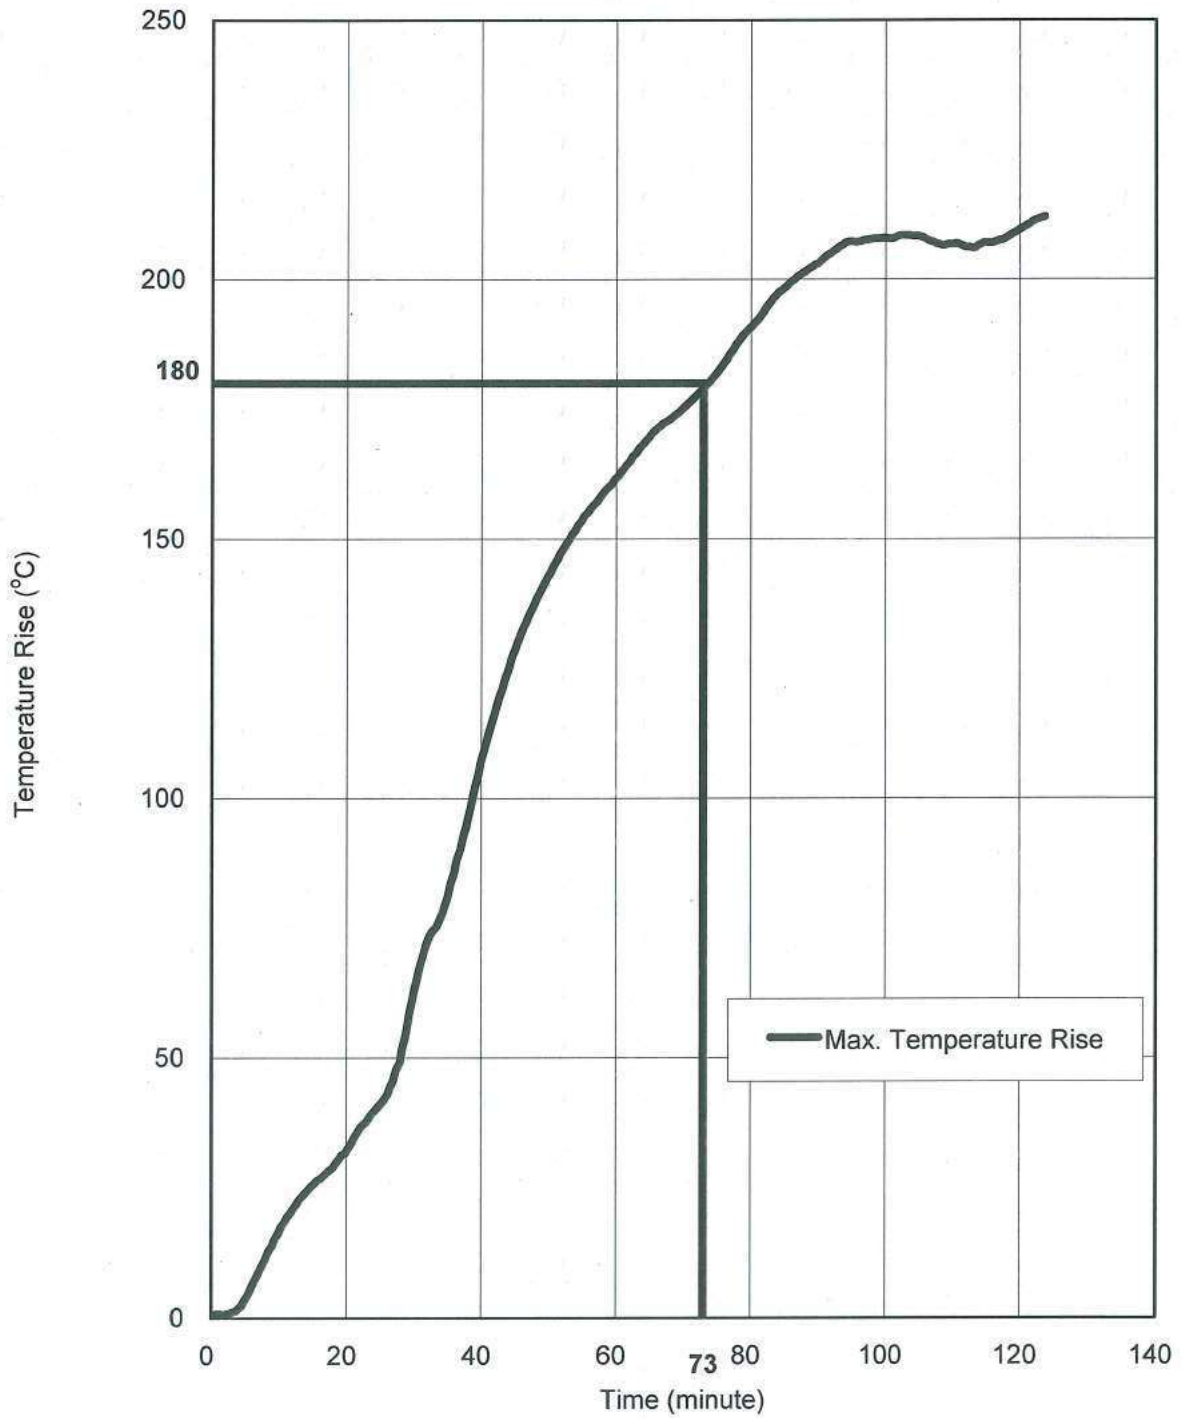
Figure 11 – Temperature rise of unexposed surface of horizontal linear gap seal

The maximum temperatures of the horizontal linear gap seal are shown graphically in Figure 11.
