# Hilti CFS-SP WB Firestop Joint Spray

## Submission Folder

Firestop joint spray CFS-SP WB

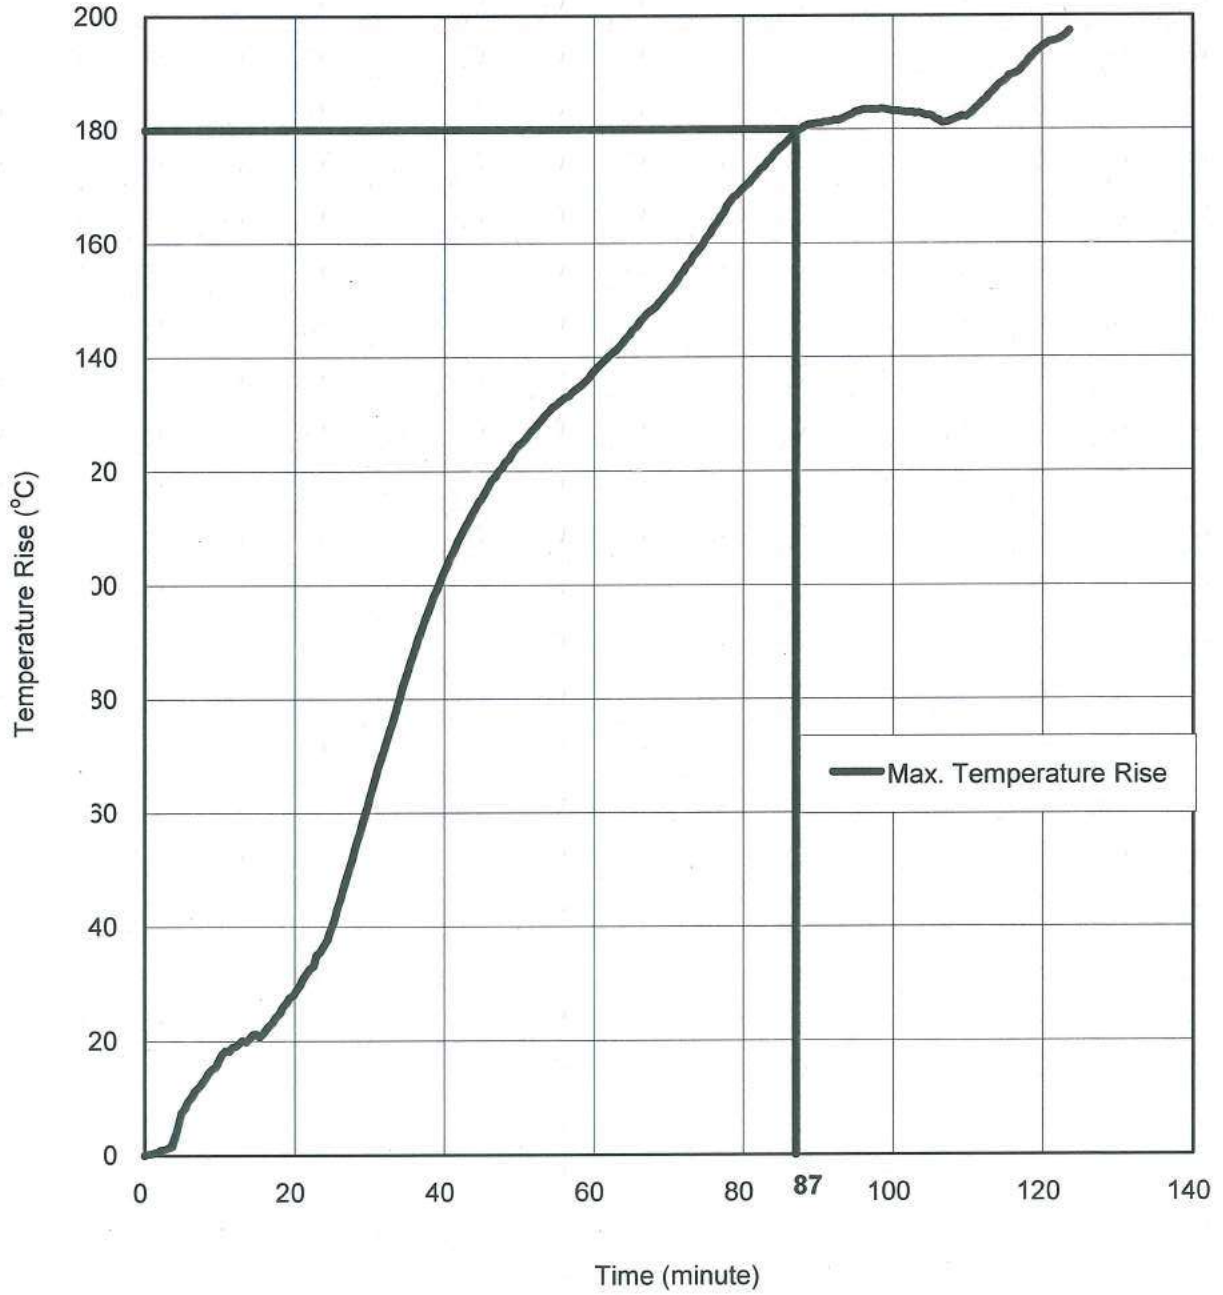
Figure 12 – Temperature rise of unexposed surface of left vertical linear gap seal

The maximum temperatures of the left vertical linear gap seal are shown graphically in Figure 12.

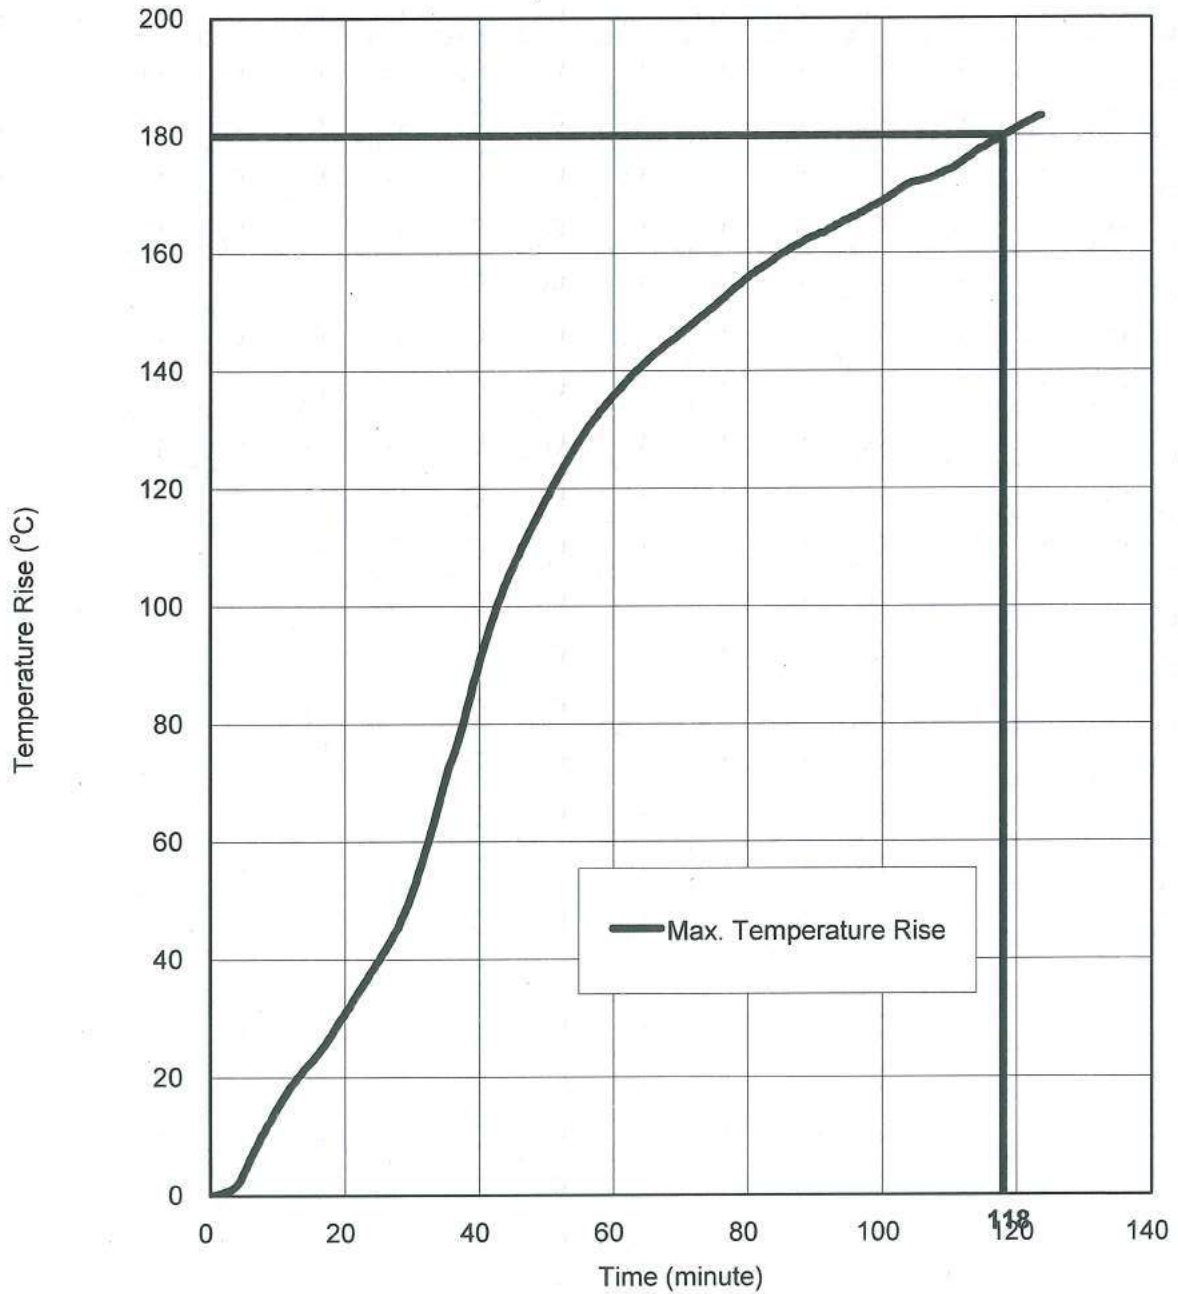
Figure 13 – Temperature rise of unexposed surface of right vertical linear gap seal

The maximum temperatures of the right vertical linear gap seal are shown graphically in Figure 13.

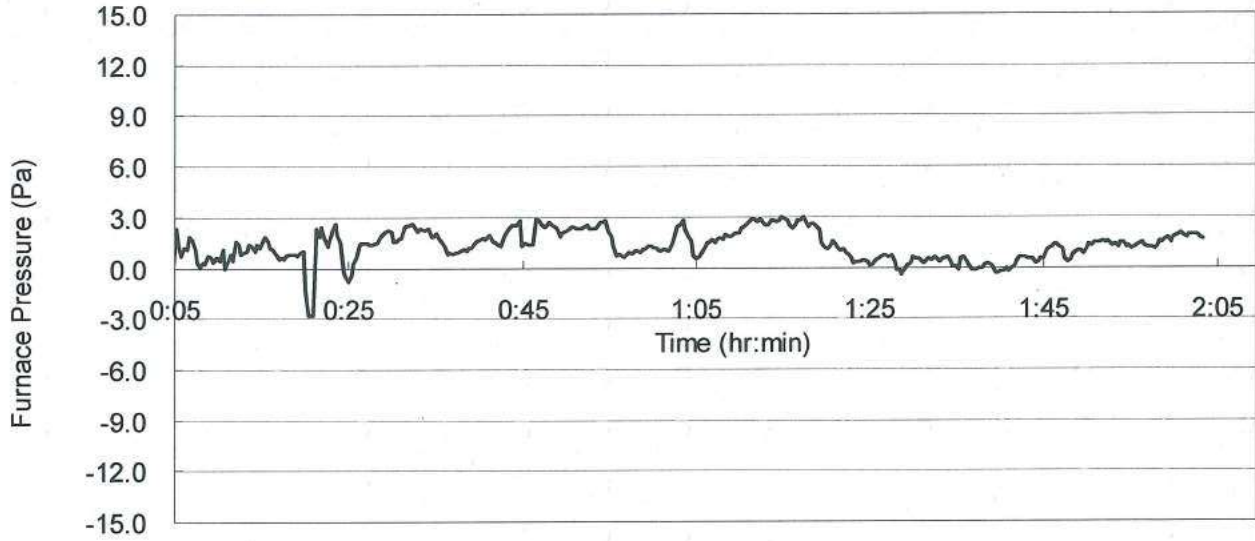
After the first 5 minutes of the test, the furnace pressure was maintained at  $0 \pm 3$  Pa relative to atmosphere, at 500 mm from the notional floor level.

Figure 14 – Furnace pressure.

The furnace pressure is shown graphically in Figure 14.

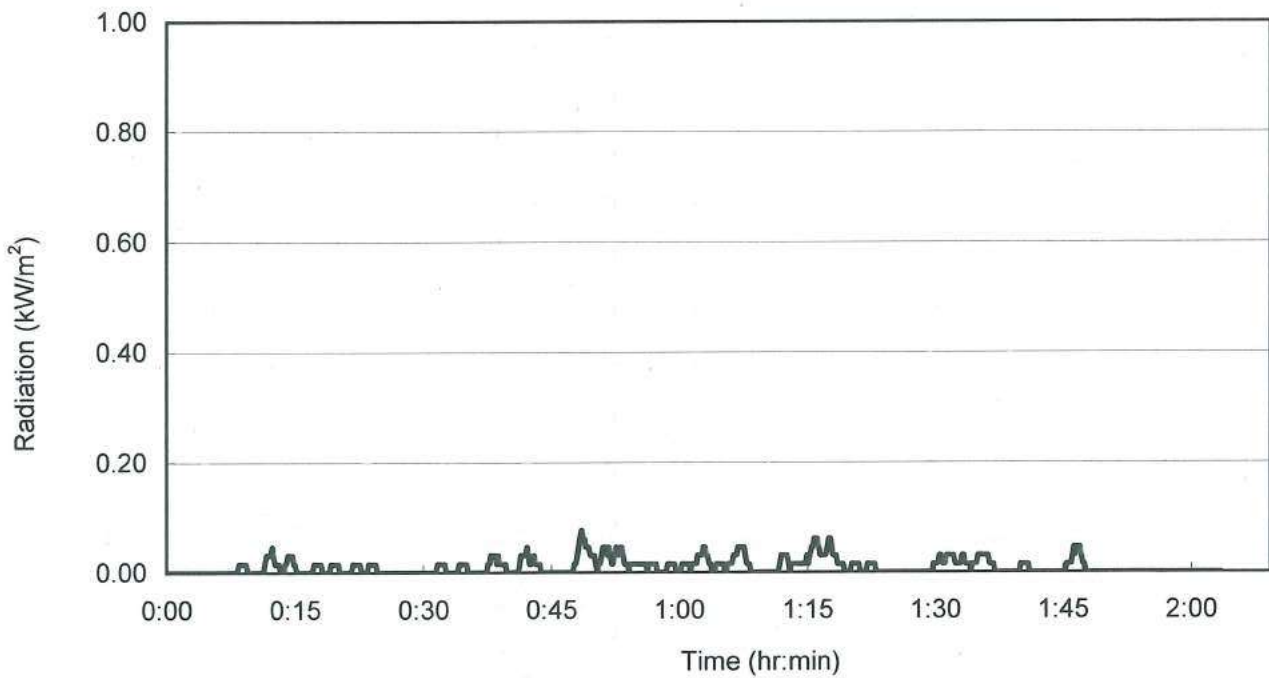
A radiometer placed at 1,000 mm away from the unexposed surface to measure the radiation of unexposed surface of the specimen.

Figure 15 – Radiation.

The radiation is shown graphically in Figure 15.

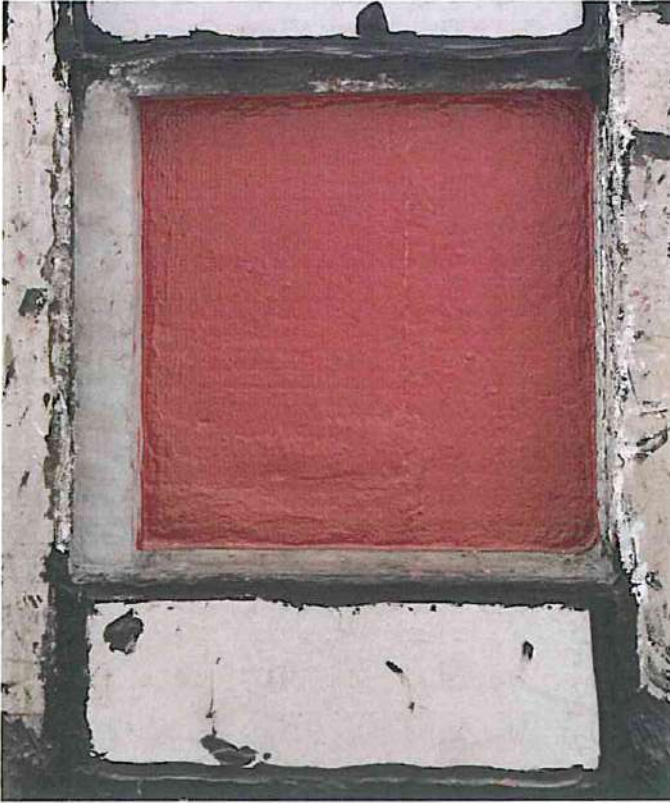
Photo 1: The unexposed face of specimen.

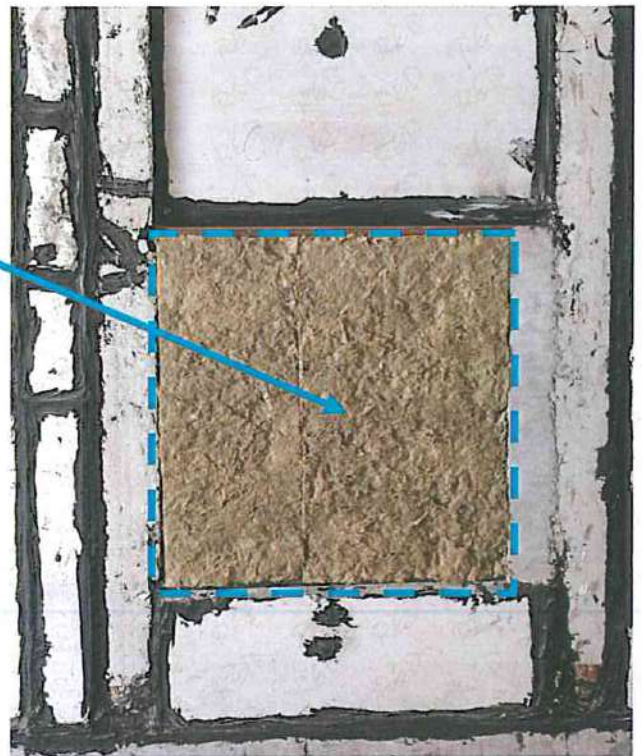
Photo 2: Exposed face of specimen before the test.

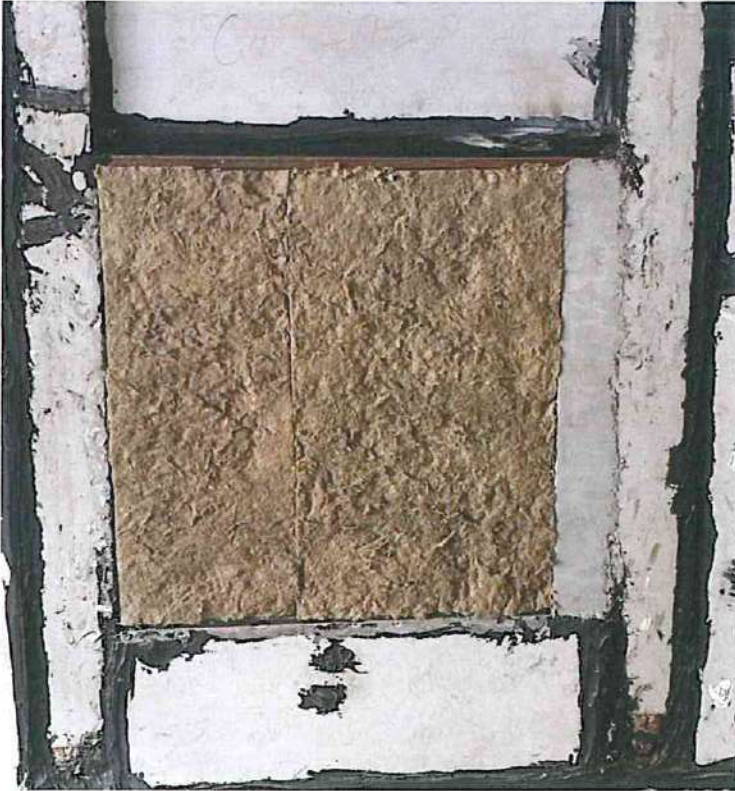
Photo 3: The exposed face of specimen after the test

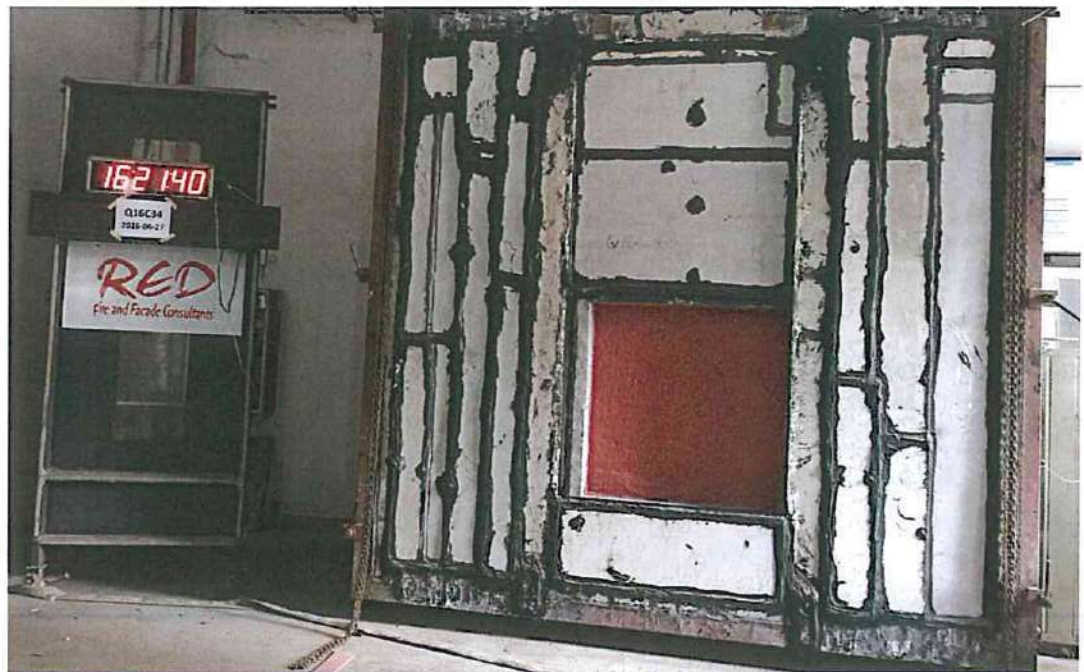
Photo 4: The unexposed face of the specimen during the test

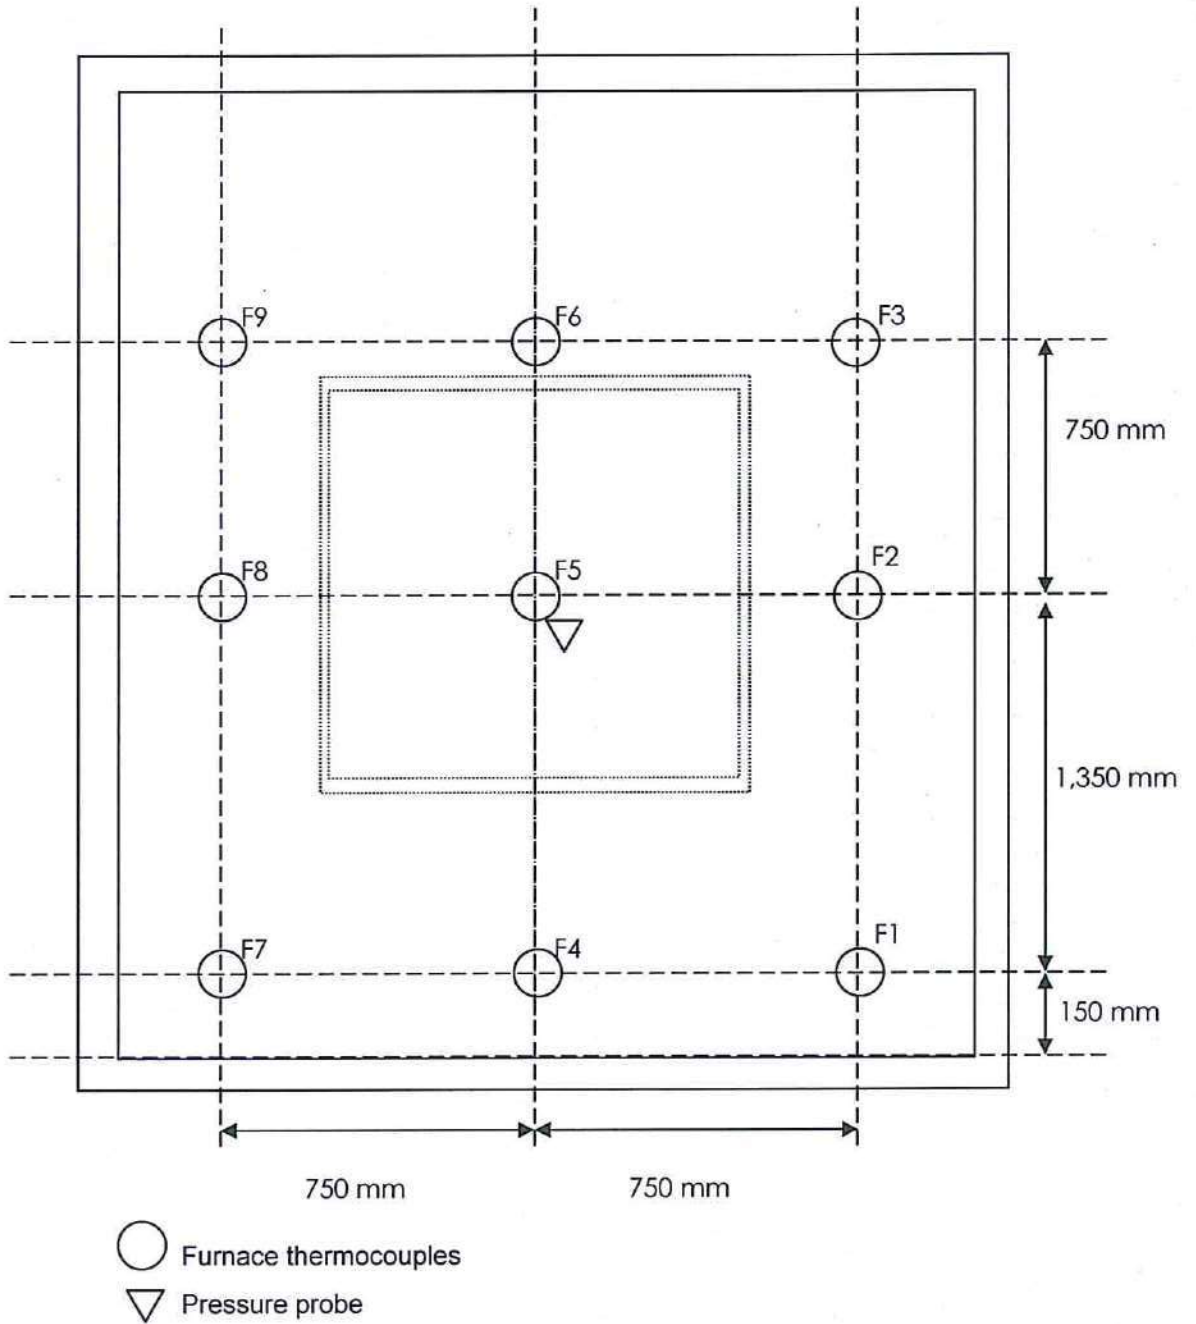
(The illustration not to scale)

Figure 1 – Locations and reference numbers of furnace thermocouples.

Nine (9) thermocouples to monitor the temperature of the test chamber, which were kept at 100 mm from the face of the specimen (see Figure 1).

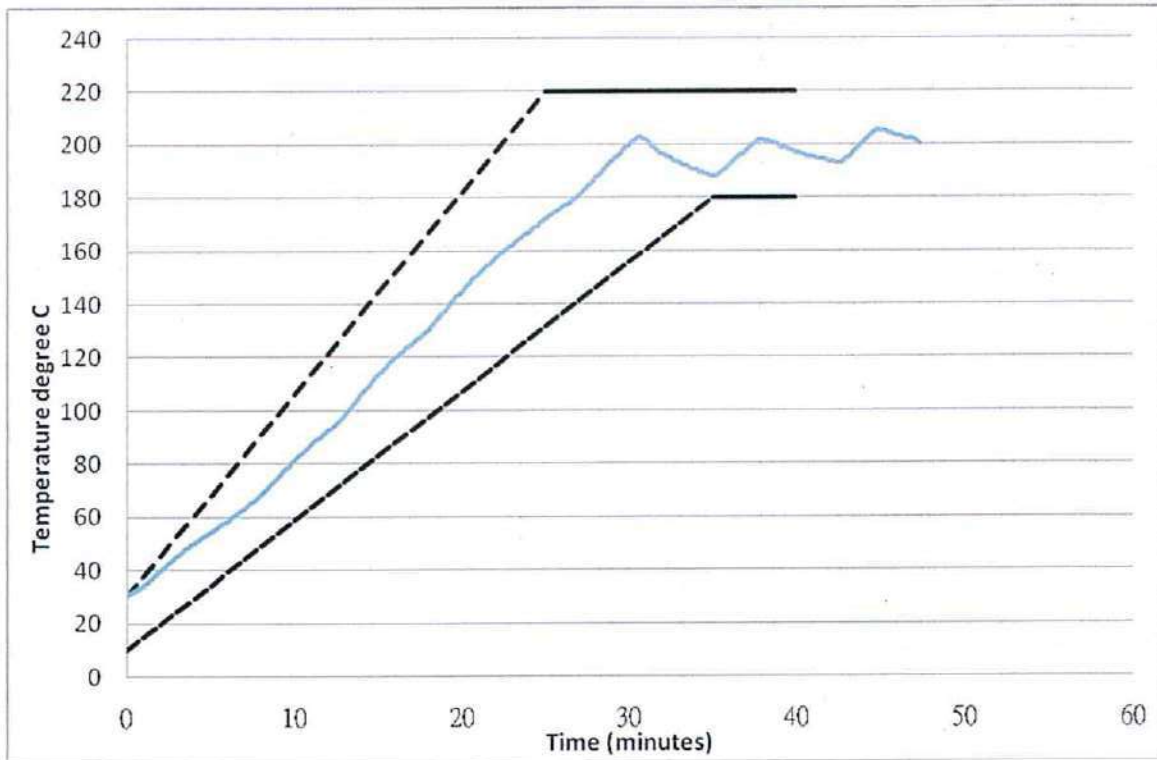
Figure 2 – Test chamber temperature (Medium Test)

The chamber was controlled so that the mean test chamber temperature at medium temperature test complied with the requirement of Clause 10.2.2.2 of BS EN 1634-3: 2004. The temperatures recorded are shown graphically in Figure 2.
