Hilti CP 606 Firestop Acrylic

Sealant Submission Folder

Flexible firestop sealant CP 606

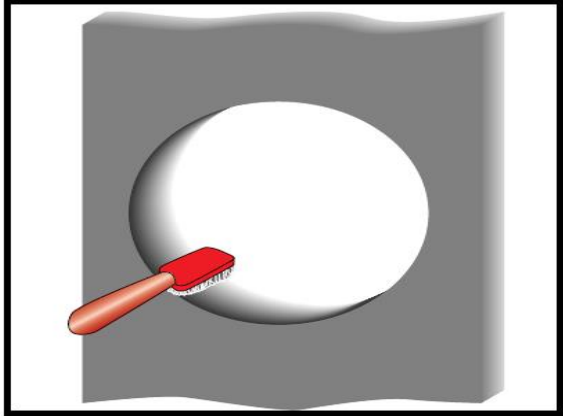
Setting Operation		
1	Clean the opening. Joint sides and surfaces to which CP 606 will be applied must be sound, dry and free from dust, oil and grease.

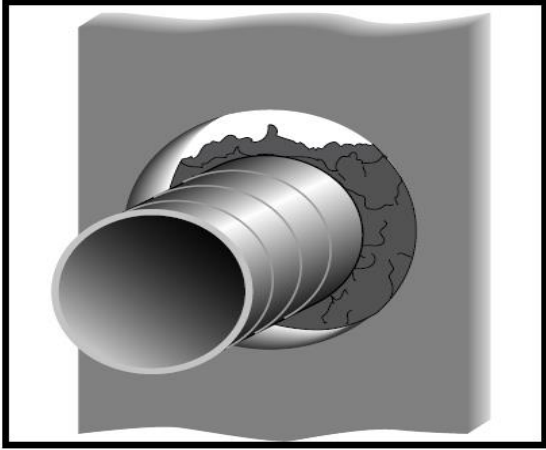
2	Insert the required fill of mineral wool and backer.

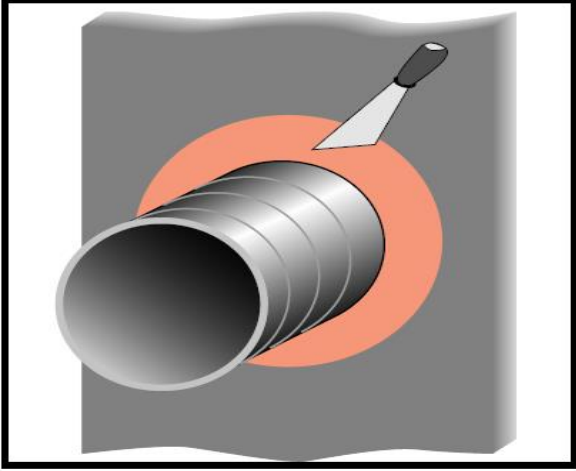
4	<p>Smooth the firestop sealant with a trowel before the skin forms. Once cured, CP 606 can only be removed mechanically.</p>

An illustration showing a grey pipe protruding from a grey wall. A red circular sealant is applied around the pipe. A trowel with a black handle and a silver blade is shown smoothing the sealant. The background is a light grey gradient.
5	<p>For maintenance reasons, a penetration seal could be permanently marked with an identification plate. In such a case, mark the identification plate and fasten it in a visible position next to the seal.</p>

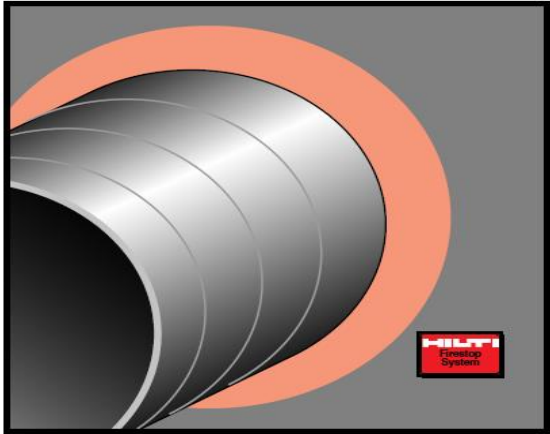
An illustration showing a grey pipe protruding from a grey wall. A red circular sealant is applied around the pipe. A small red identification plate with the HILTI logo and the text 'Firestop Systems' is fastened to the wall next to the sealant. The background is a light grey gradient.

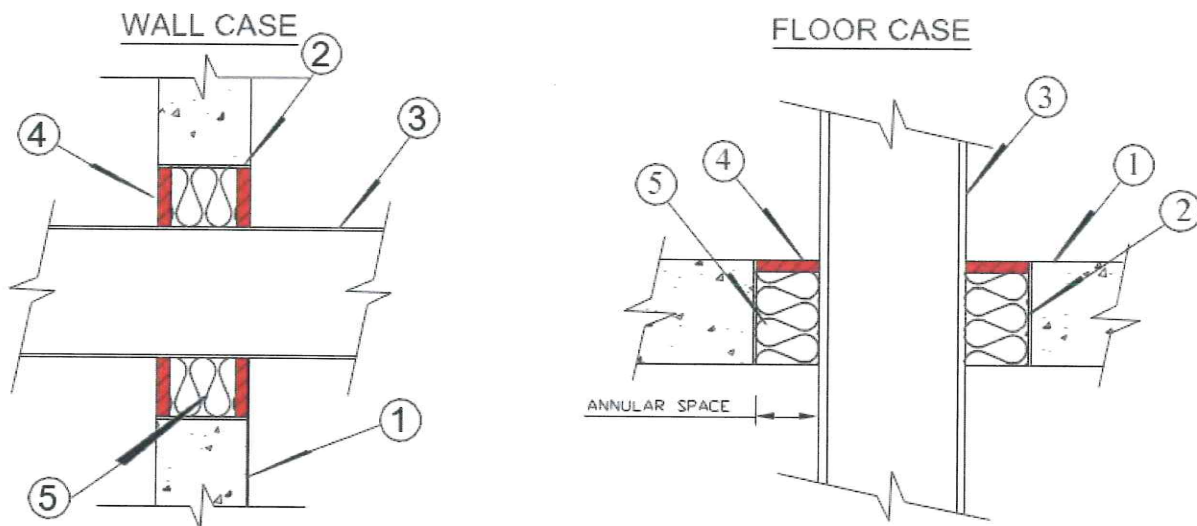
Drawing refers to Table 4.2.1 & 4.2.2 on metal pipe penetration application by using CP606 or CP601S

1. FLOOR ASSEMBLY: CONCRETE FLOOR
WALL ASSEMBLY: CONCRETE WALL OR FIRE-RATED BLOCK WALL
2. OPTIONAL: METAL SLEEVE
3. REPENETRATING ITEM: STEEL/CAST/D.I./COPPER PIPE
4. CP606 / CP601S
5. MINIMUM 100 KG/M³ DENSITY MINERAL WOOL AS BACKING MATERIAL

- (b) The annual gaps at the pipe penetration may be maximum 42 mm wide or narrower;
- (c) The condition of penetration sealing using either CP606 or CP601S for various type of pipe, pipe diameter, pipe wall thickness, depth of sealant to be applied, the conditions of backing mineral wool and the expected fire resistance performance are as given in the tables below;

- (d) The condition of penetration sealing using the CP 606 backed with Hilti CF-F 750 filling foam may be used, but the pipe diameter may be up to 50 mm for copper pipe and up to 140 mm for steel pipe. Also the width of annular gap need to reduce to 10 mm.
