Hilti CP643N Firestop Collar

Submission Folder

Firestop collar CP 643 N

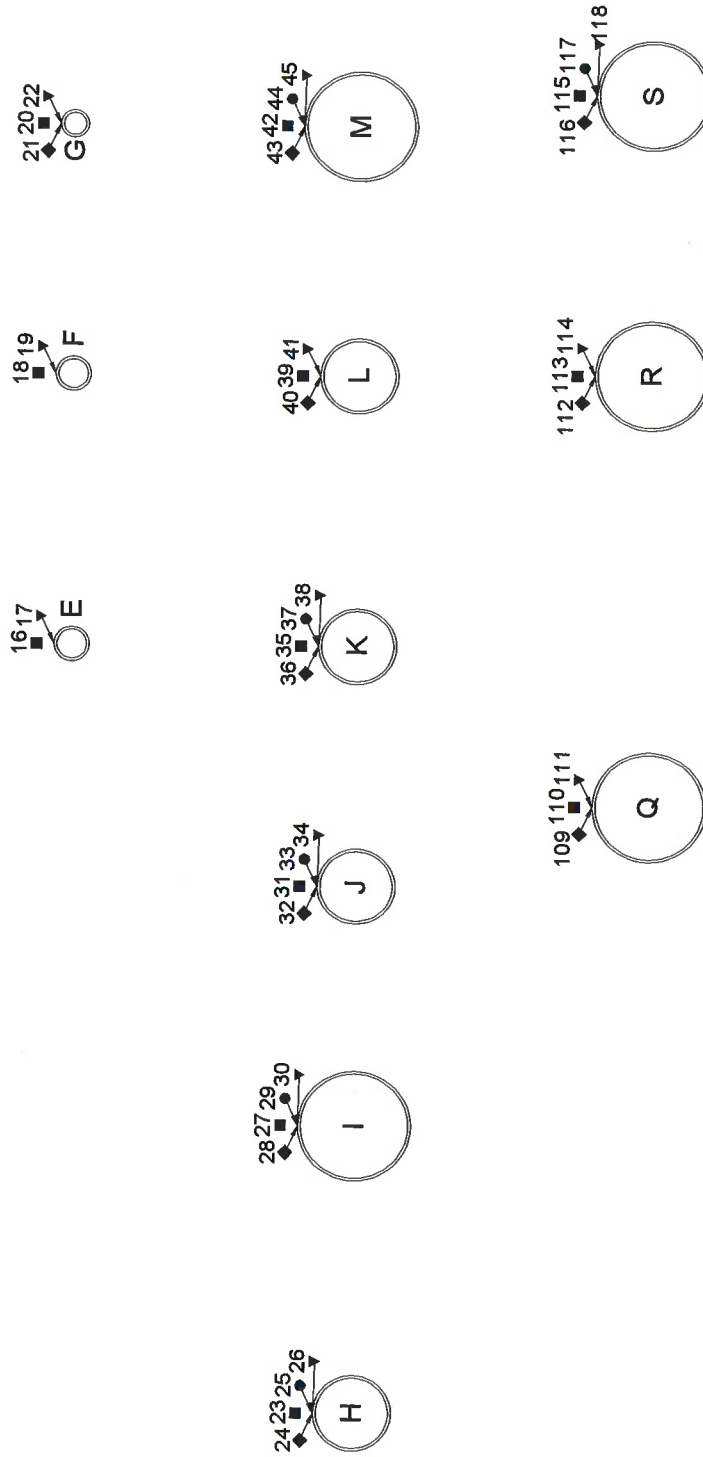
■◆▼ Positions of thermocouples, also refer to Figures 3 & 4

THEMOCOUPE POSITIONS

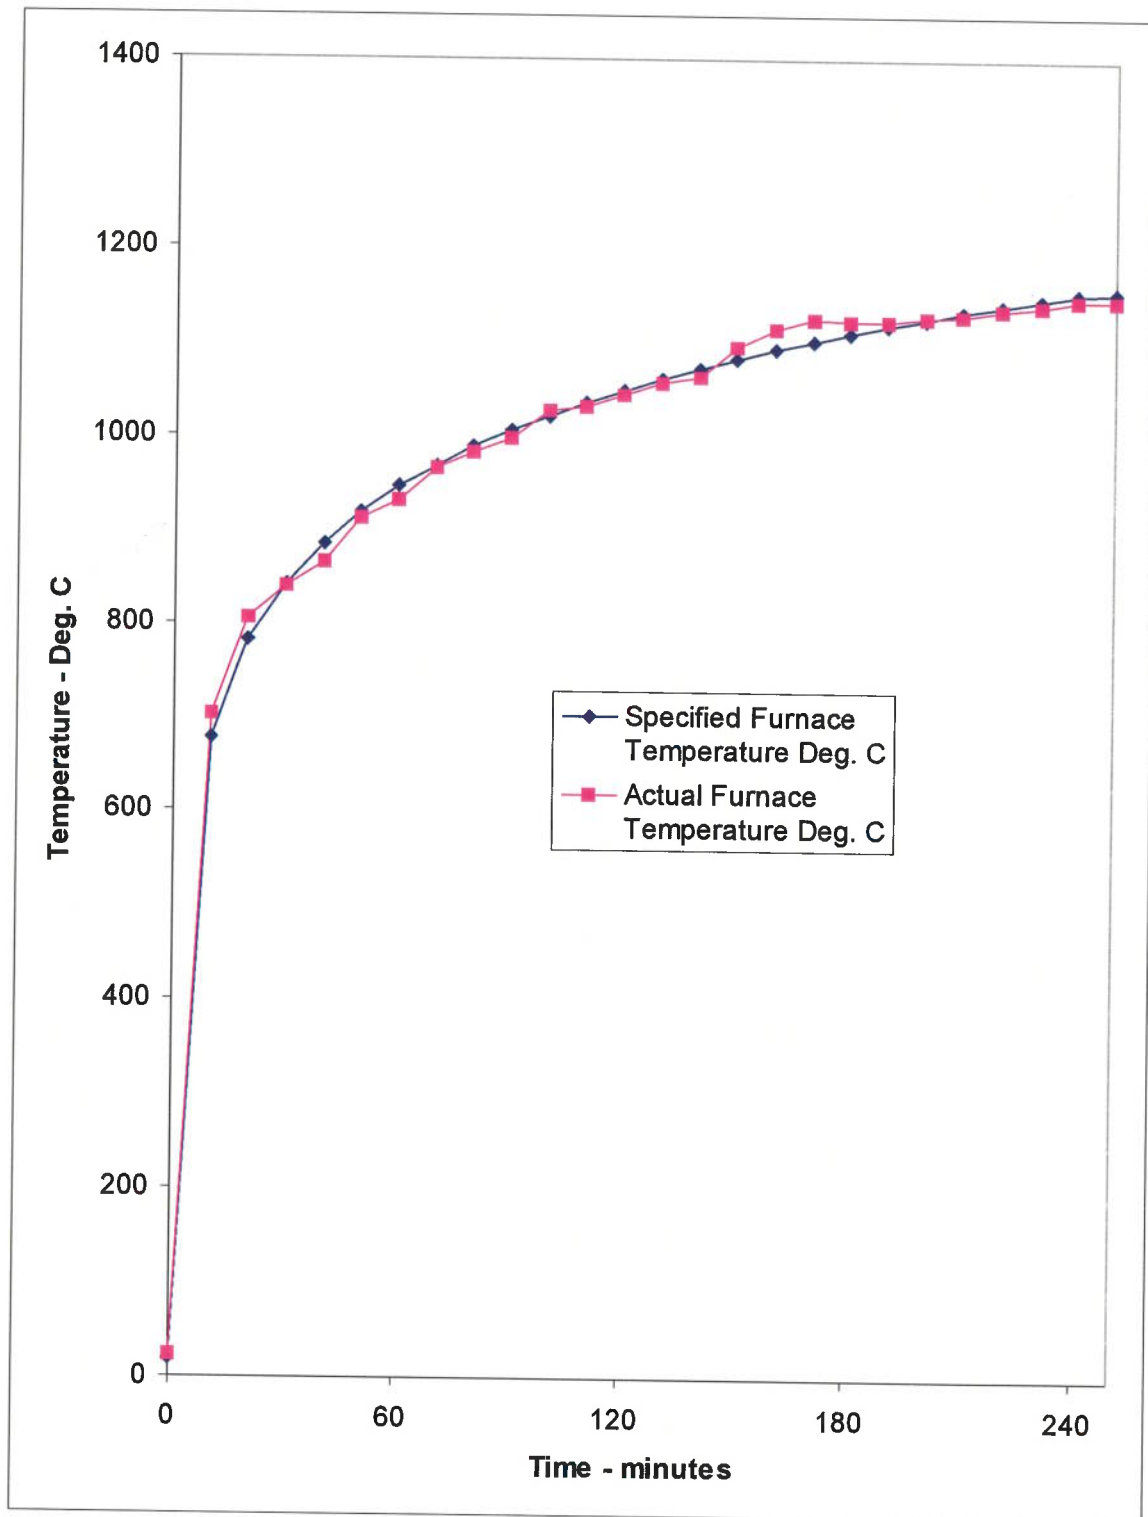
Graph 1

Specified and Actual Furnace Temperatures

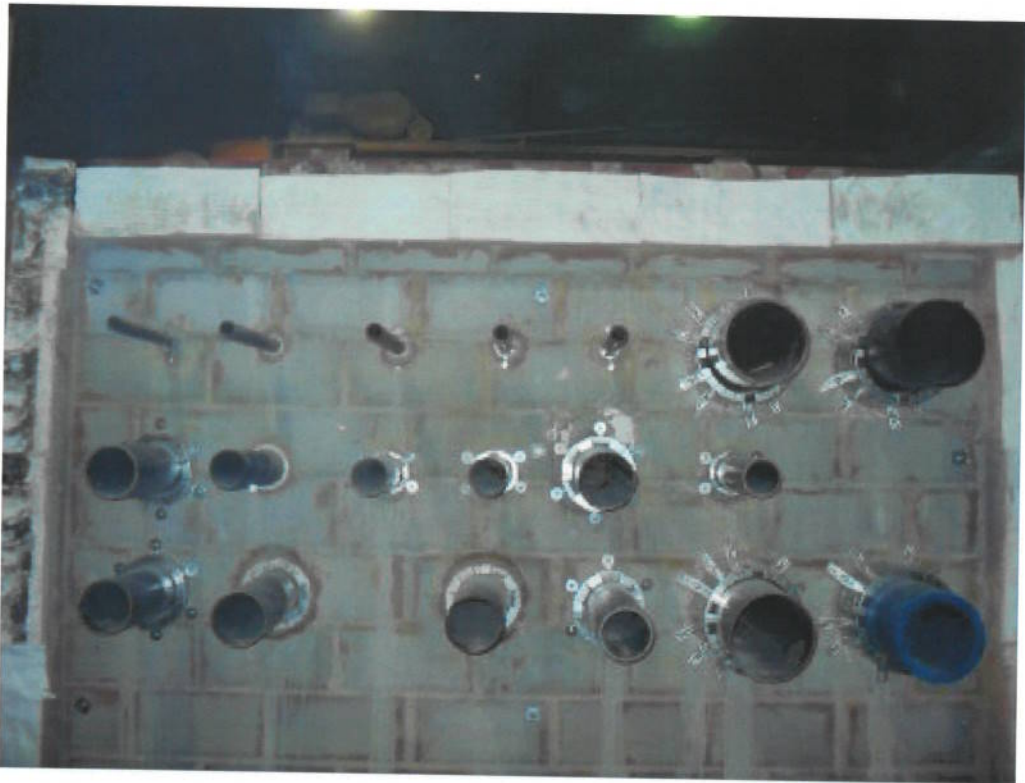
- Plate 1 : Showing the exposed face of the assembly prior to the test
- Plate 2 : Showing the unexposed face of the assembly prior to the test
- Plate 3 : Showing the unexposed face of the assembly during the test
- Plate 4 : Showing the unexposed face of the assembly during the test
- Plate 5 : Showing the unexposed face of the assembly during the test
- Plate 6 : Showing the unexposed face of the assembly during the test
- Plate 7 : Showing the unexposed face of the assembly during the test
- Plate 8 : Showing the unexposed face of the assembly during the test
- Plate 9 : Showing the unexposed face of the assembly during the test
- Plate 10 : Showing the exposed face of the assembly directly after the test

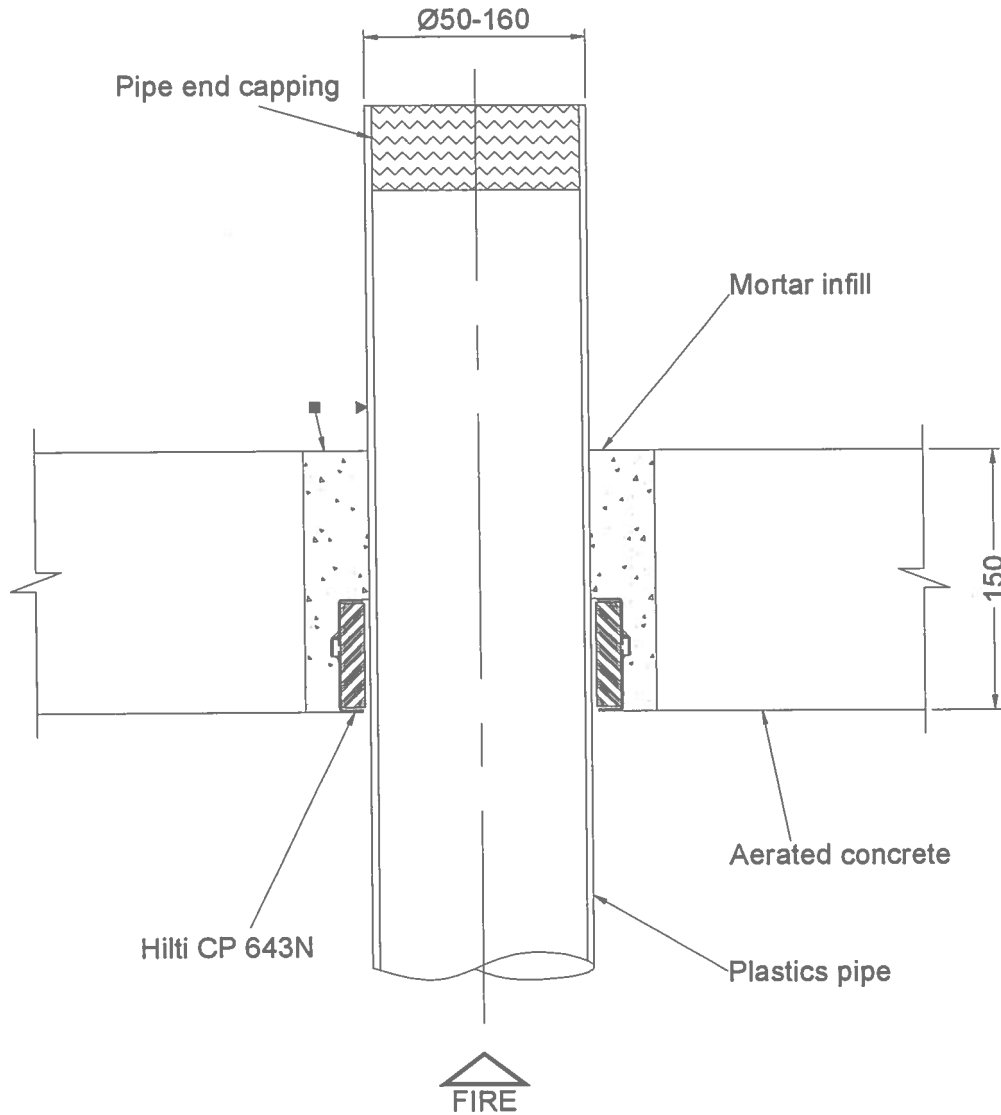
FIGURE 3

TYPICAL SECTION THROUGH
SPECIMENS REFERENCED P, Q, R, U, V & W

■ ▼ Positions of thermocouples relating to Figure 2

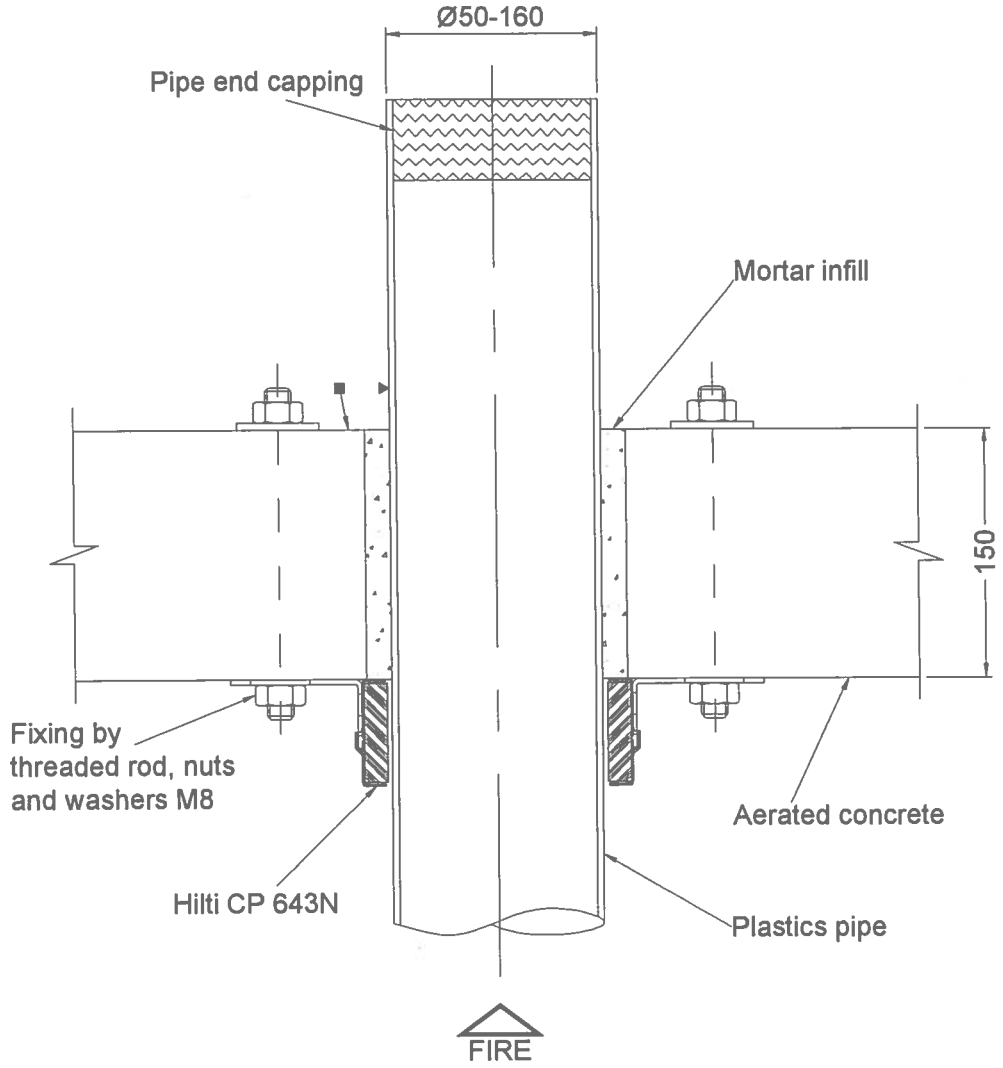
TYPICAL SECTION THROUGH
SPECIMENS REFERENCED M, N, O, S, T, X & Y

▀ ▾ Positions of thermocouples relating to Figure 2

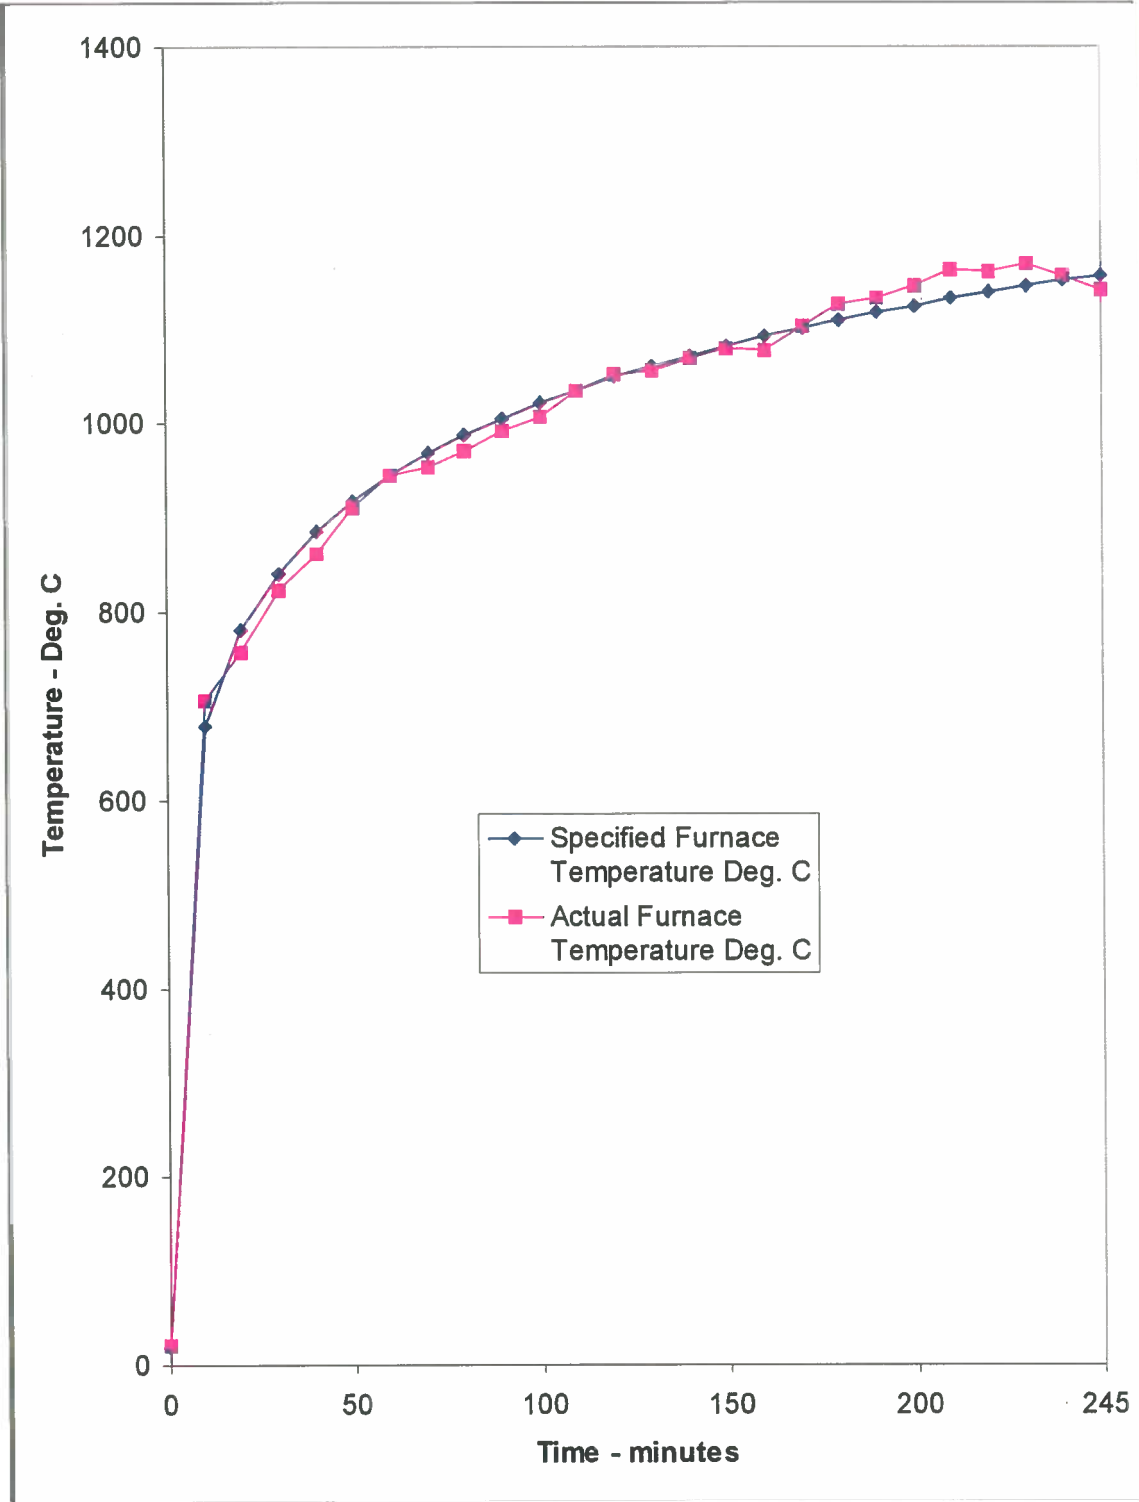
Graph 1

Specified and Actual Furnace Temperatures

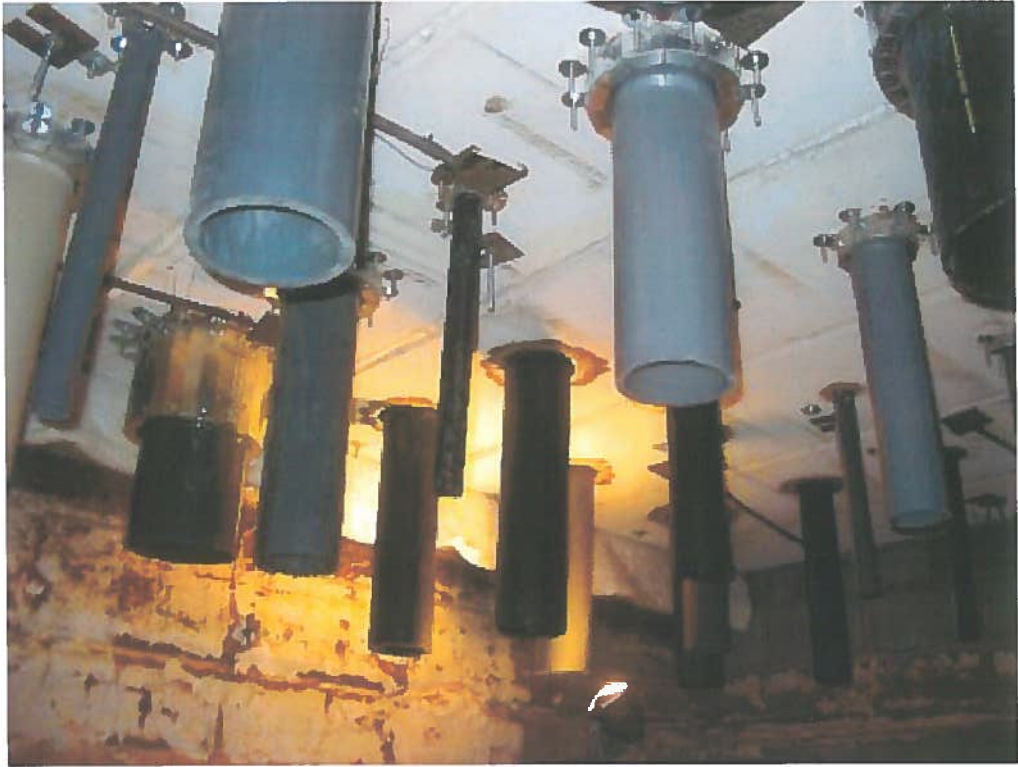
- Plate 1 : Showing the exposed face of the specimens prior to the test
- Plate 2 : Showing the exposed face of the specimens prior to the test
- Plate 3 : Showing the exposed face of the specimens prior to the test
- Plate 4 : Showing the unexposed face of the specimens during the test
- Plate 5 : Showing the unexposed face of the specimens during the test
- Plate 6 : Showing the unexposed face of the specimens during the test
- Plate 7 : Showing the unexposed face of the specimens during the test
- Plate 8 : Showing the unexposed face of the specimens during the test
- Plate 9 : Showing the unexposed face of the specimens during the test
- Plate 10: Showing the unexposed face of the specimens directly after the test
