# Hilti HIT-RE100 Epoxy Anchor

## (Post-Installed Rebar) Submission Folder

Product Information	2
Technical Data & Setting Details	7
Test Reports	
Loading test report (BS5080: Part 1)	11
Letters	
Country of Origin	67
Phase-in Letter	68
Material Safety Data Sheet	69
Job Reference	92

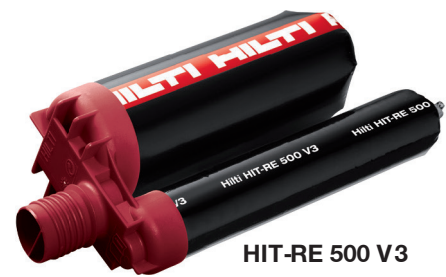
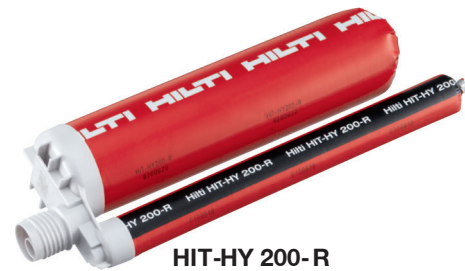
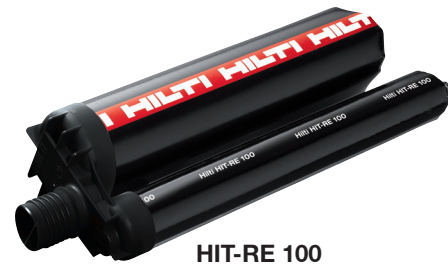
Hilti **SAFE-ET** Technology eliminates the most load-affecting and time-consuming step in the installation process: cleaning the hole before injection of the adhesive. As a consequence, engineers can now have peace of mind because the specified application will perform on the jobsite as it has been designed in the plan.
